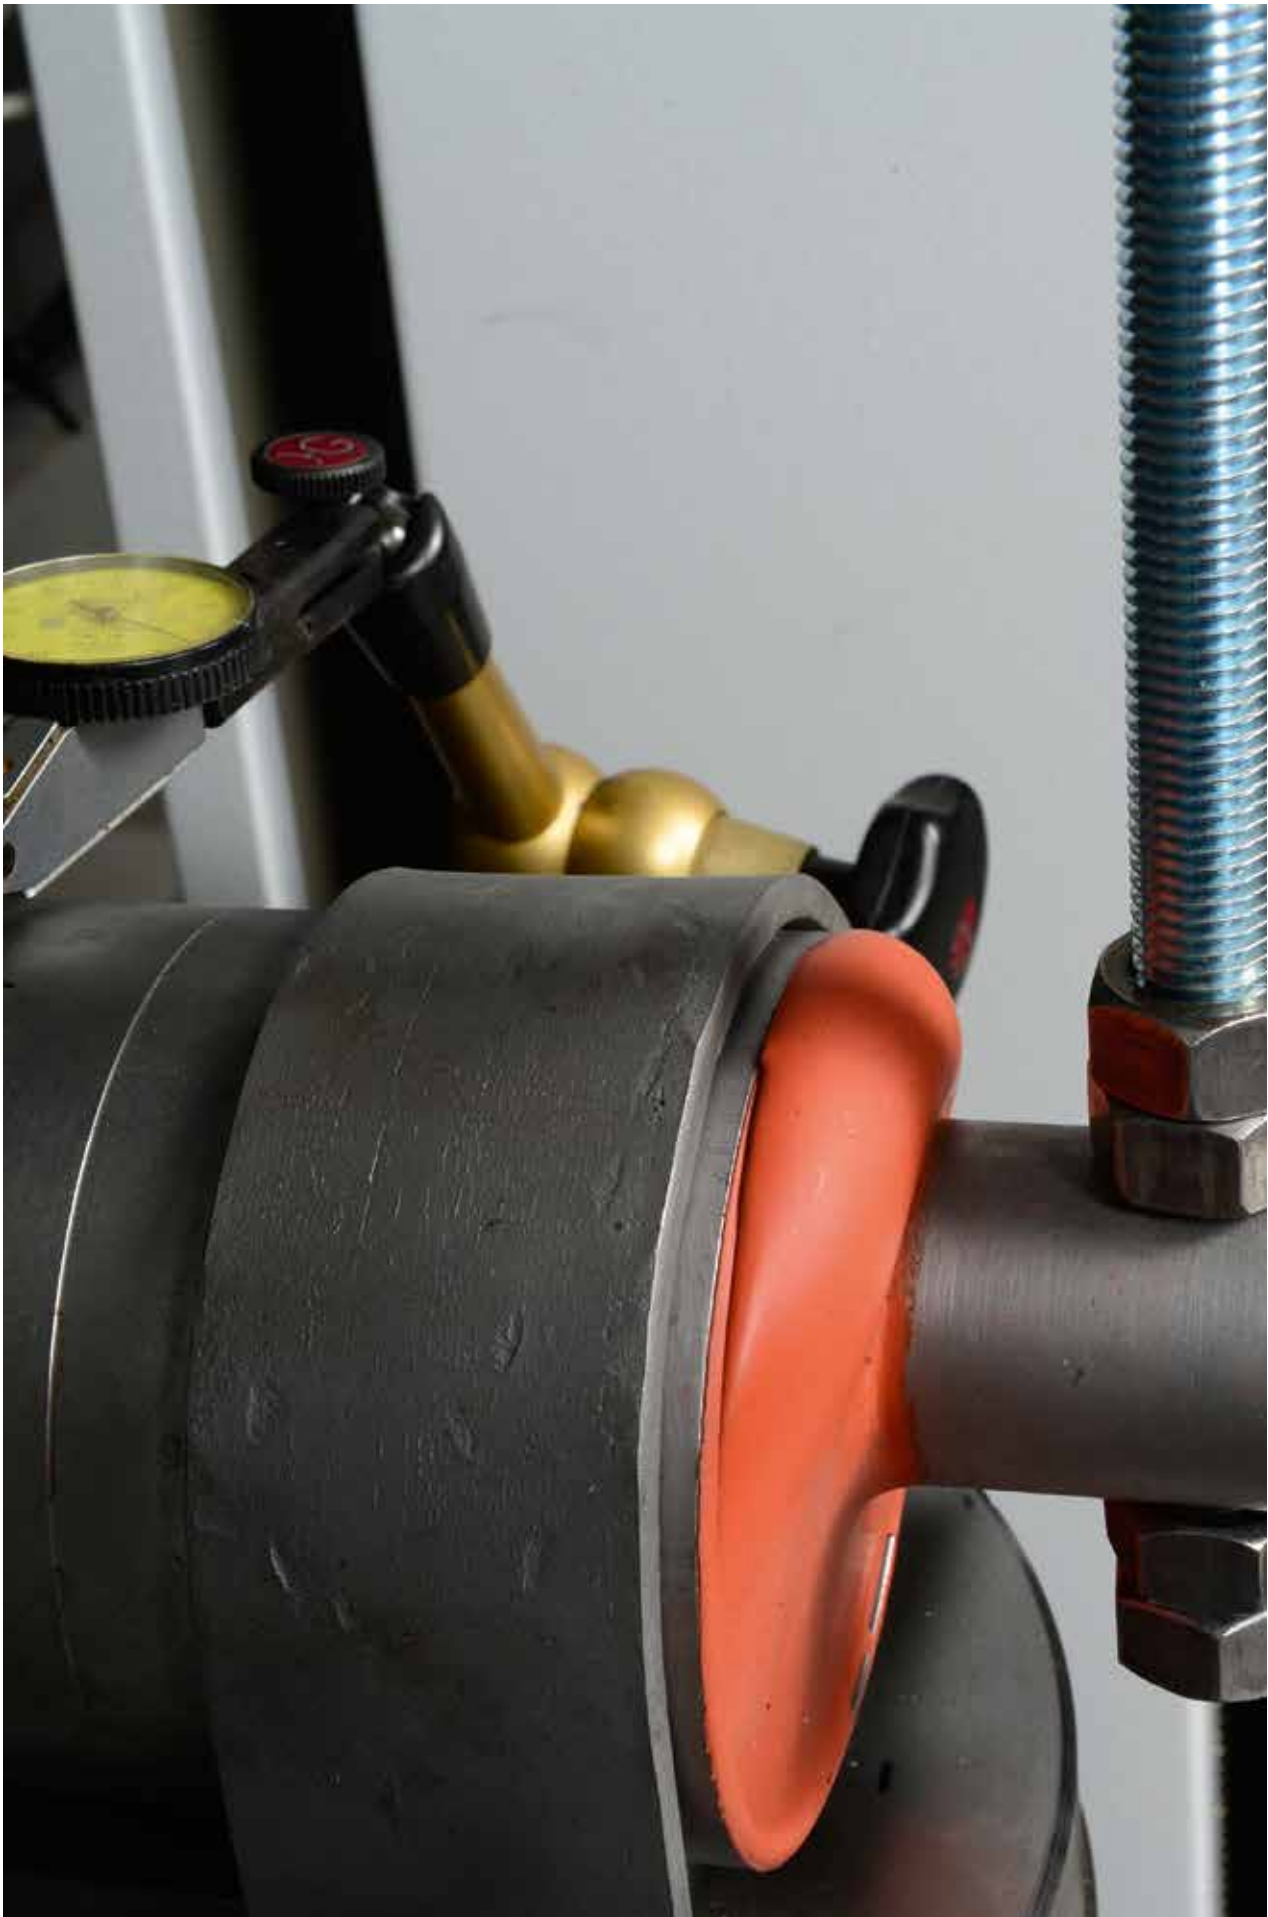
Movement fully downwards. Due to the bulging of the sealant layer over the edge of the conduit sleeve a rupture is visible. However, it is not a full loss of adhesion of the sealant layer.

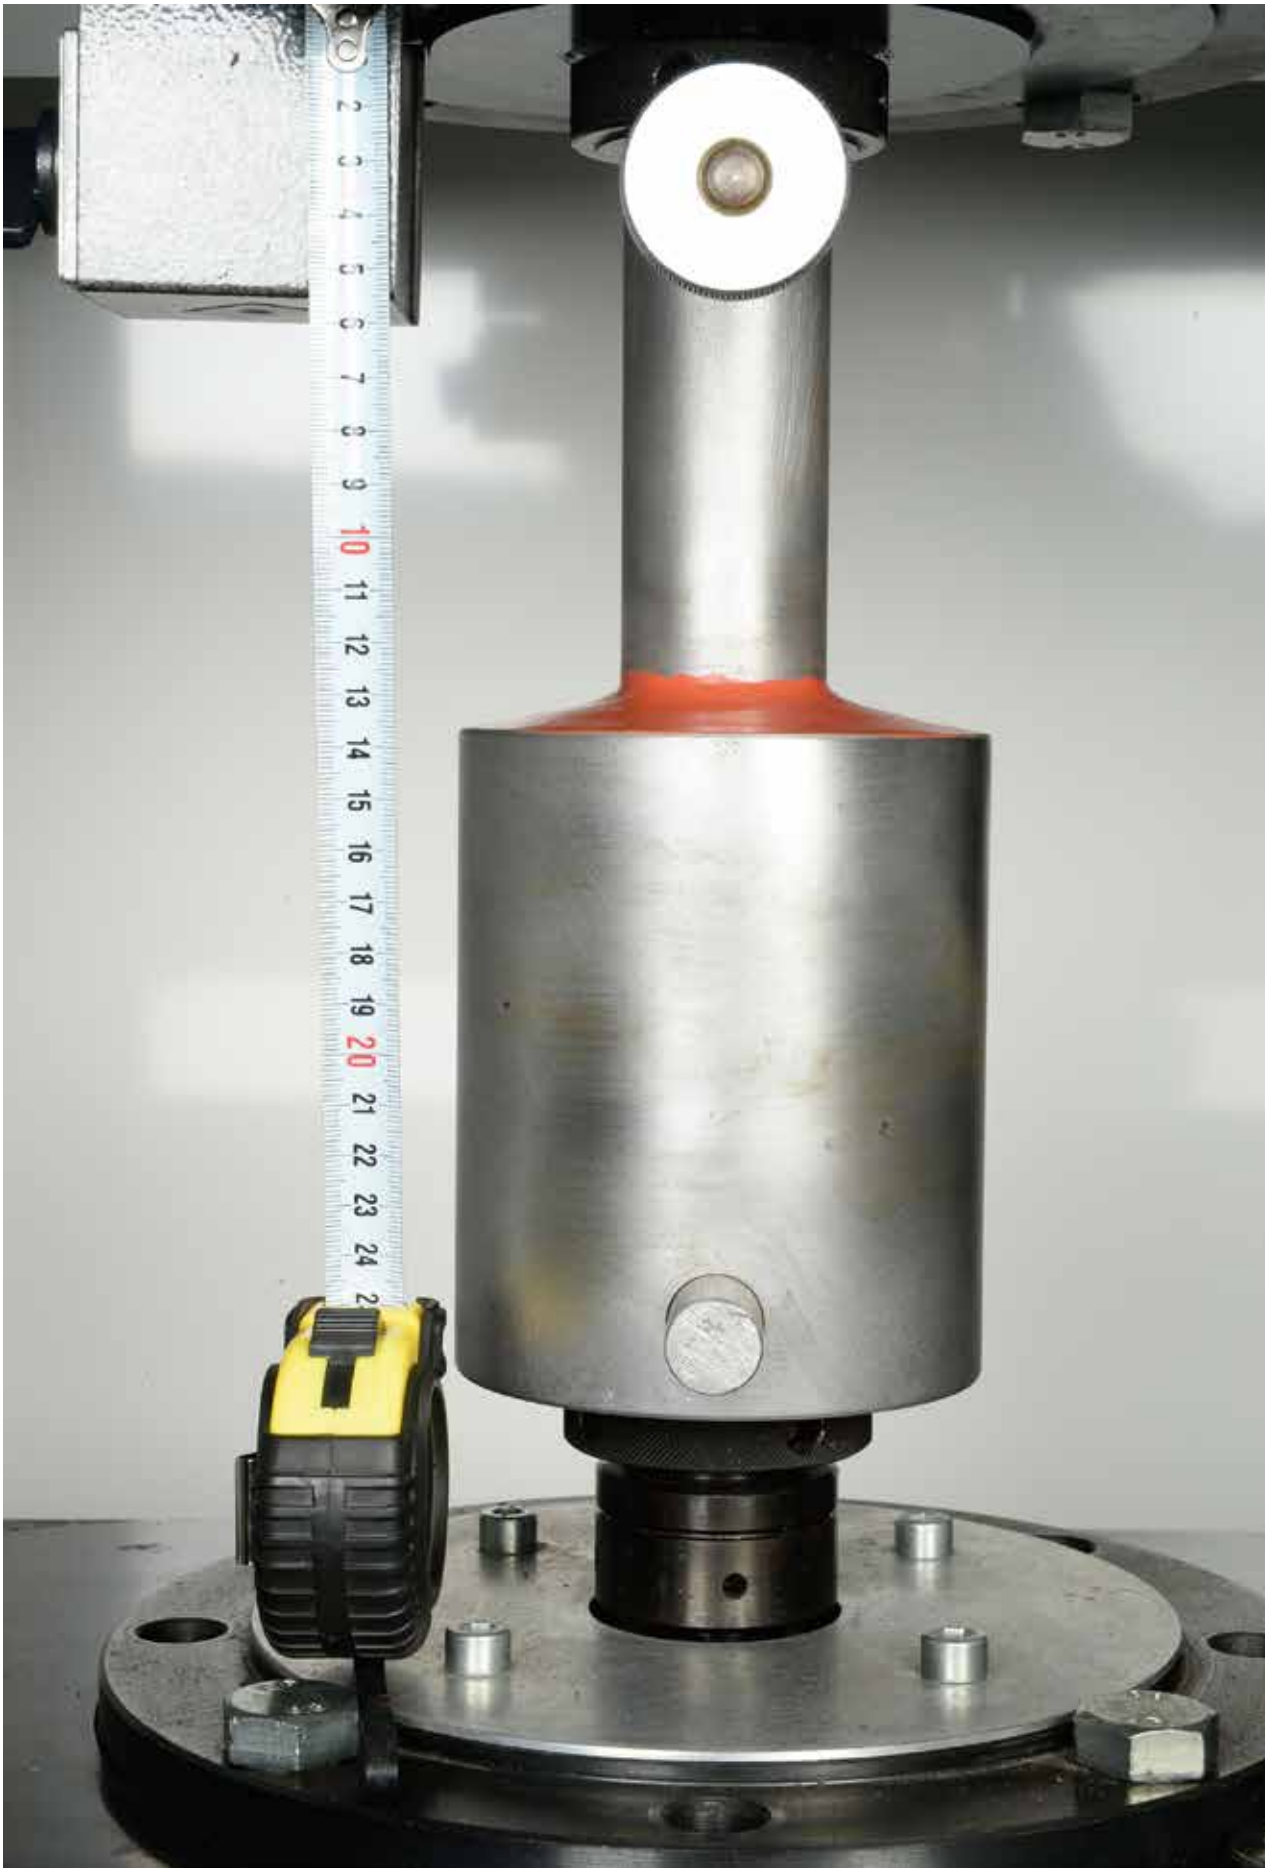
On top compression, at the bottom stretch. Total displacement 20 mm. Initially 60 cycles have been exposed to the sealing system. Exposure at 7 different speeds have been investigated.

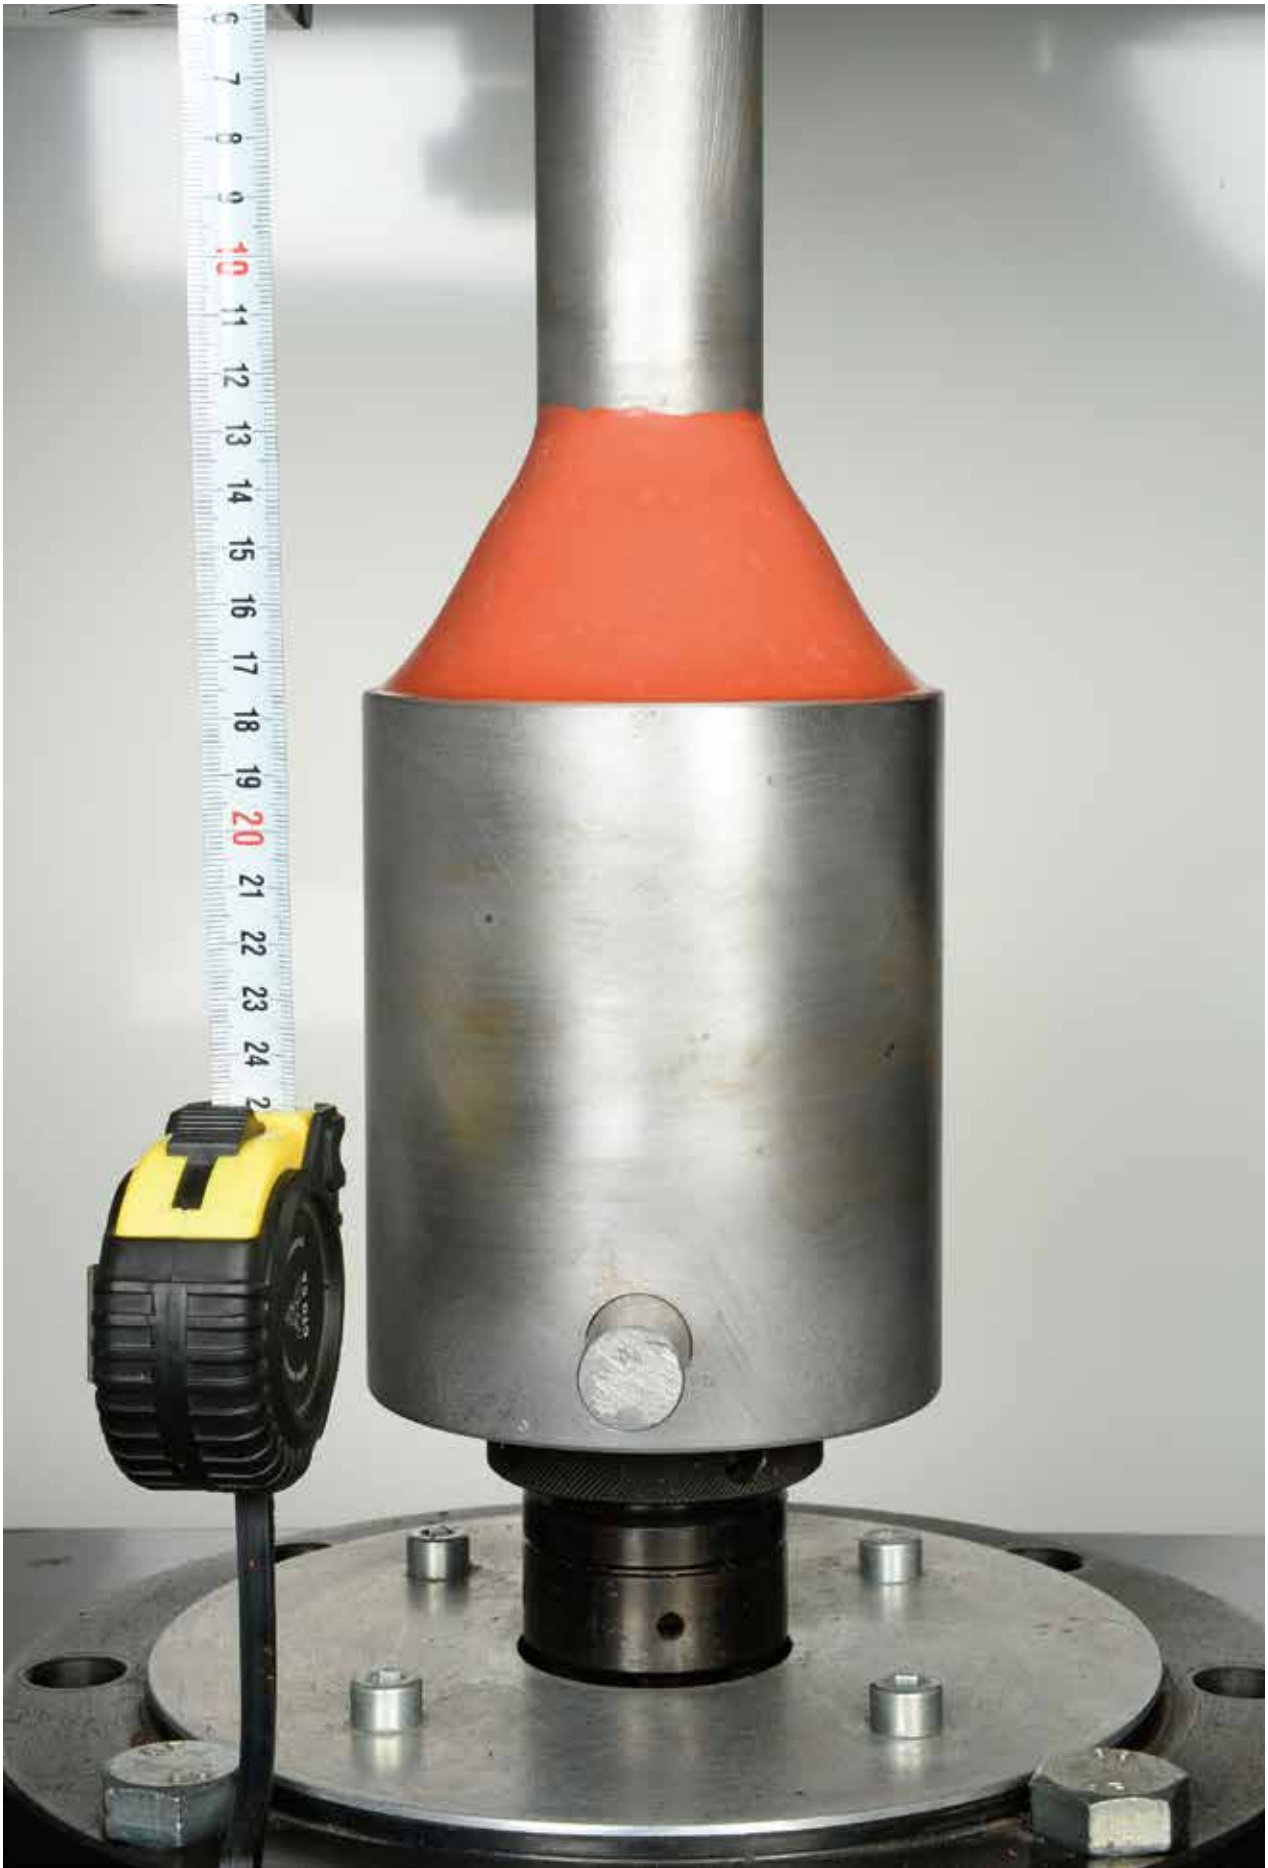
Movement of 30 mm. Stretch of the layer $141\% = (\sqrt{3^2+3^2}):3$

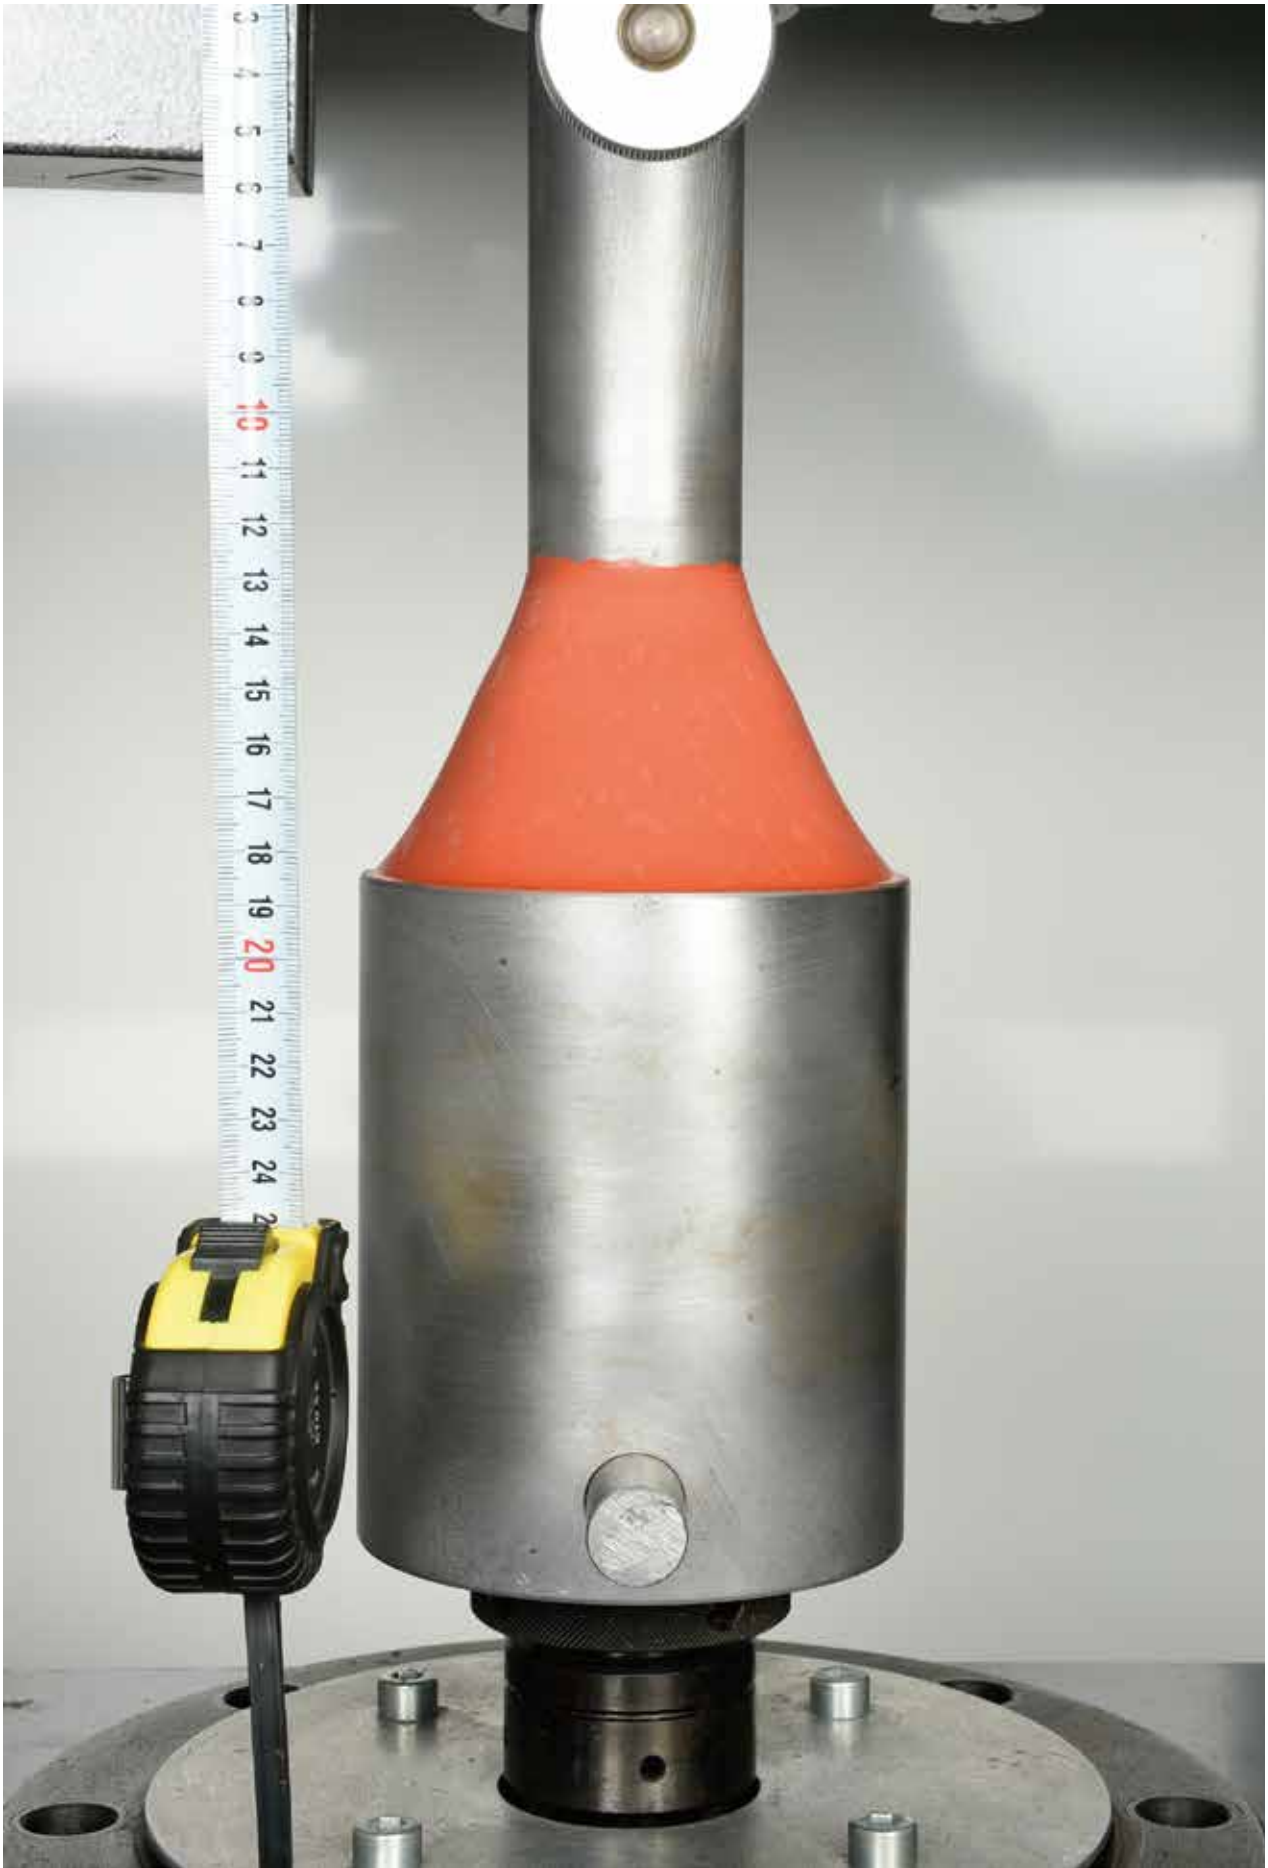
Movement of 40 mm. Stretch of the layer $167\% = (\sqrt{3^2+4^2}):3$
