## **TEST REPORT**

# PF25097

# Fire resistance test for penetrations passing through a horizontal separating element

Client: Firestop Centre Ltd

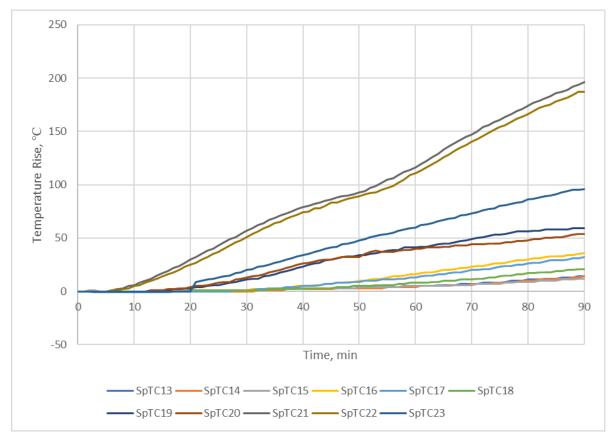
Test results		
Structural adequacy	Not applicable	
Integrity	No failure at 91 minutes	
Insulation	83 minutes

Figure 4 - Specimen 1 thermocouple temperature rise readings

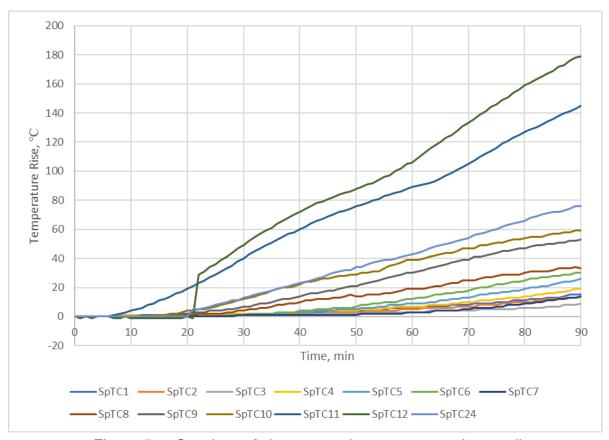
Test results		
Structural adequacy	Not applicable	
Integrity	No failure at 91 minutes	
Insulation	91 minutes

Figure 5 - Specimen 2 thermocouple temperature rise readings

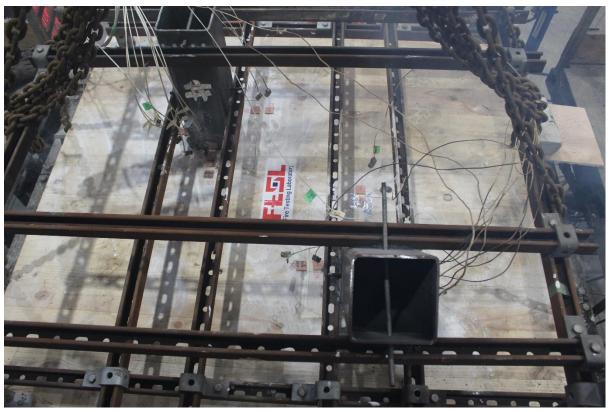
Figure 14 - Unexposed face at 60 minutes

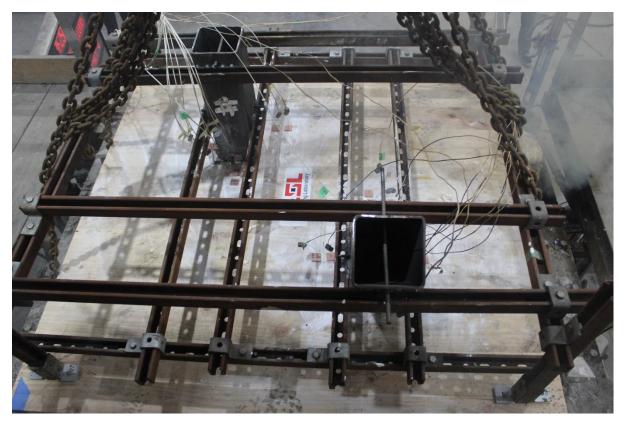
Time min	Test face	SP#	OBSERVATIONS/REMARKS
15	U	1, 2	No major changes observed
30	U	1, 2	No major changes observed
38	U	2	Moisture visible on mortar
60	U	1, 2	No major changes observed
75	U	1, 2	No major changes observed
80	U	2	Crack developed in CLT next to the specimen
88	U	SE	Smoke coming through knot in CLT
91			TEST DISCONTINUED

Figure 16 - Unexposed face at 90 minutes

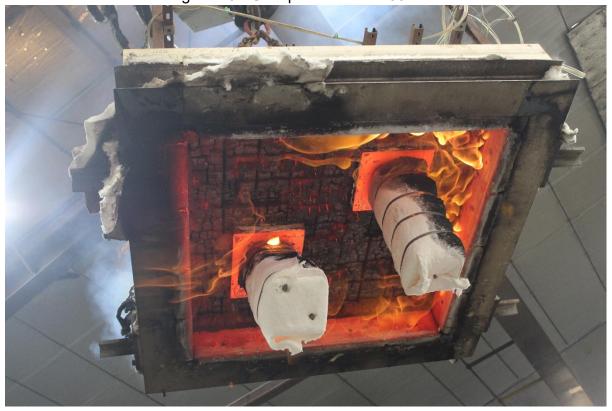
Figure 17 - Exposed face after the test
