# **Test report # PF23016**

**Client: Tech Coatings NZ Limited**

**Fire resistance test for the steel penetrations  
through the wall**

**Test method: AS 1530.4:2014**

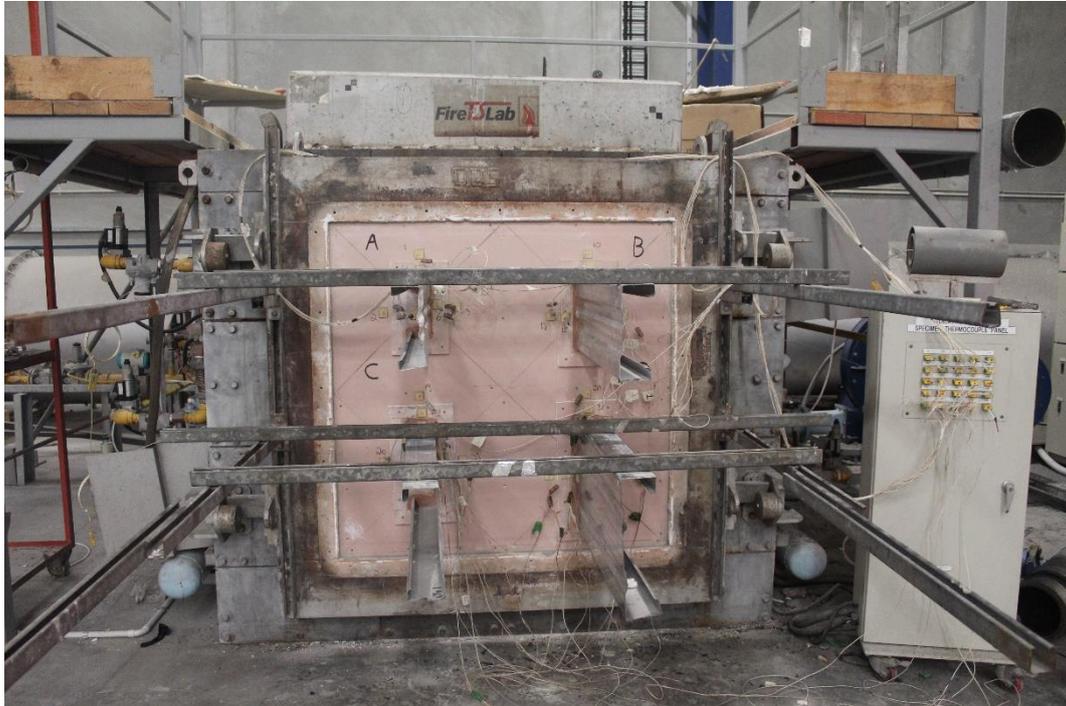
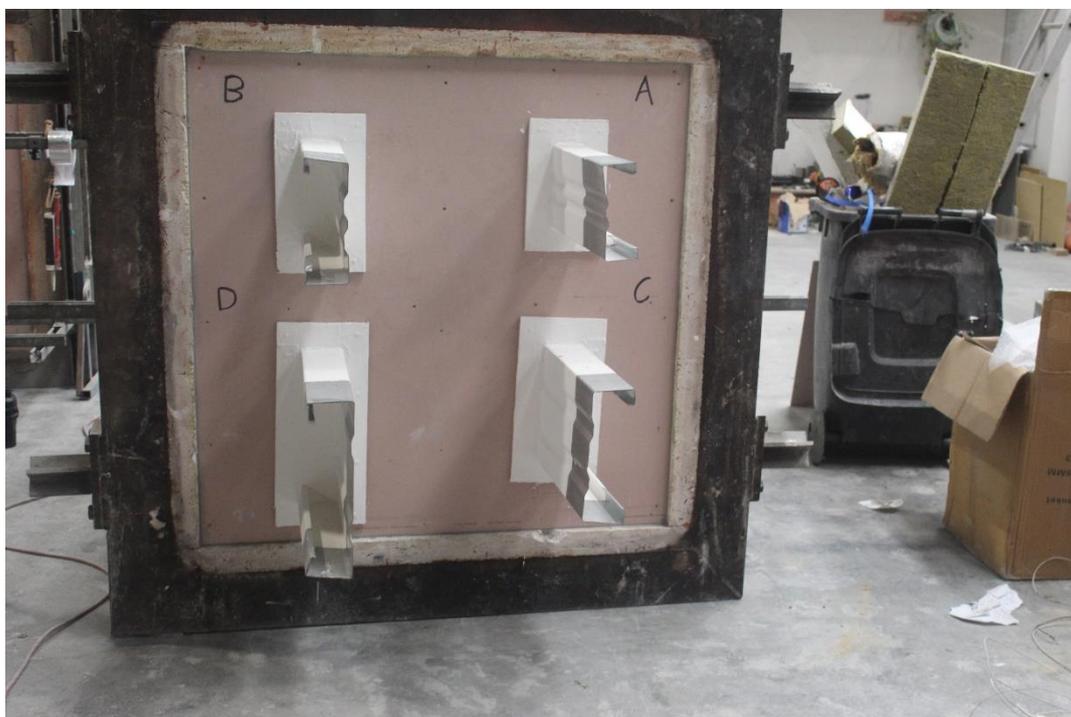
Time Minutes	Test Face	SP#	Observations
4	E	ALL	Coating expansion on all the specimens
5	U	B	Visible smoke top right corner above specimen B
8	U	D	Visible smoke on the left side of the plasterboard pattress
10	U	A	Visible smoke on the left side of the plasterboard pattress
17	U	D	Noticeable smoke at the bottom of the purlin
20	U	A	Visible smoke top left corner above specimen A
22	U	D	Large increase in amount of smoke at the bottom of the purlin
25	E	ALL	Further expansion of the coating
30	U	ALL	No notable changes
31	E	A	Small visible cracking on the coating (between coating and plasterboard patch)
37	U	A	Increased amount of smoke
45	U	D	Discolouring at the top side of the plasterboard pattress
45	U	D	Discolouring at the left side of the plasterboard pattress
50	E	ALL	No notable changes
60	U	ALL	No notable changes
67			TEST DISCONTINUED

Fig.1 – Test specimens. Unexposed (top) and exposed (bottom) face.

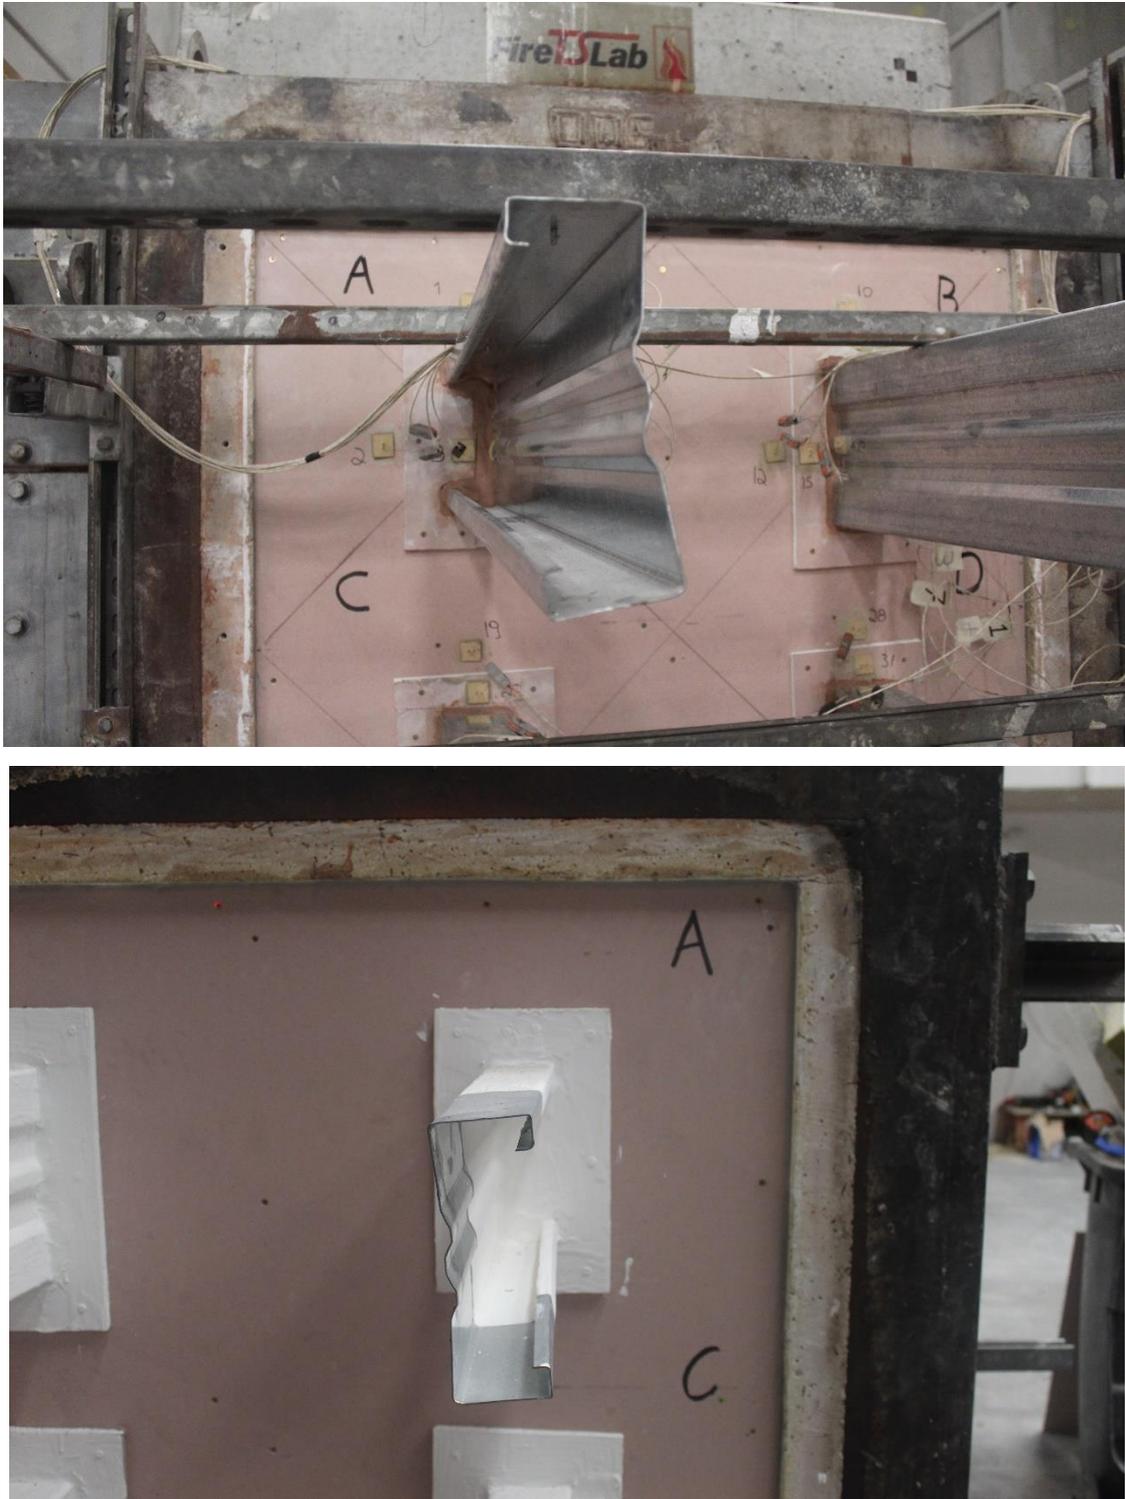
Fig.2 – Specimen A. Unexposed (top) and exposed (bottom) face.

<b>Structural adequacy</b>	<b>Not applicable</b>
<b>Integrity</b>	<b>No failure at 63 min</b>
<b>Insulation</b>	<b>No failure at 63 min</b>

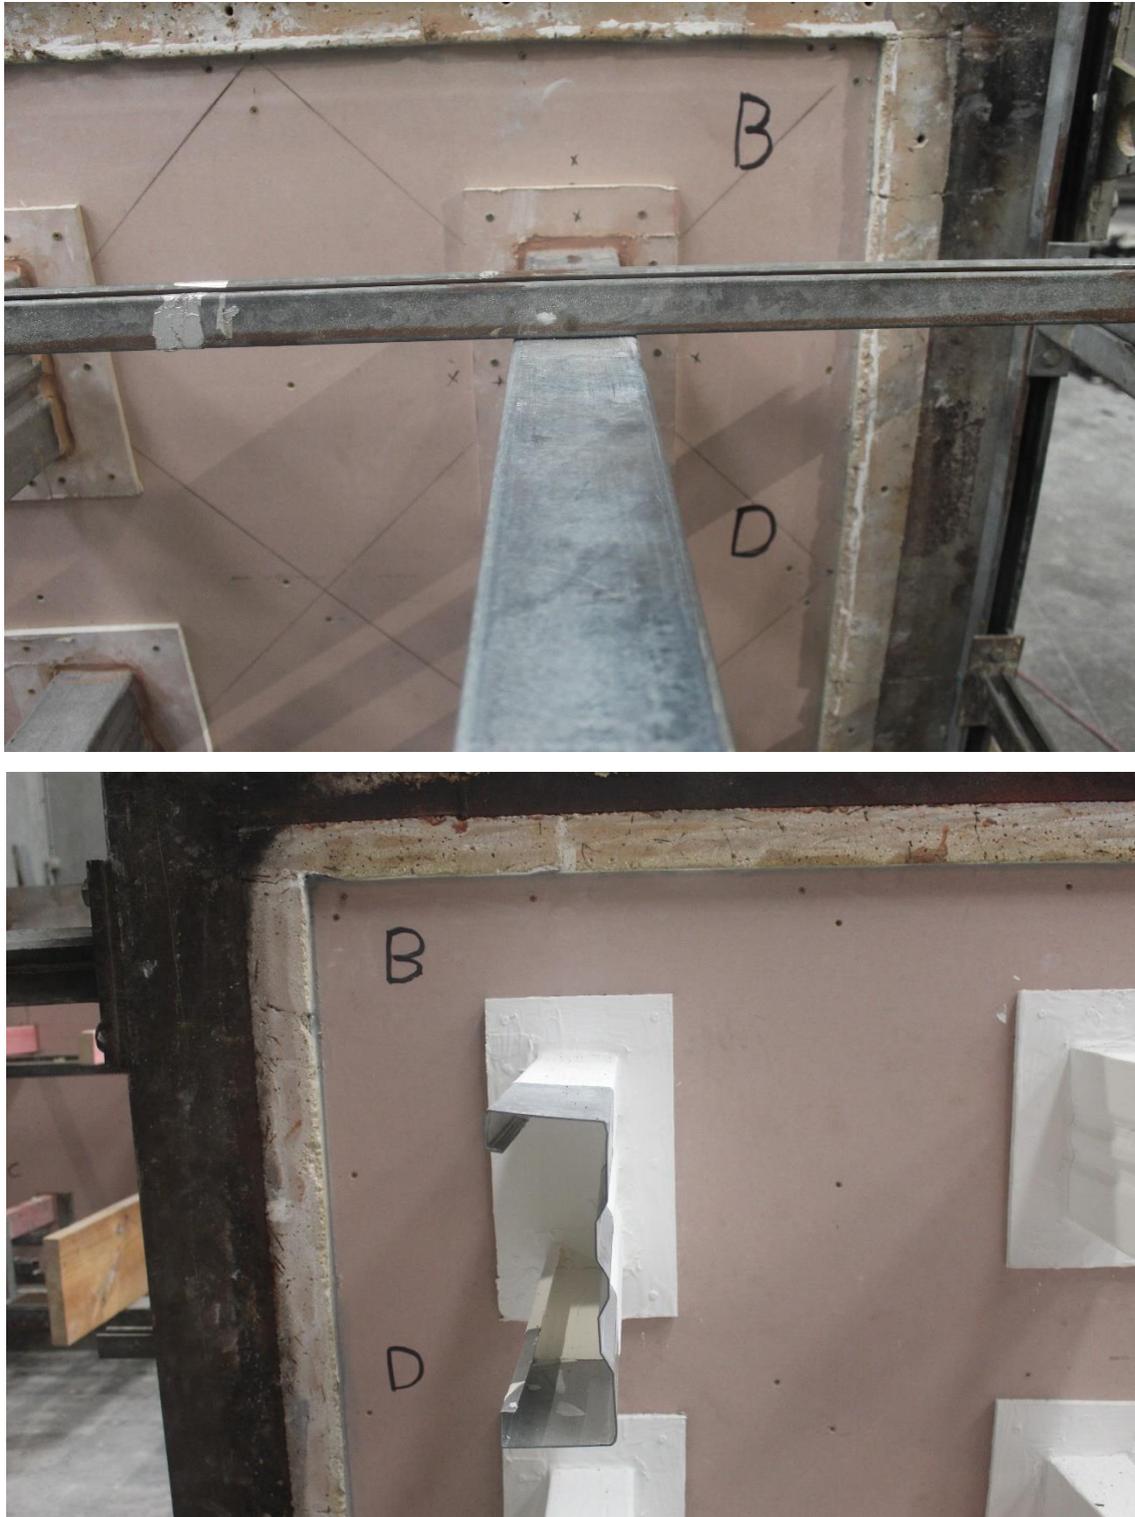
Fig. 5 – Specimen B. Unexposed (top) and exposed (bottom) face.

<b>Structural adequacy</b>	<b>Not applicable</b>
<b>Integrity</b>	<b>No failure at 63 min</b>
<b>Insulation</b>	<b>No failure at 63 min</b>

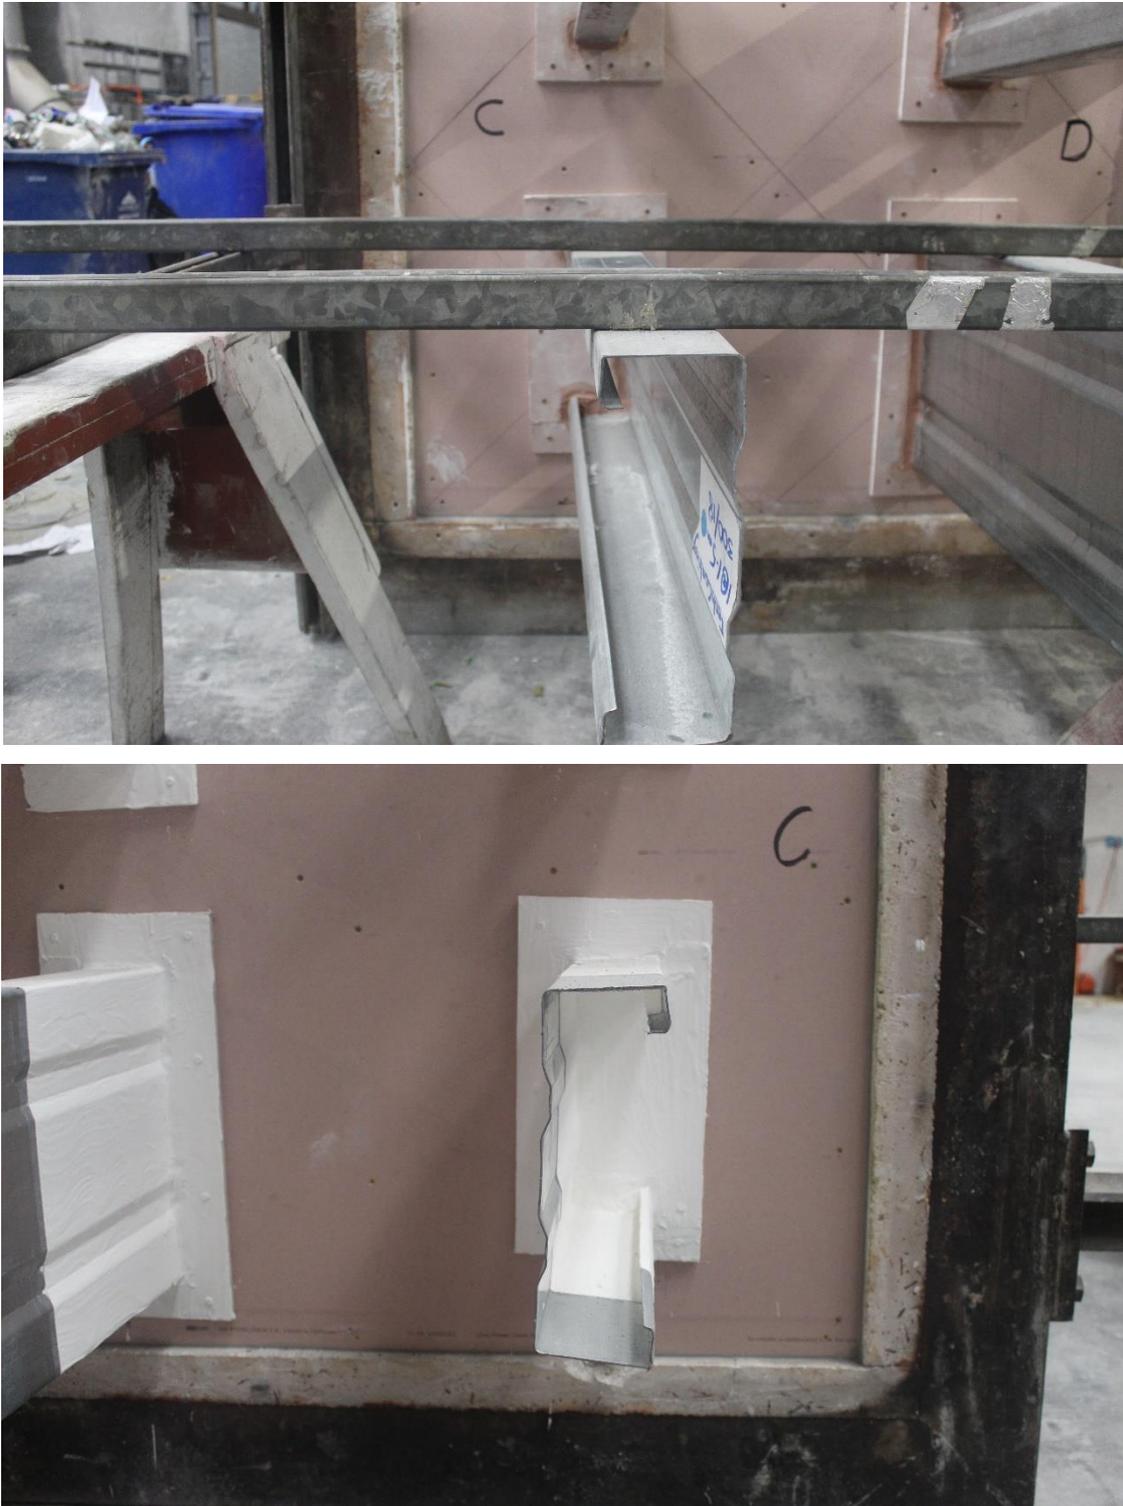
Fig. 7 – Specimen C. Unexposed (top) and exposed (bottom) face.

<b>Structural adequacy</b>	<b>Not applicable</b>
<b>Integrity</b>	<b>No failure at 63 min</b>
<b>Insulation</b>	<b>No failure at 63 min</b>

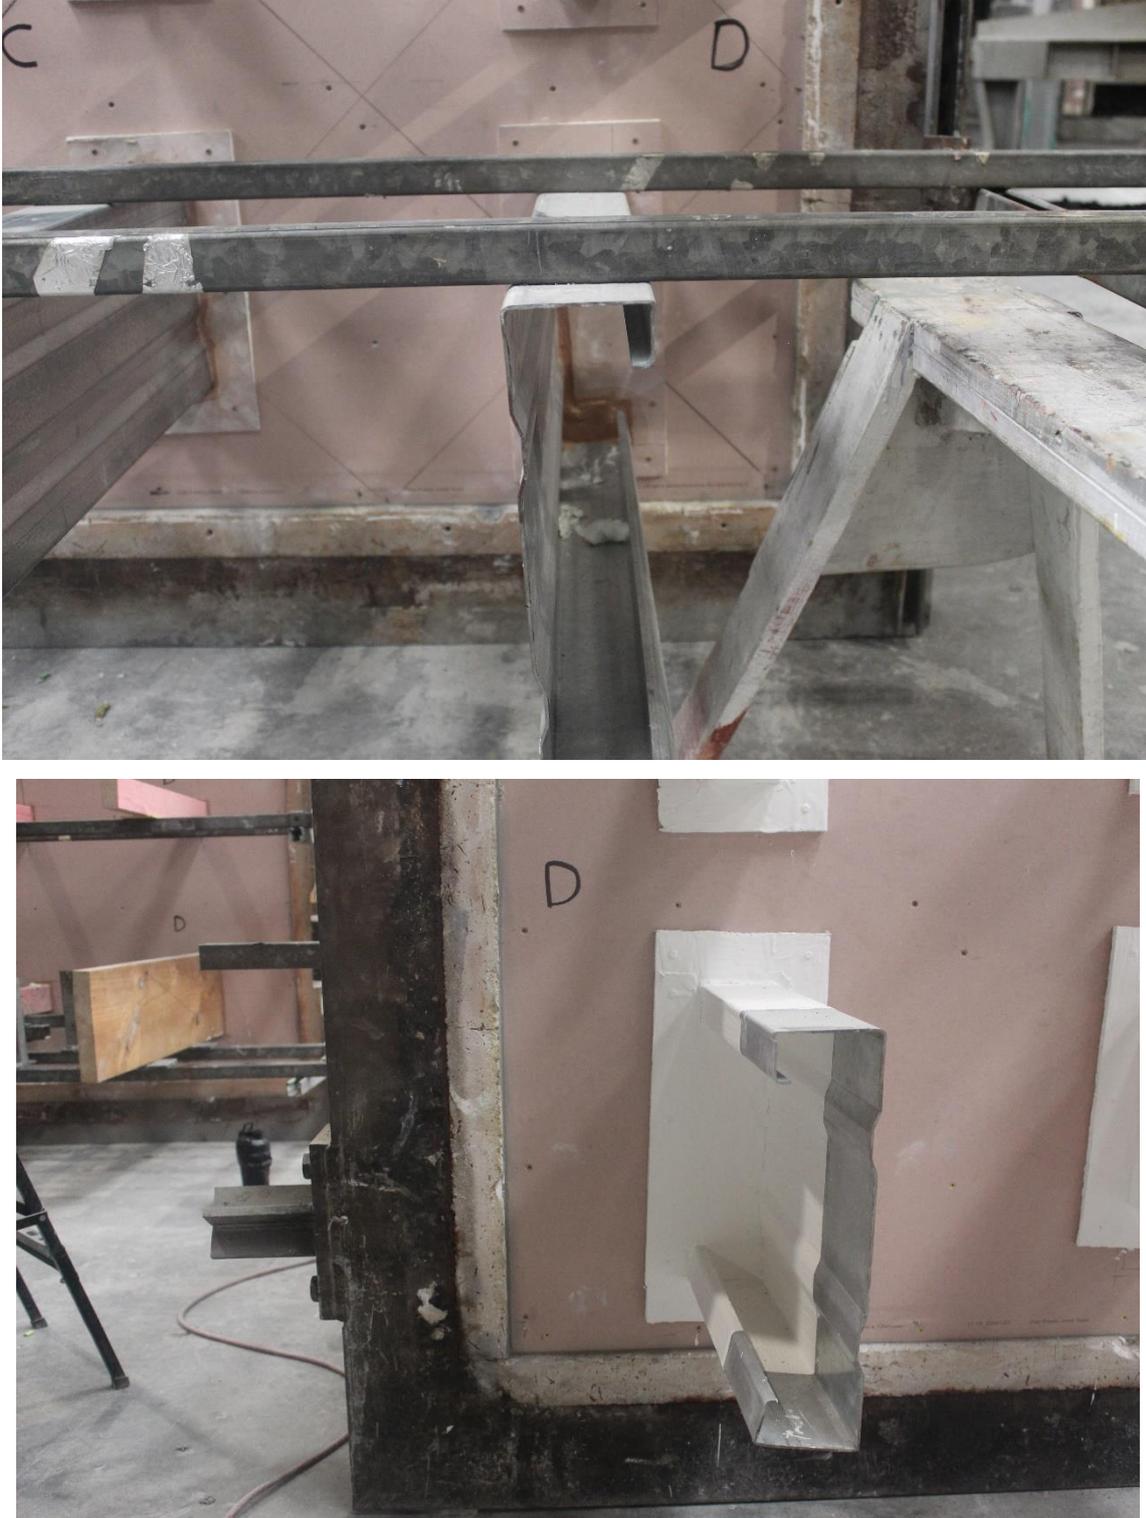
Fig. 9 – Specimen D. Unexposed (top) and exposed (bottom) face.

<b>Structural adequacy</b>	<b>Not applicable</b>
<b>Integrity</b>	<b>No failure at 63 min</b>
<b>Insulation</b>	<b>No failure at 63 min</b>
