TEST REPORT

PF24026

**Fire resistance test for penetrations through
the vertical separating element**

Client:	Agnitek Pty Ltd
Test method:	AS1530.4-2014
Report Date:	05/07/2024
Test number:	PF24026

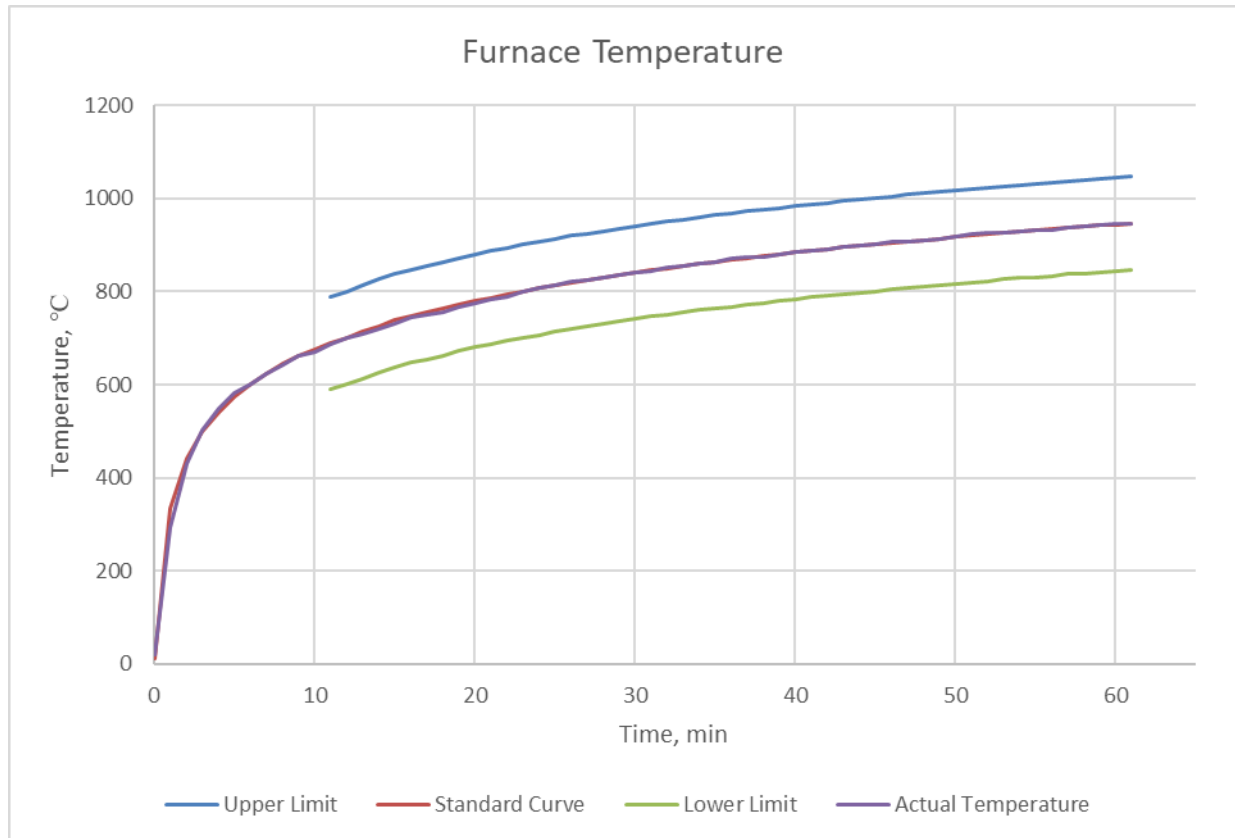
The furnace was controlled to follow the temperature/time relationship specified in AS 1530.4-2014.

Figure 1 – Furnace Temperature during the test

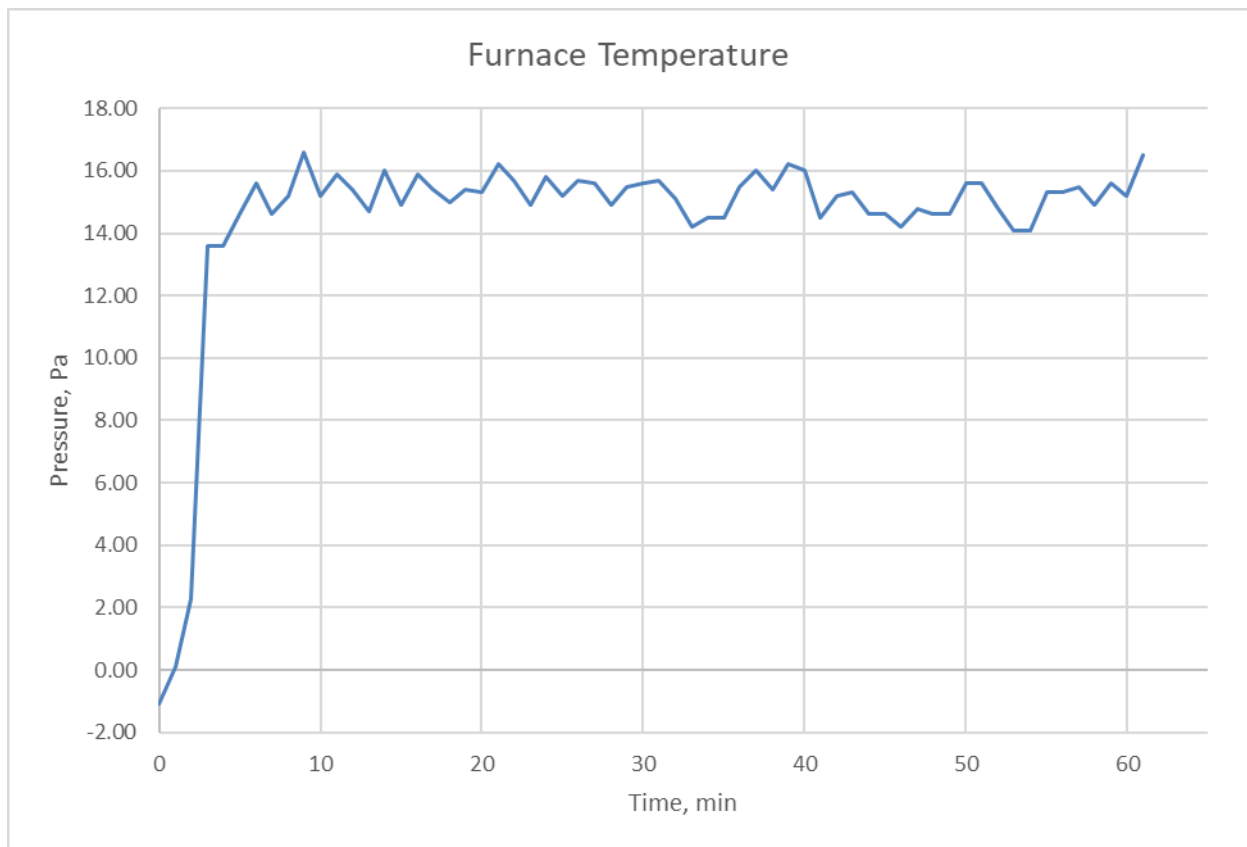
After the first 5 minutes of the test, the furnace pressure was maintained at 15 ± 3 Pa with respect to atmosphere. The probe was located 500mm above the furnace floor.

Figure 2 – Furnace Pressure during the test

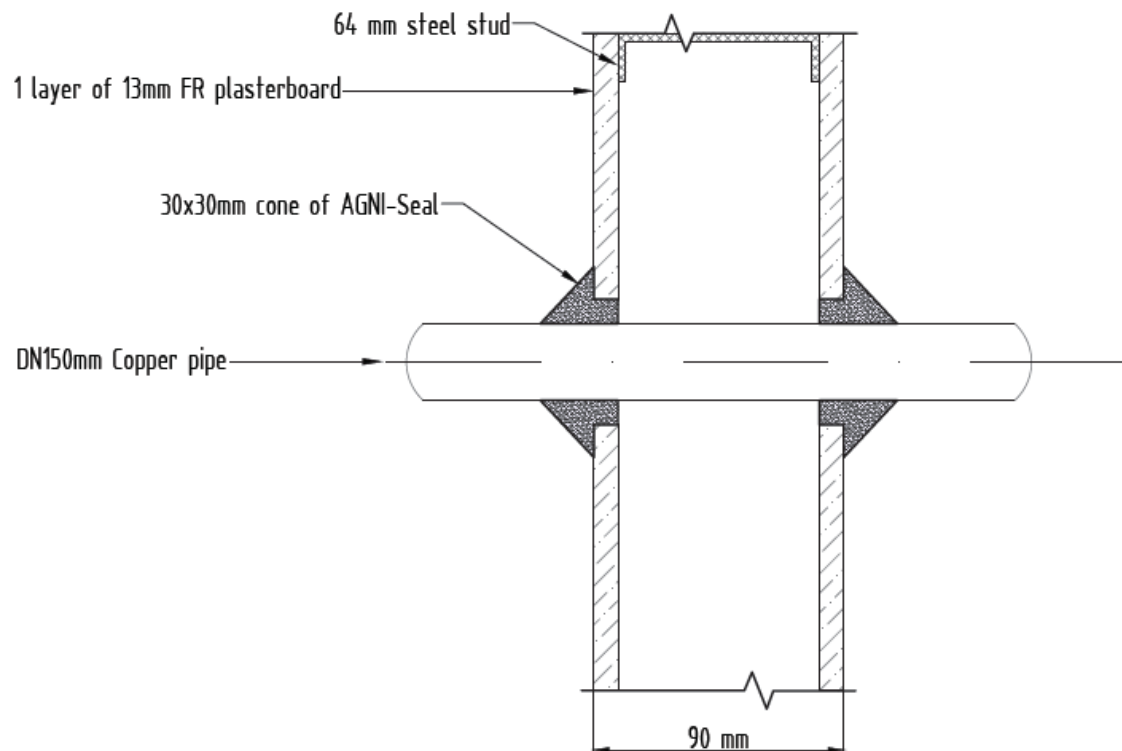
Figure 3 – Specimen 1

Service penetration details	
Service	DN150 Copper Tube
Service Support	Unistrut structure at 360mm
Aperture Diameter	170mm
Annular Spacing	Min: 8mm, Max: 9.5mm

Local Fire-stopping system	
Application	Symmetrical – installed on both faces of separating element
System description	13mm (nominal) deep seal in annular space and a 30mm × 30mm cone of sealant between pipe and separating element.

Structural adequacy	Not applicable
Integrity	No failure at 61 minutes
Insulation	12 minutes

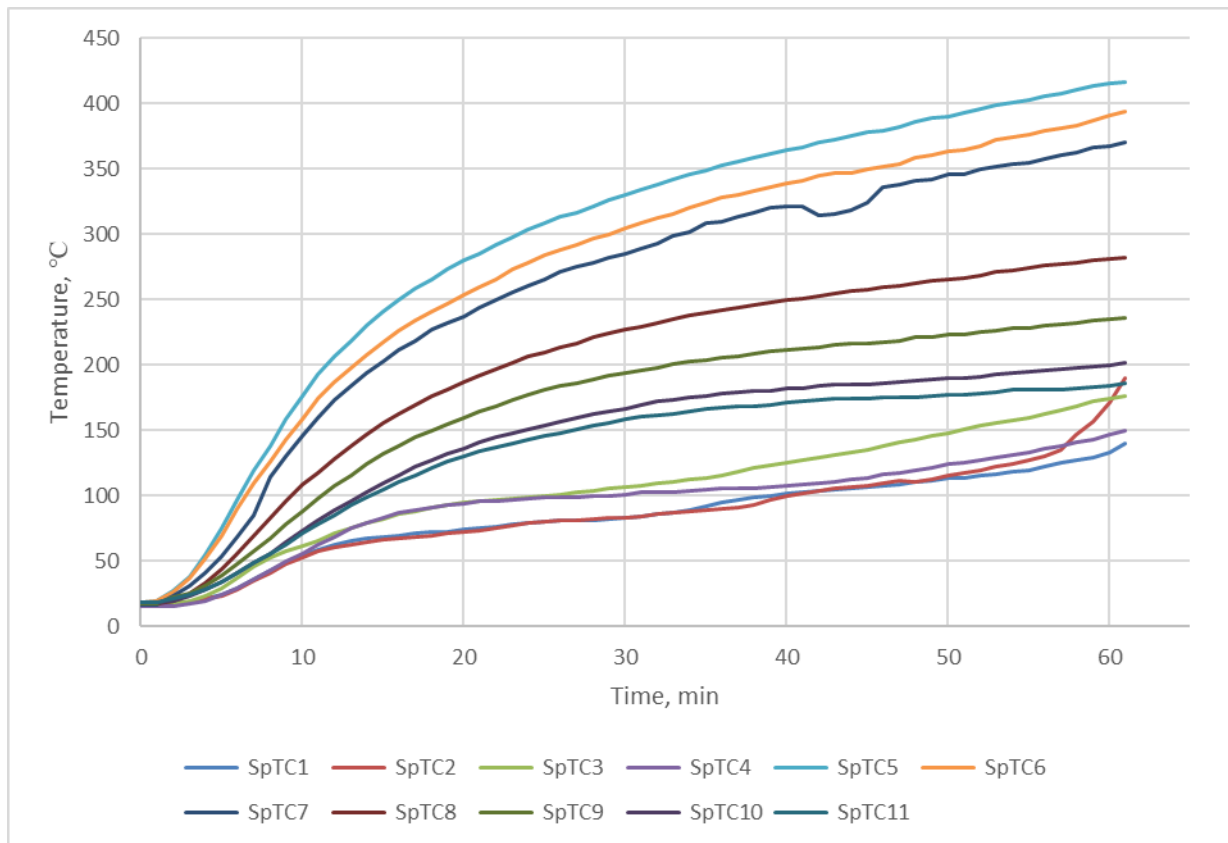
Figure 4 – Specimen 1 thermocouple readings

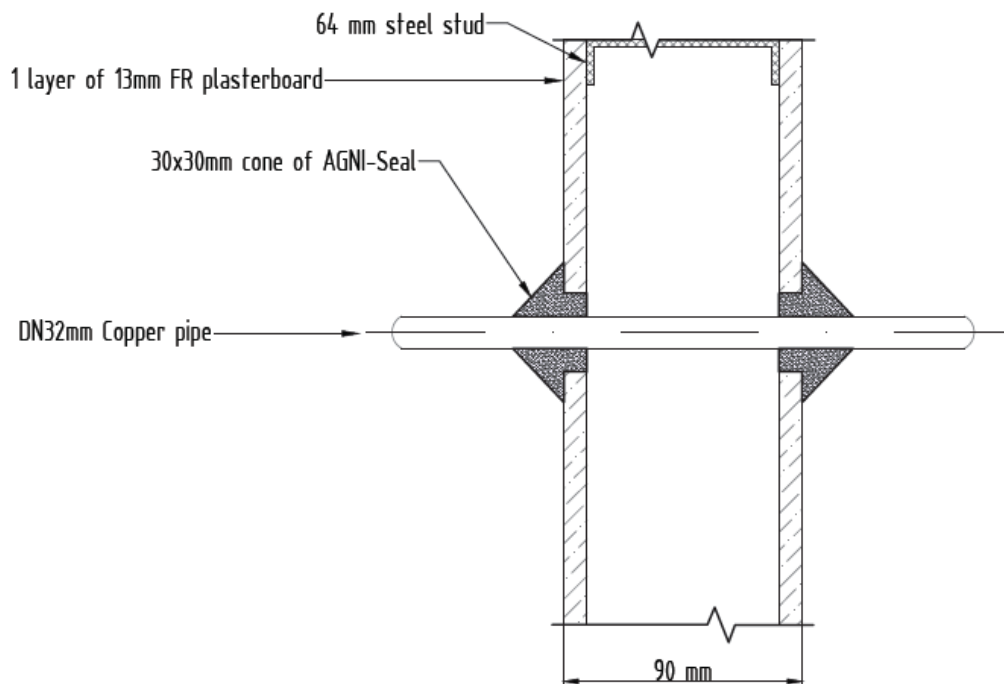
Figure 5 – Specimen 2

Service penetration details	
Service	DN32 Copper Tube
Service Support	Unistrut structure at 360mm
Aperture Diameter	53mm
Annular Spacing	Min: 9.5mm, Max: 11.5mm

Local Fire-stopping system	
Application	Symmetrical – installed on both faces of separating element
System description	13mm (nominal) deep seal in annular space and a 30mm × 30mm cone of sealant between pipe and separating element.

Structural adequacy	Not applicable
Integrity	No failure at 61 minutes
Insulation	24 minutes

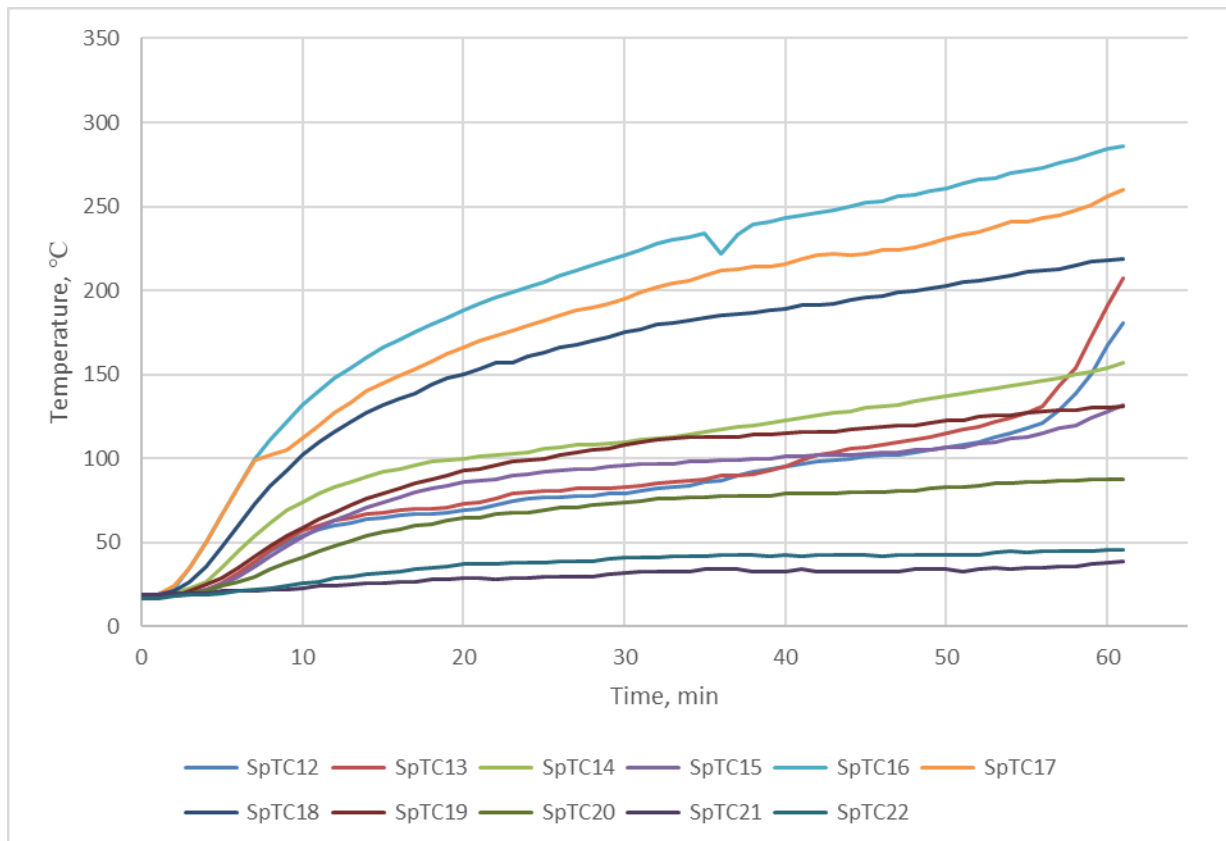
Figure 6 – Specimen 2 thermocouple readings

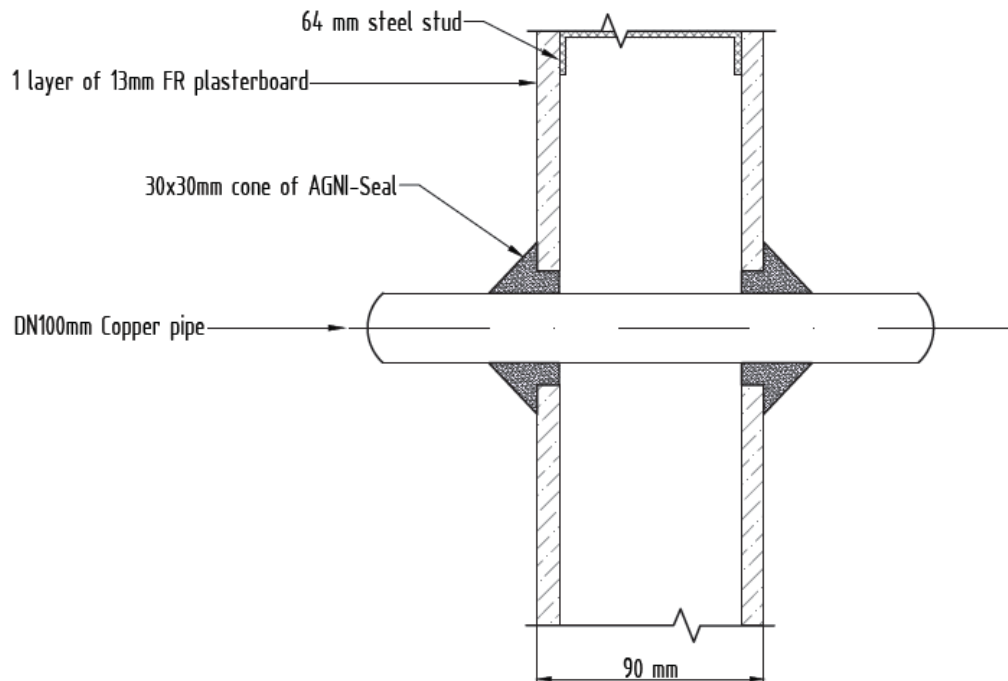
Figure 7 – Specimen 3

Service penetration details	
Service	DN100 Copper Tube
Service Support	Unistrut structure at 360mm
Aperture Diameter	120mm
Annular Spacing	Min: 6mm, Max: 9mm

Local Fire-stopping system	
Application	Symmetrical – installed on both faces of separating element
System description	13mm (nominal) deep seal in annular space and a 30mm × 30mm cone of sealant between pipe and separating element.

Structural adequacy	Not applicable
Integrity	No failure at 61 minutes
Insulation	10 minutes

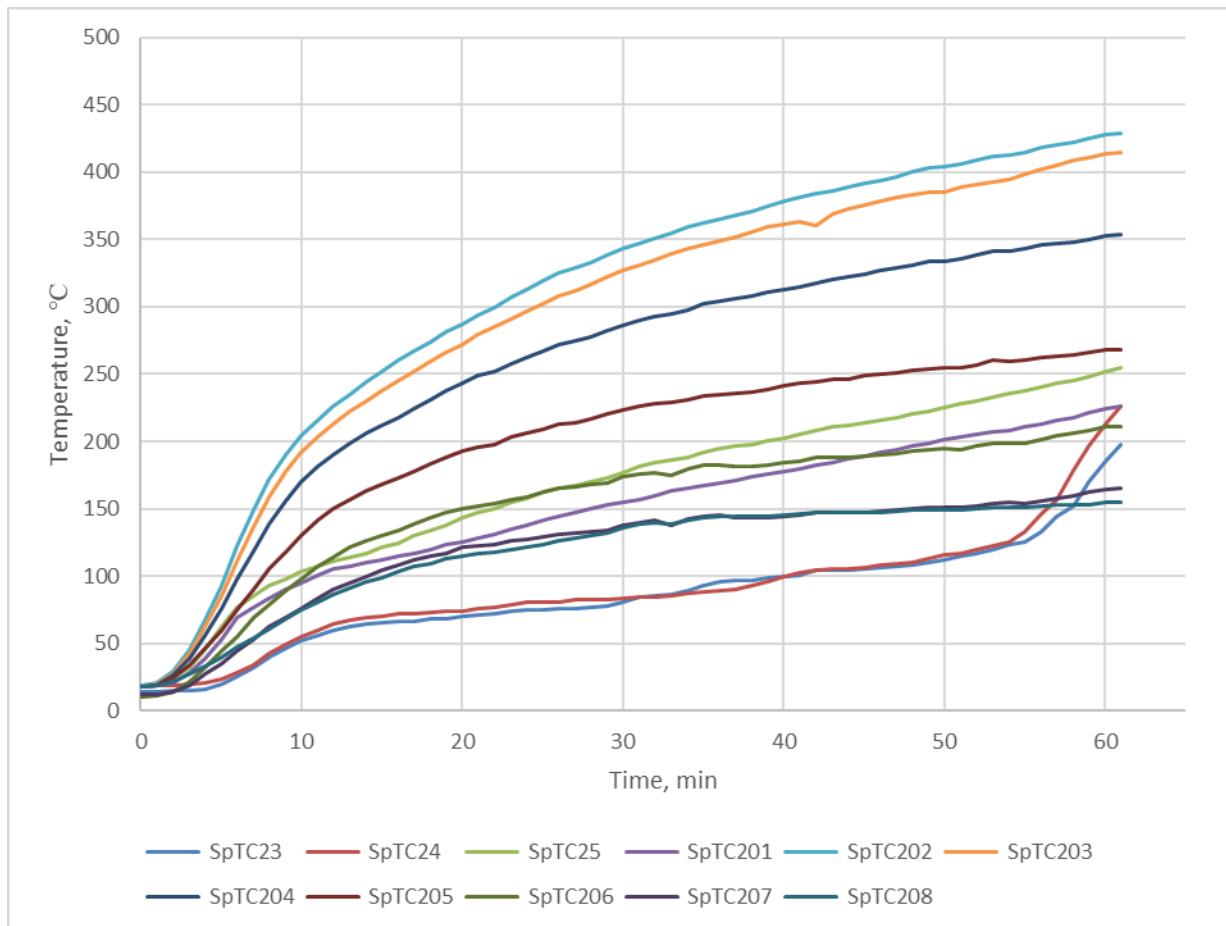
Figure 8 – Specimen 3 thermocouple readings

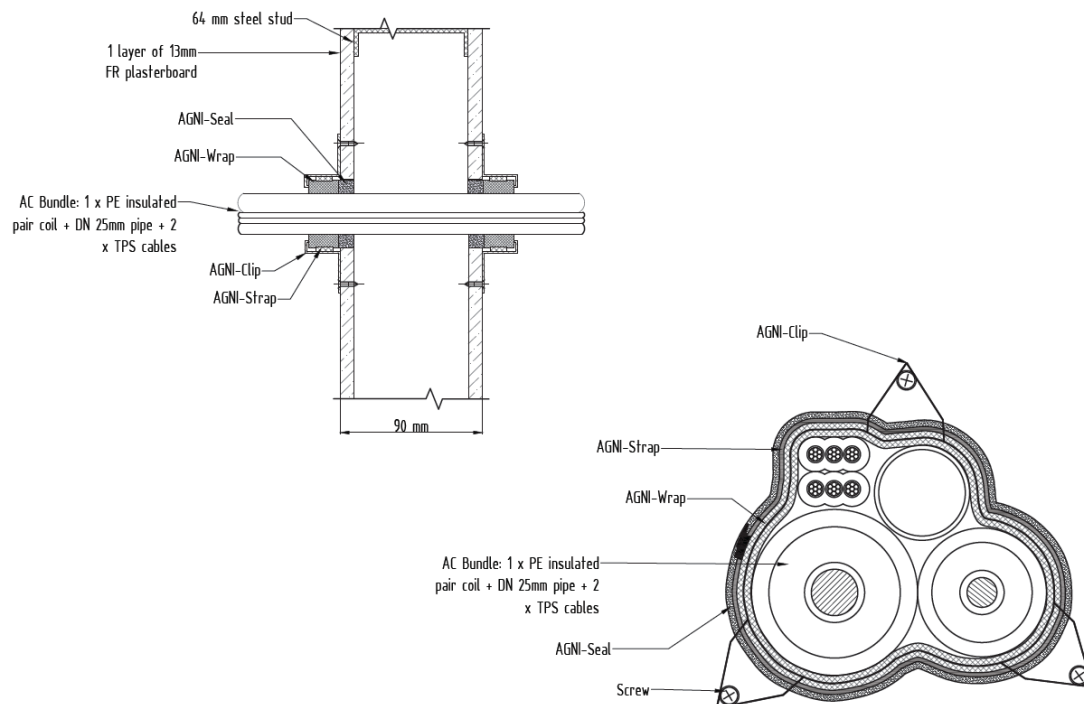
Figure 9 – Specimen 4

Service penetration details	
Service	PE Insulated Pair Coil + 25mm Pipe + 2 TPS Cables
Service Support	Unistrut structure at 360mm
Aperture Diameter	70mm
Annular Spacing	Min: 3mm, Max: 16mm

Local Fire-stopping system	
Application	Symmetrical – installed on both faces of separating element
System description	13mm (nominal) deep seal in annular space, AGNI-Wrap wrapped around the HAVC bundle twice with 10mm overlap. The AGNI-Wrap was secured using a cable tie then fixed to the separating element with 3 screw and clip fixings.

Structural adequacy	Not applicable
Integrity	No failure at 61 minutes
Insulation	42 minutes

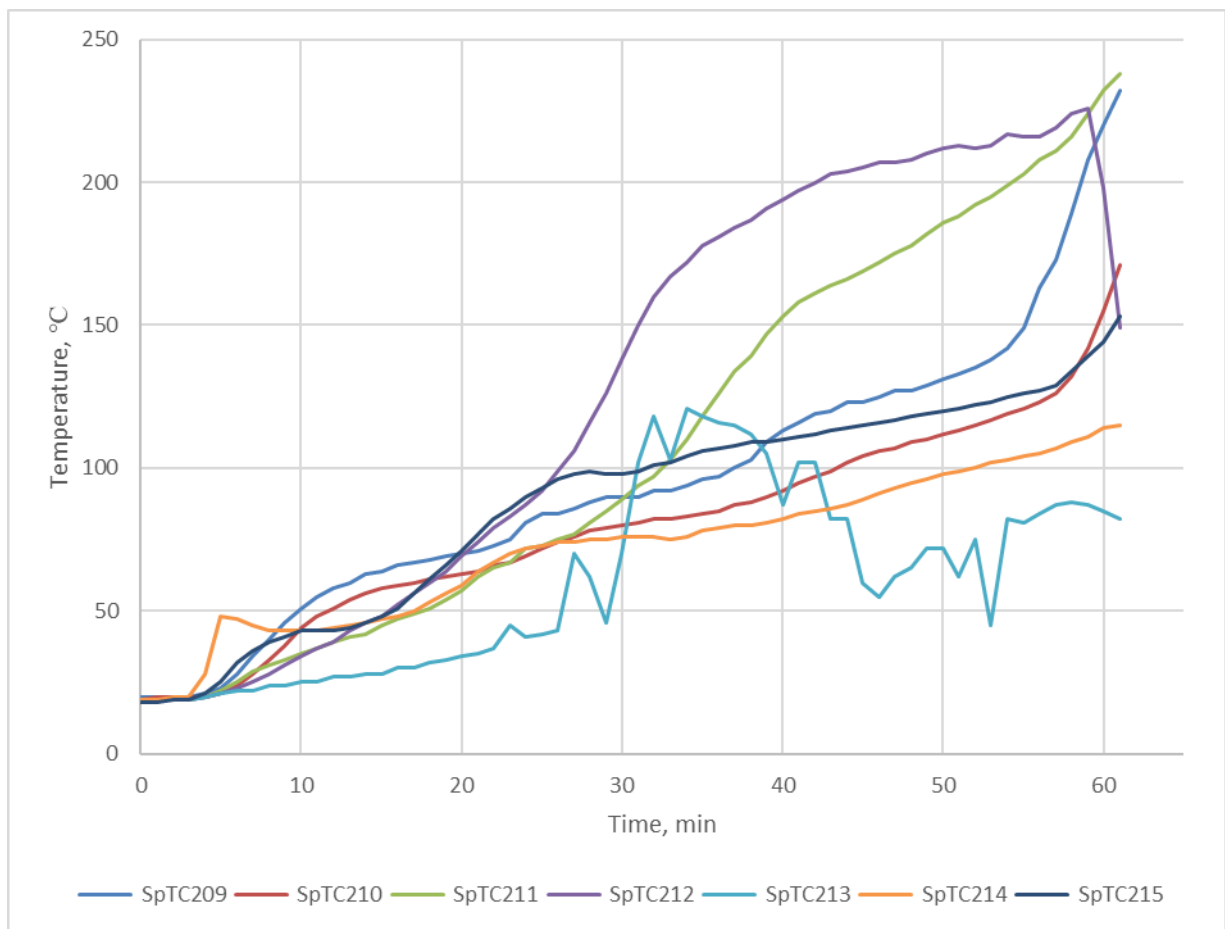
Figure 10 – Specimen 4 thermocouple readings

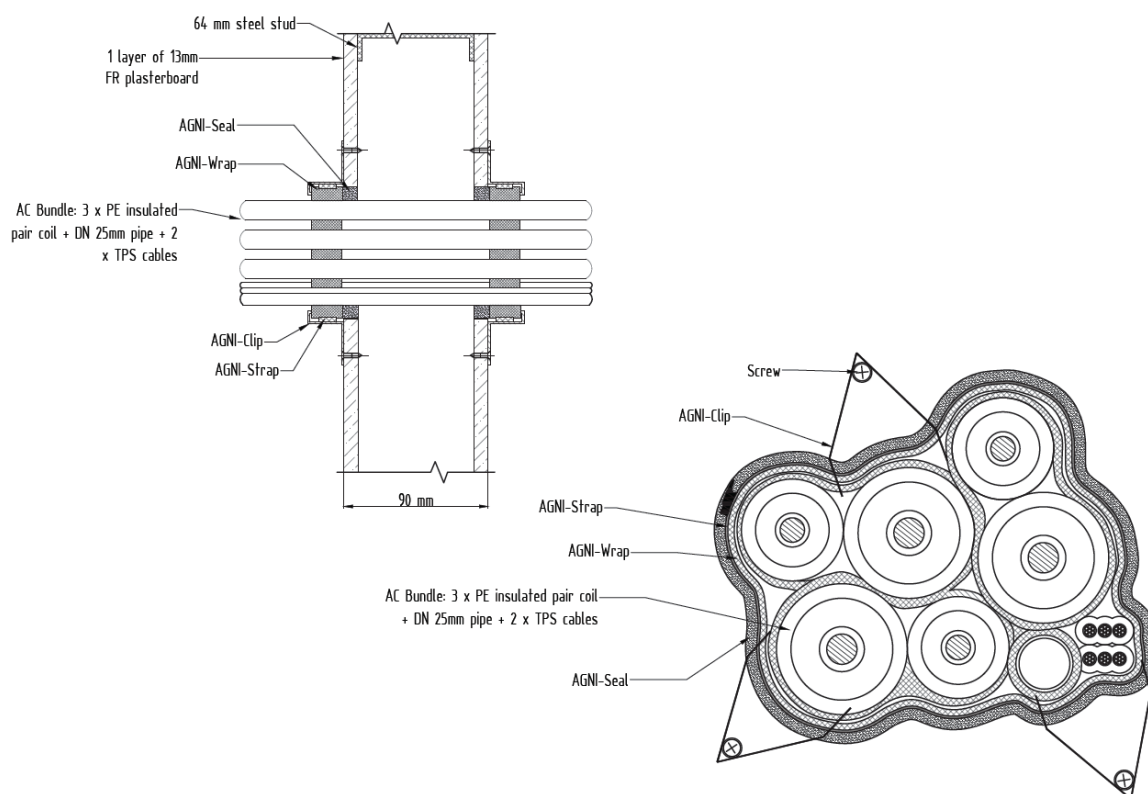
Figure 11 – Specimen 5

Service penetration details	
Service	3 PE insulated Pair Coils + 25mm Pipe + 2 TPS Cables
Service Support	Unistrut structure at 530mm
Aperture Diameter	115mm
Annular Spacing	Min: 8mm, Max: 30mm

Local Fire-stopping system	
Application	Symmetrical – installed on both faces of separating element
System description	13mm (nominal) deep seal in annular space. AGNI-Wrap wrapped 2 pair coils individually with 10mm overlap. AGNI-Wrap wrapped a bundle of pair coil, 25mm OD pipe and 2 TPS cables with 10mm overlap. AGNI-Wrap wrapped the wrapped pair coils and bundle with 10mm overlap. AGNI-Wrap was secured with a cable tie and fixed to separating element with 3 screw and clip fixings.

Structural adequacy	Not applicable
Integrity	No failure at 61 minutes
Insulation	31 minutes

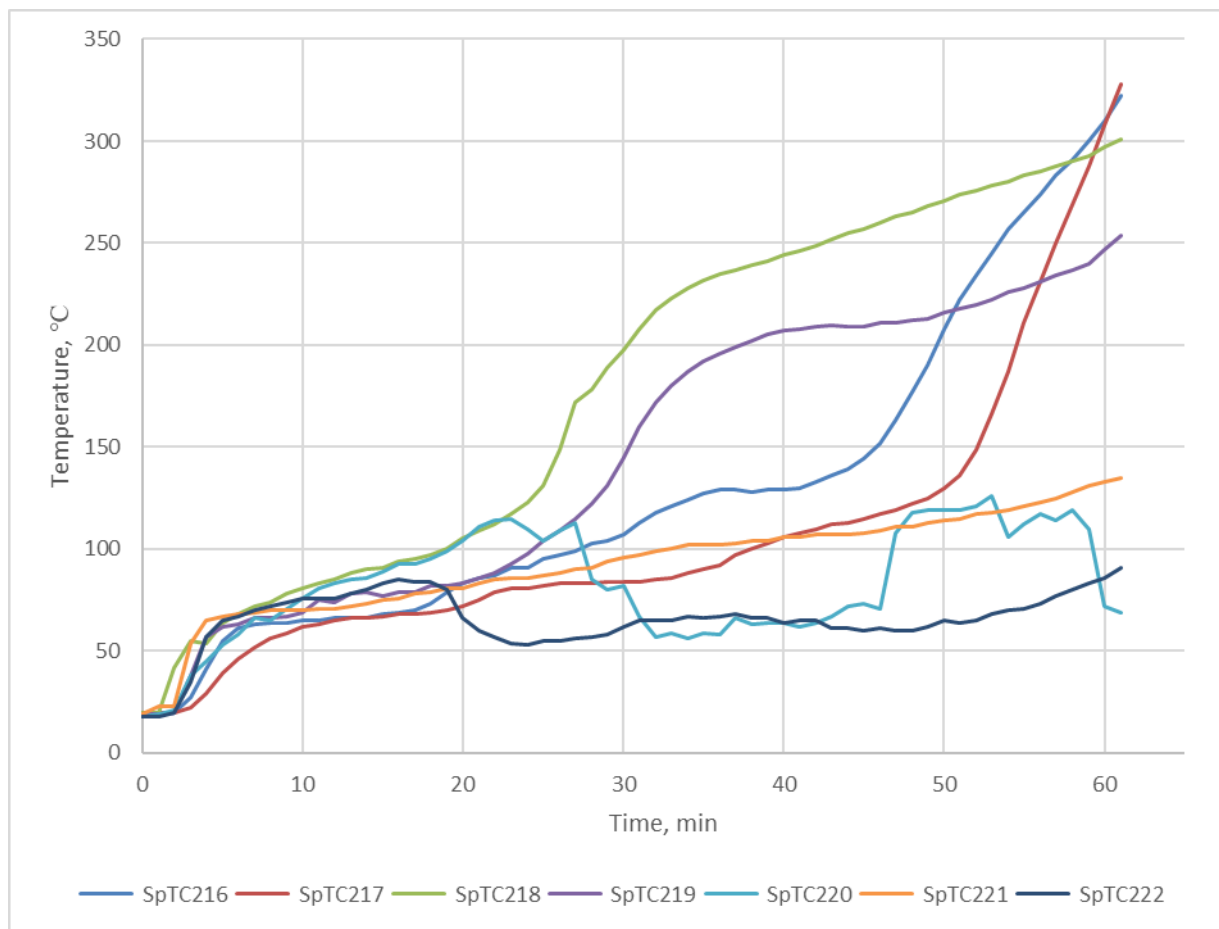
Figure 12 – Specimen 5 thermocouple readings

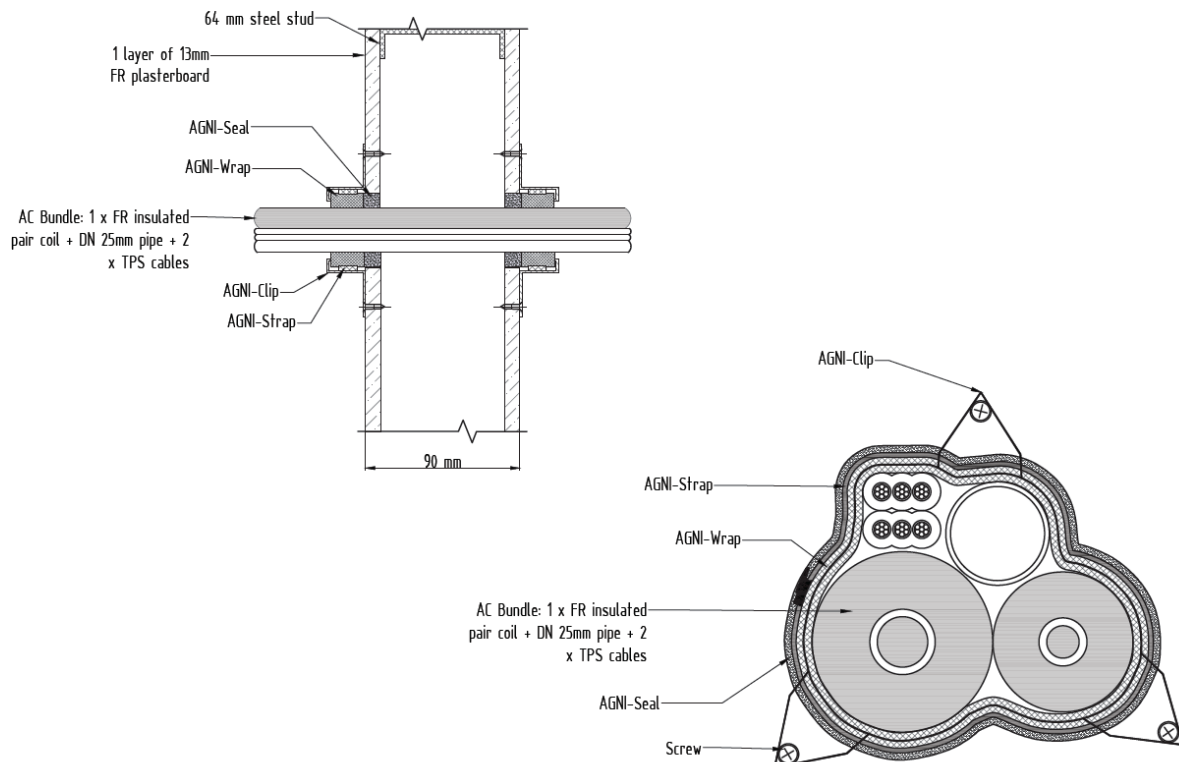
Figure 13 – Specimen 6

Service penetration details	
Service	Fire Retardant Pair Coil + 25mm Pipe + 2 TPS Cables
Service Support	Unistrut structure at 360mm
Aperture Diameter	102mm
Annular Spacing	Min: 12mm, Max: 29mm

Local Fire-stopping system	
Application	Symmetrical – installed on both faces of separating element
System description	13mm (nominal) deep seal in annular space, AGNI-Wrap wrapped around the HAVC bundle twice with 10mm overlap. The AGNI-Wrap was secured using a cable tie then fixed to the separating element with 3 screw and clip fixings.

Test results	
Structural adequacy	Not applicable
Integrity	No failure at 61 minutes
Insulation	60 minutes

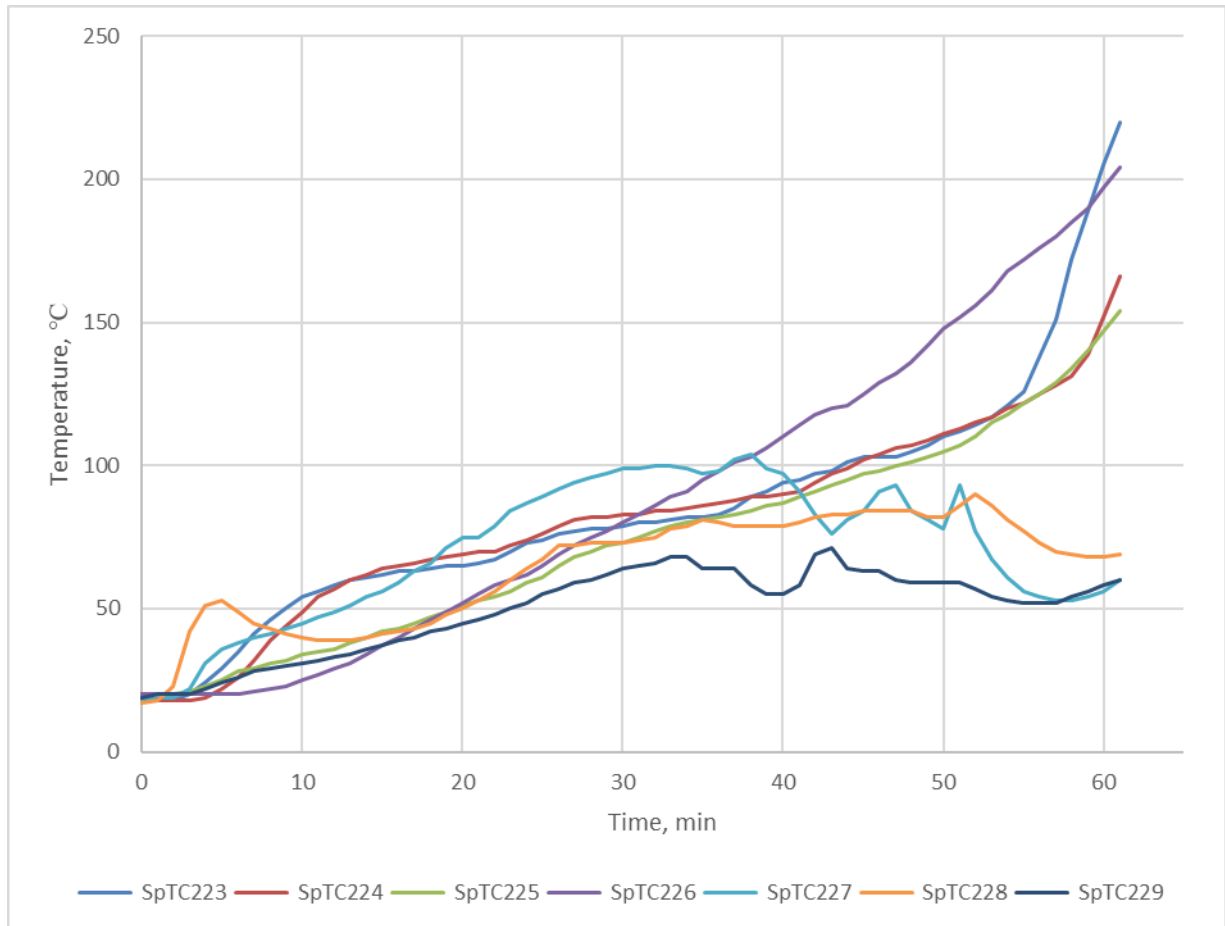
Figure 14 – Specimen 6 thermocouple readings

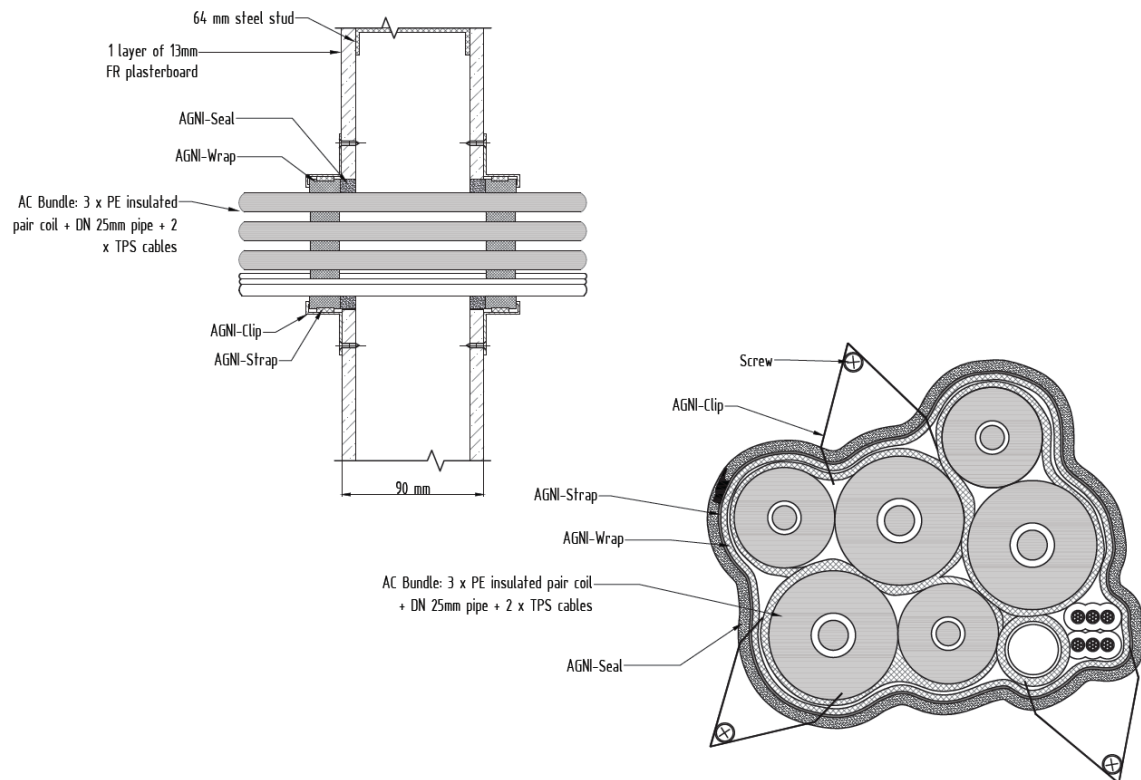
Figure 15 – Specimen 7

Service penetration details	
Service	Three Fire Retardant Pair Coils + 25mm Pipe + 2 TPS Cables
Service Support	Unistrut structure at 360mm
Aperture Diameter	140mm
Annular Spacing	Min: 6mm, Max: 18mm

Local Fire-stopping system	
Application	Symmetrical – installed on both faces of separating element
System description	13mm (nominal) deep seal in annular space. AGNI-Wrap wrapped 2 pair coils individually with 10mm overlap. AGNI-Wrap wrapped bundle of pair coil, 25mm OD pipe and 2 TPS cables with 10mm overlap. AGNI-Wrap wrapped the wrapped pair coils and bundle with 10mm overlap. AGNI-Wrap was secured with a cable tie and fixed to separating element with 3 screw and clip fixings.

Test results	
Structural adequacy	Not applicable
Integrity	No failure at 61 minutes
Insulation	54 minutes

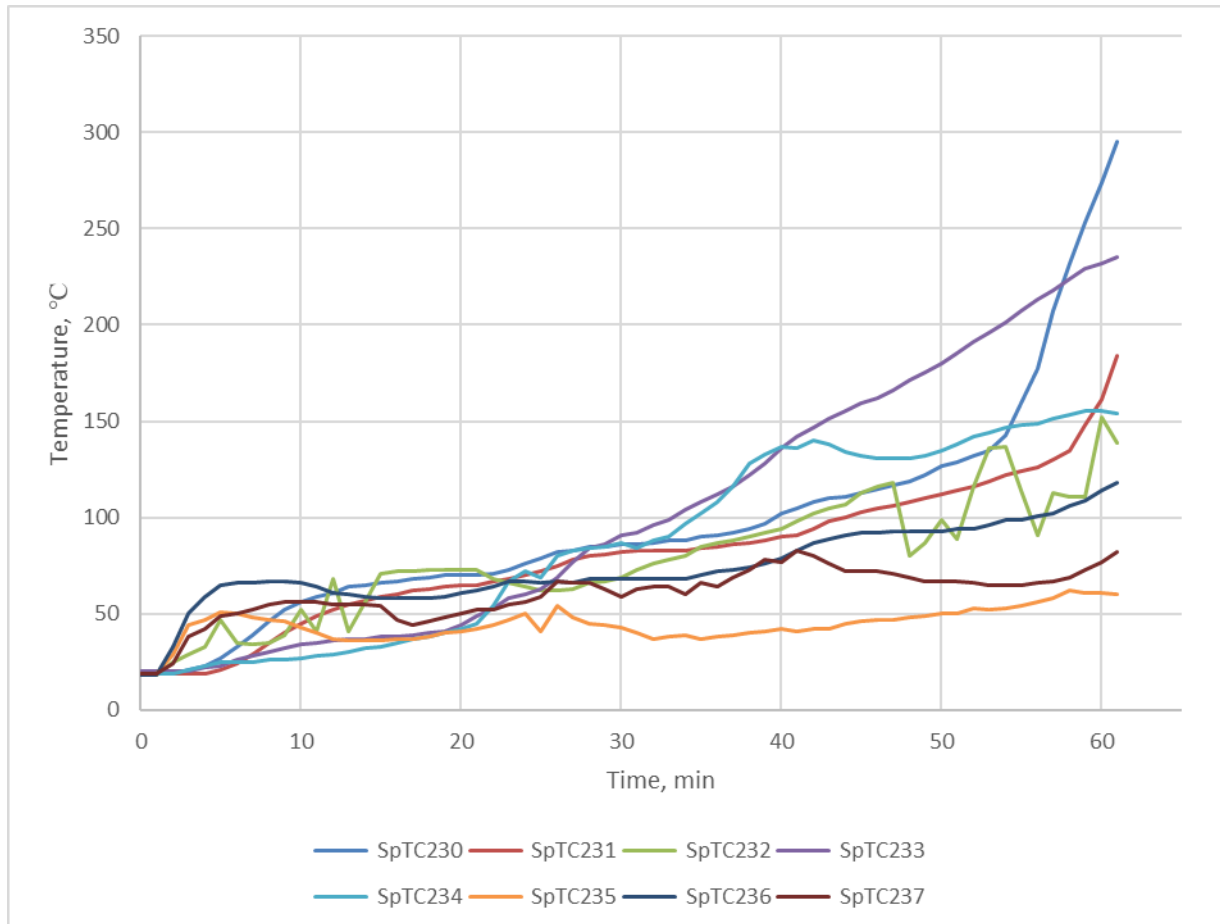
Figure 16 – Specimen 7 thermocouple readings

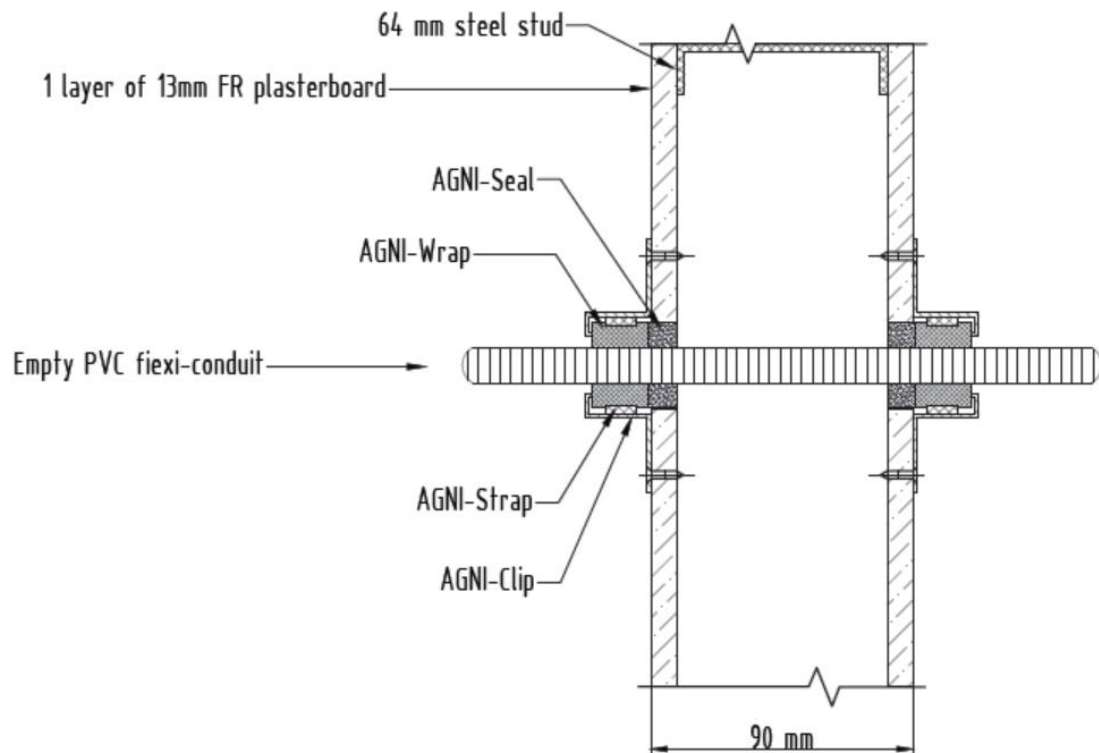
Figure 17 – Specimen 8

Service penetration details	
Service	25mm uPVC Flexible Conduit
Service Support	Unistrut structure at 530mm and 1800mm
Aperture Diameter	55.5mm
Annular Spacing	Min: 14.5mm, Max: 16mm

Local Fire-stopping system	
Application	Symmetrical – installed on both faces of separating element
System description	13mm (nominal) deep seal in annular space, AGNI-Wrap wrapped around the conduit with 10mm overlap. AGNI-Wrap was secured using a cable tie then fixed to the separating element with 2 screw and clip fixings.

Test results	
Structural adequacy	Not applicable
Integrity	No failure at 61 minutes
Insulation	54 minutes

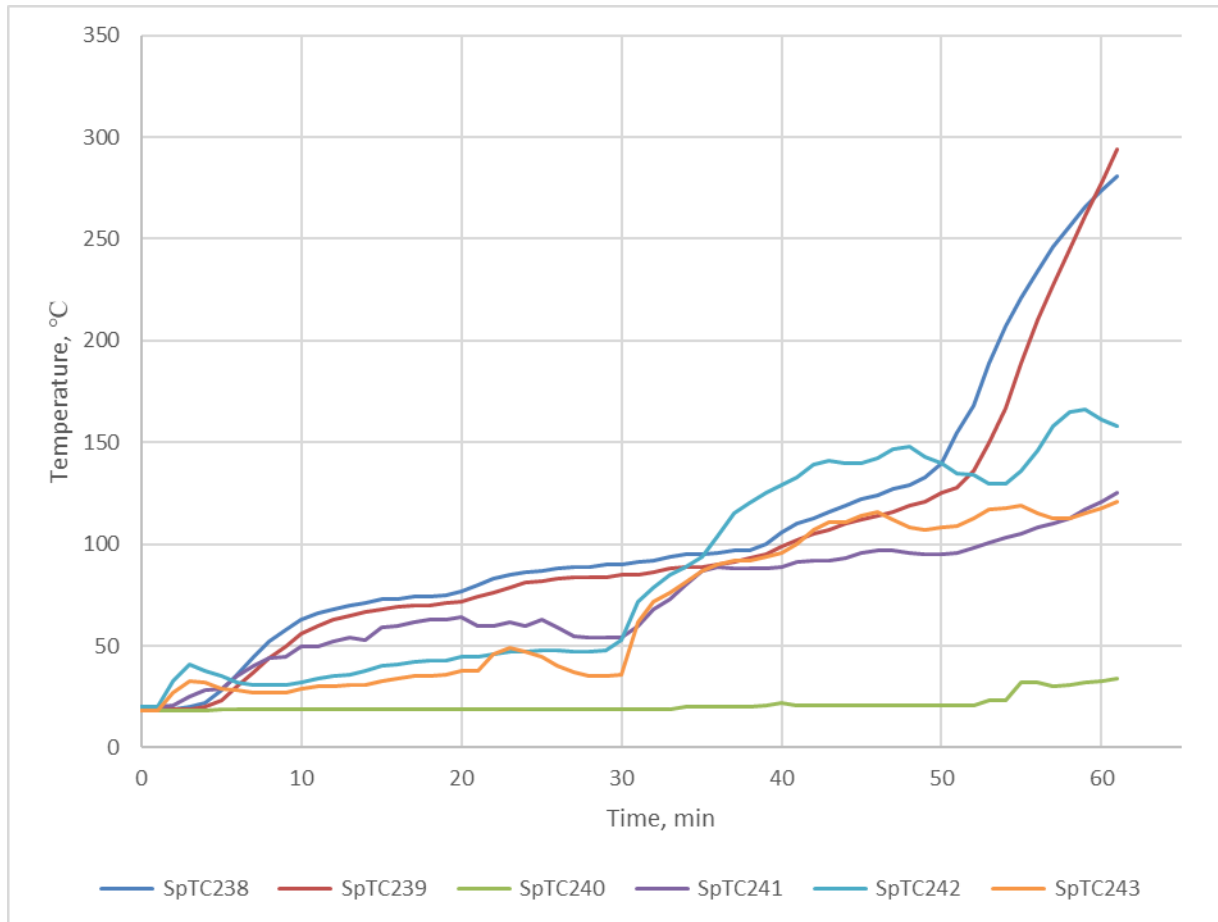
Figure 18 – Specimen 8 thermocouple readings

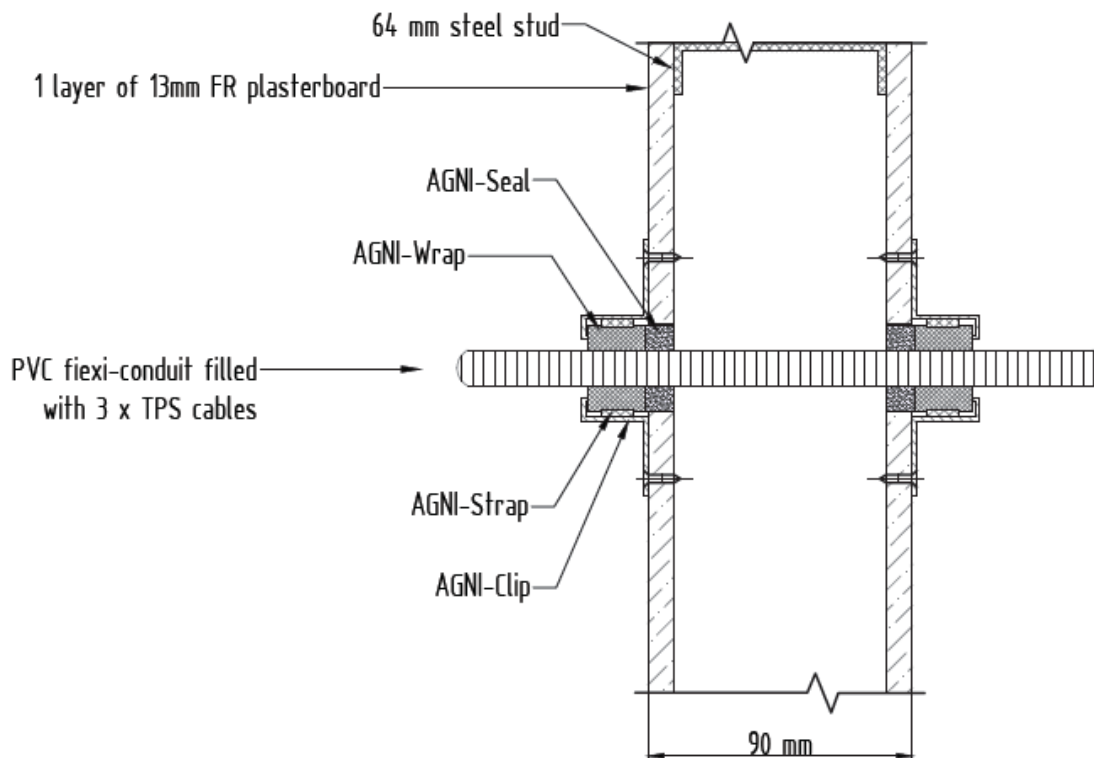
Figure 19 – Specimen 9

Service penetration details	
Service	25mm uPVC Flexible Conduit filled with 3 × 2.5mm ² 2C+E Flat TPS Cables
Service Support	Unistrut structure at 530mm and 1800mm
Aperture Diameter	56mm
Annular Spacing	Min: 14.5mm, Max: 16.5mm

Local Fire-stopping system	
Application	Symmetrical – installed on both faces of separating element
System description	13mm (nominal) deep seal in annular space, AGNI-Wrap wrapped around the conduit with 10mm overlap. AGNI-Wrap was secured using a cable tie then fixed to the separating element with 2 screw and clip fixings.

Test results	
Structural adequacy	Not applicable
Integrity	No failure at 61 minutes
Insulation	57 minutes

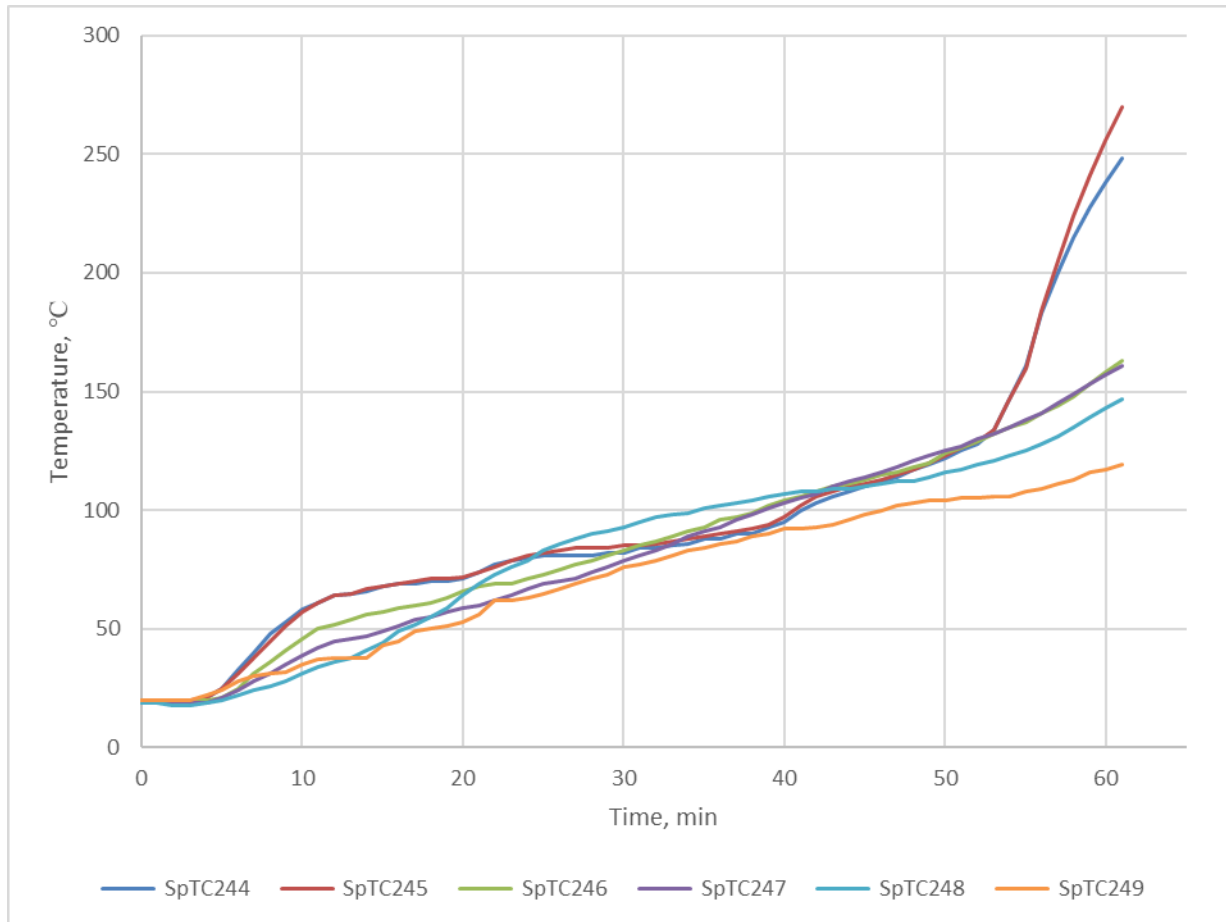
Figure 20 – Specimen 9 thermocouple readings

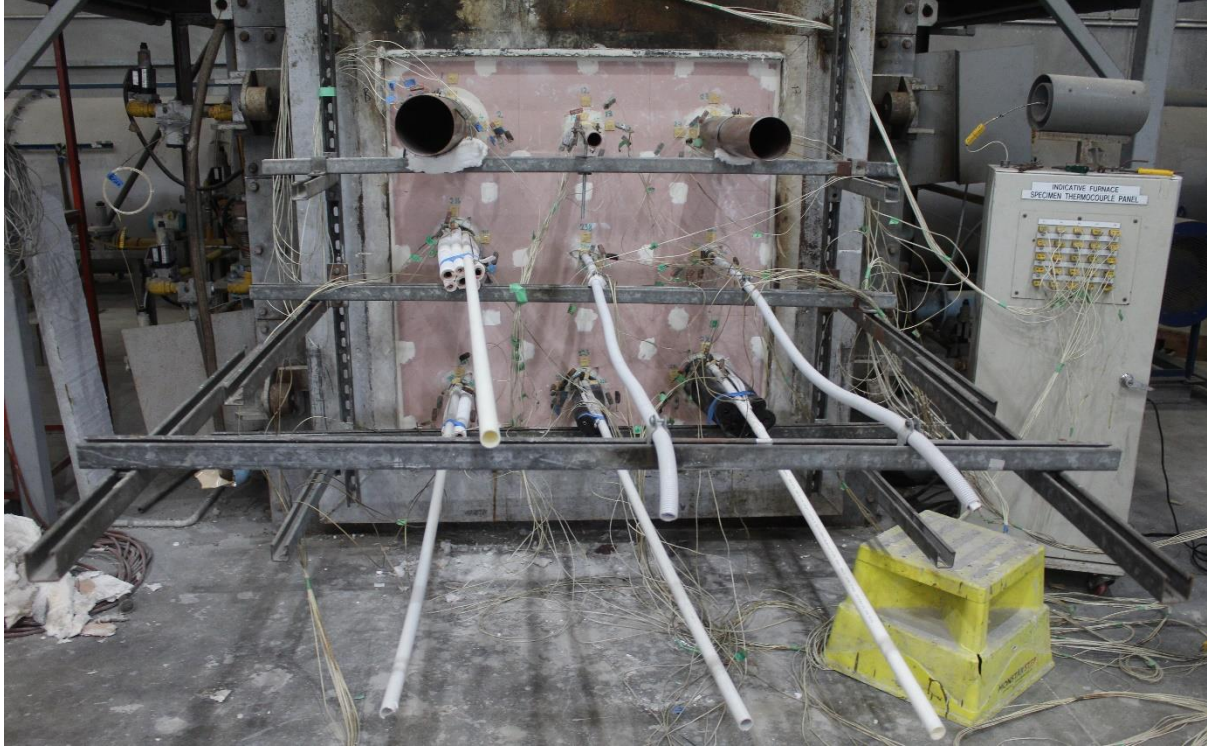
Figure 22 – Unexposed face prior to test commencement

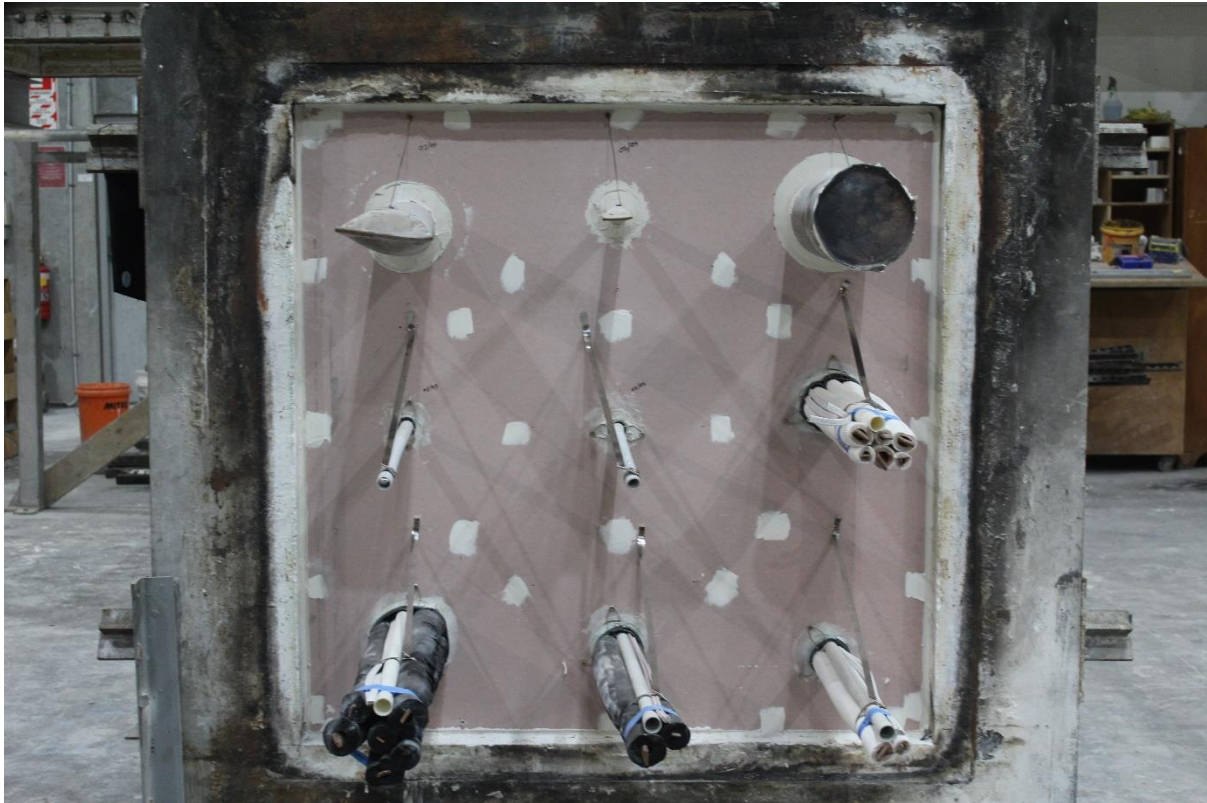
Figure 23 –Exposed face prior to test commencement
