TEST REPORT

PF24026

**Fire resistance test for penetrations through
the vertical separating element**

Client:	Agnitek Pty Ltd
Test method:	AS1530.4-2014
Report Date:	05/07/2024
Test number:	PF24026

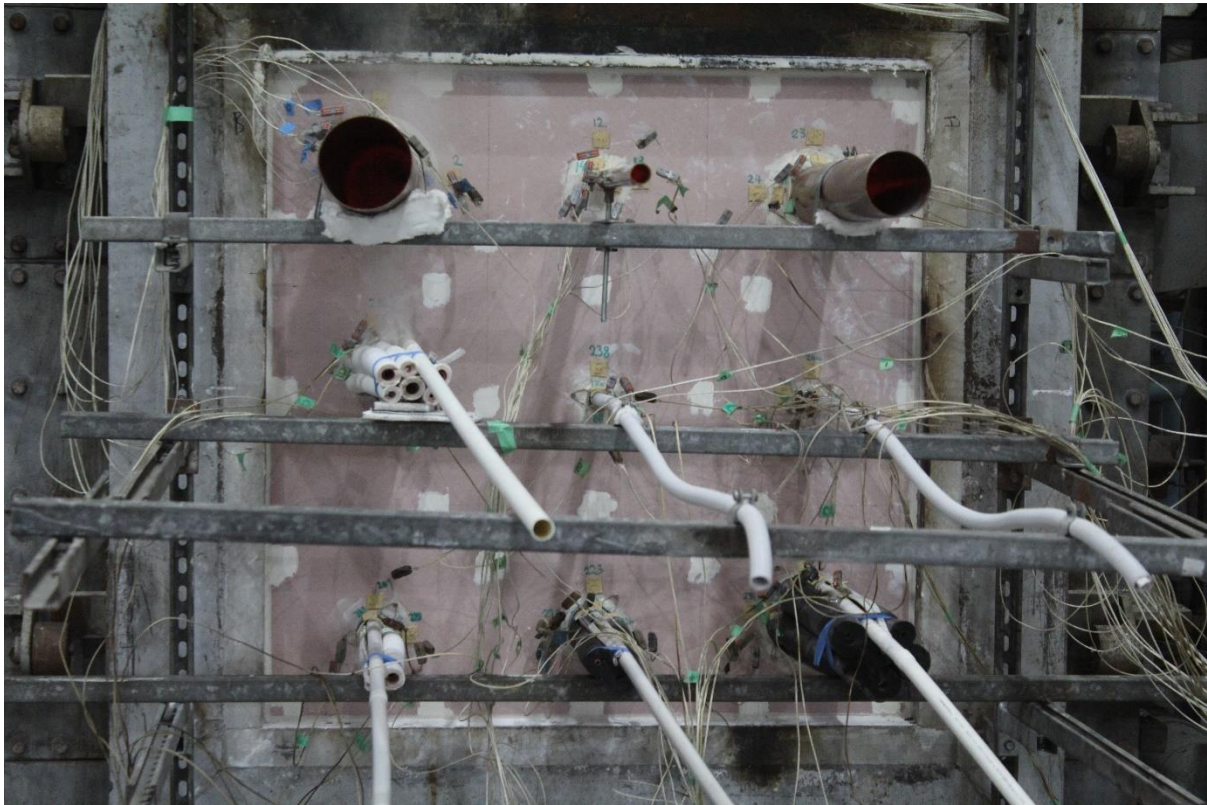
Figure 24 – Unexposed face at 15 minutes

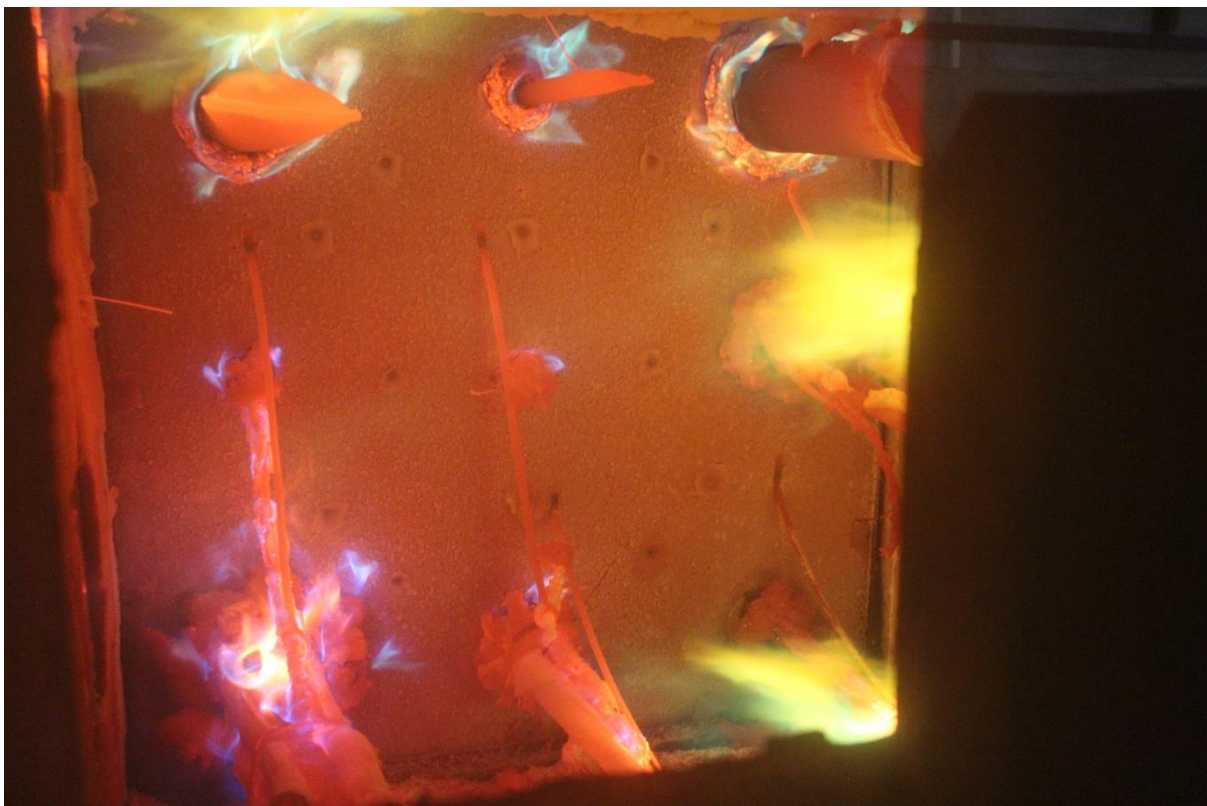
Figure 25 – Exposed face at 15 minutes

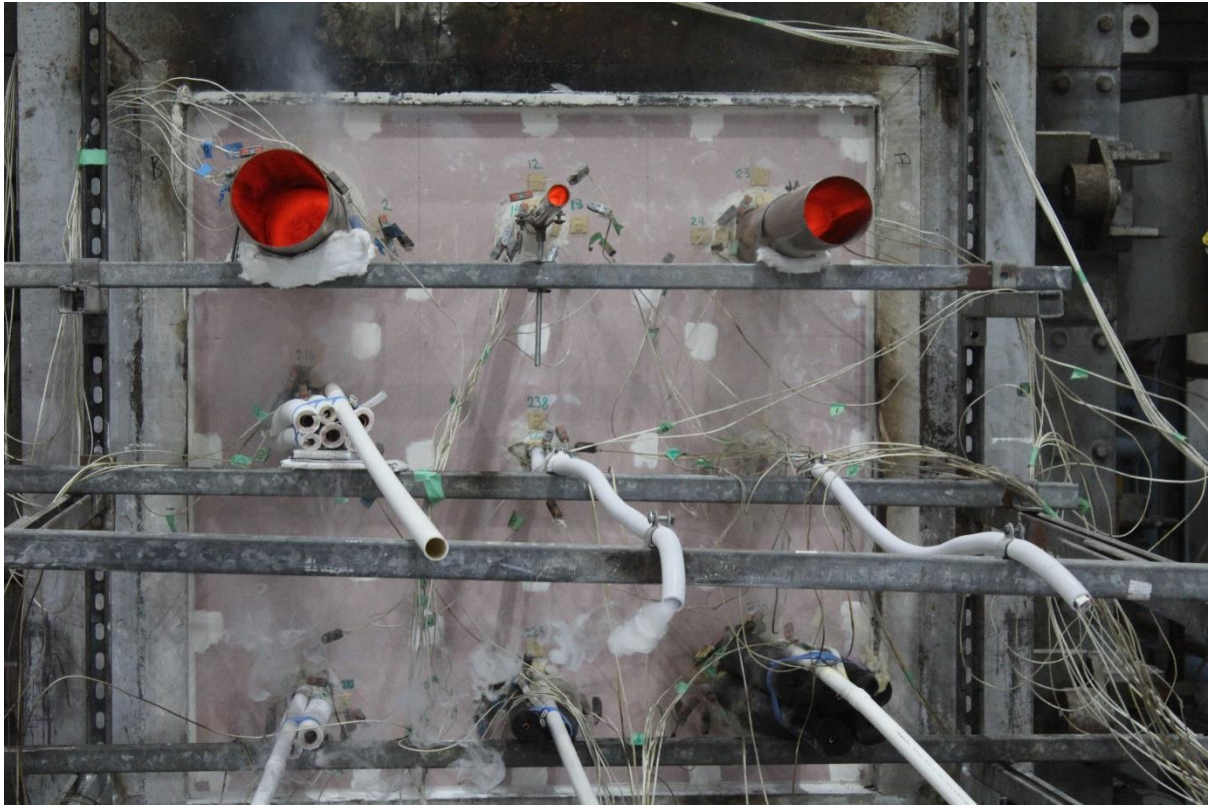
Figure 26 – Unexposed face at 30 minutes

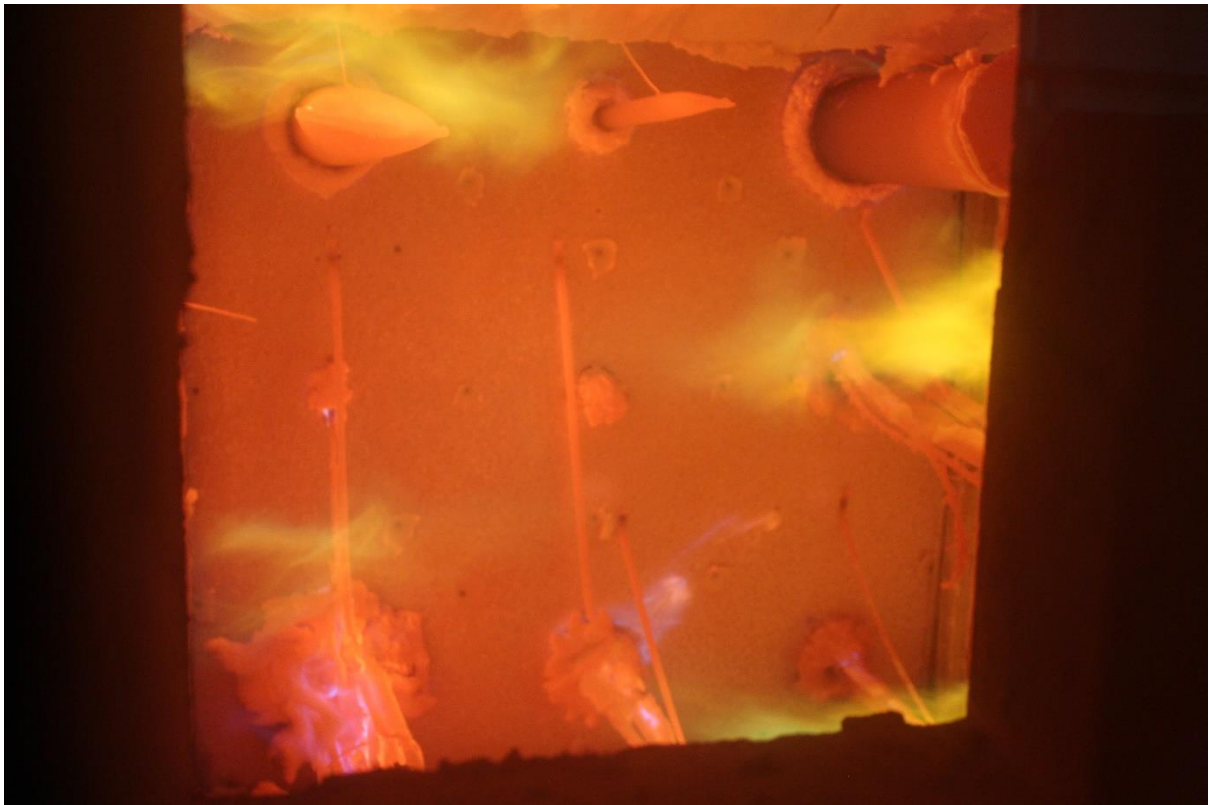
Figure 27 – Exposed face at 30 minutes

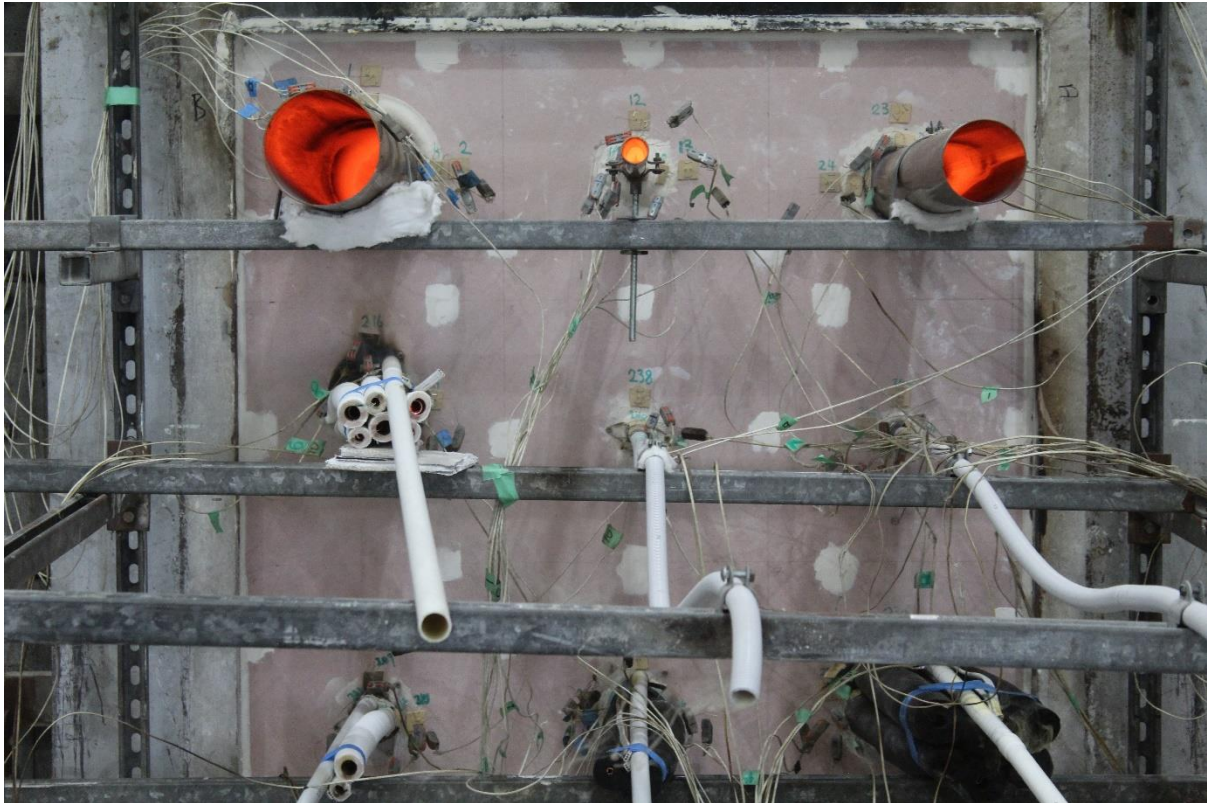
Figure 28 – Unexposed face at 45 minutes

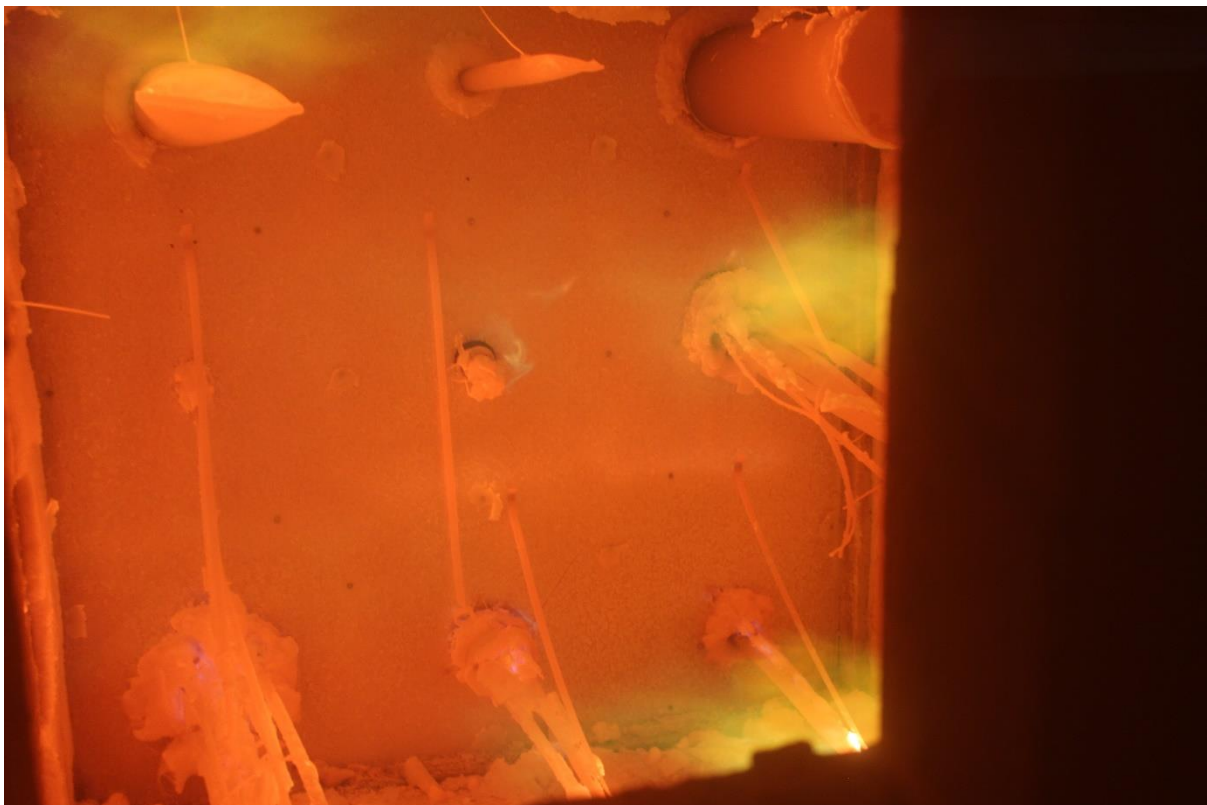
Figure 29 – Exposed face at 45 minutes

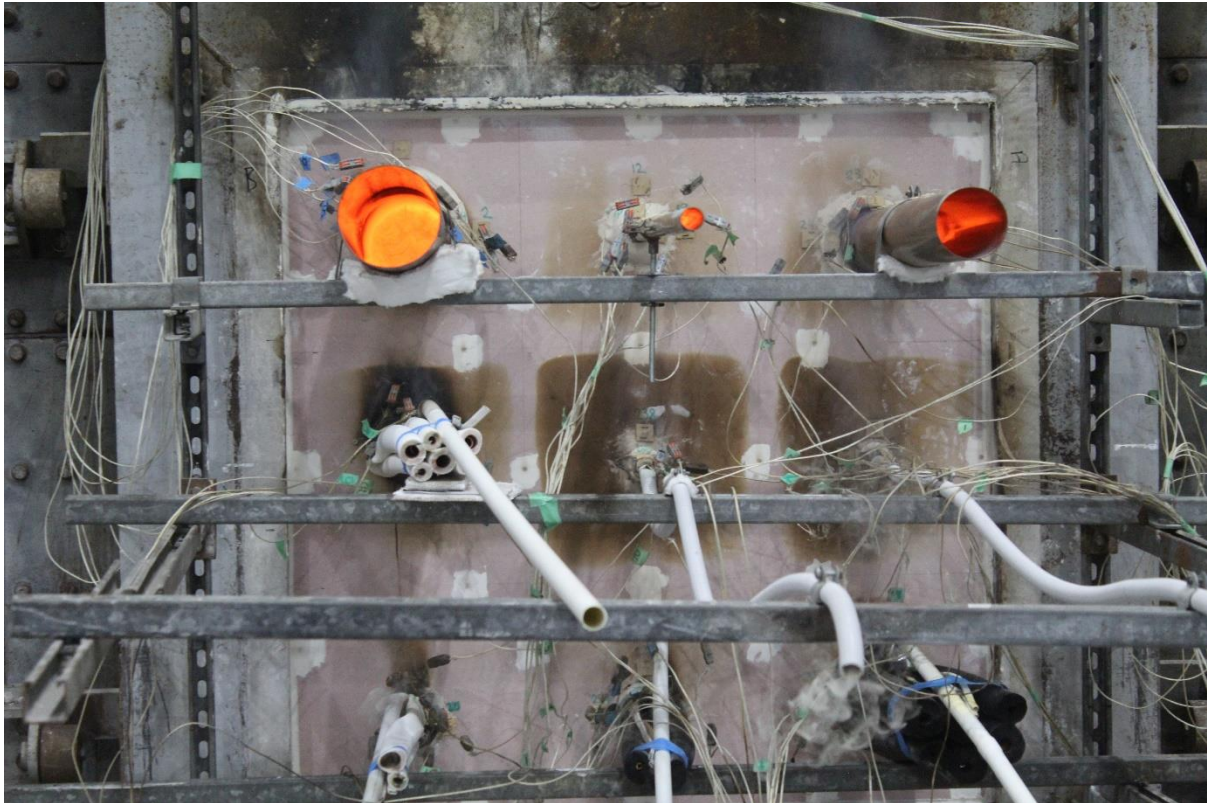
Figure 30 – Unexposed face at 60 minutes

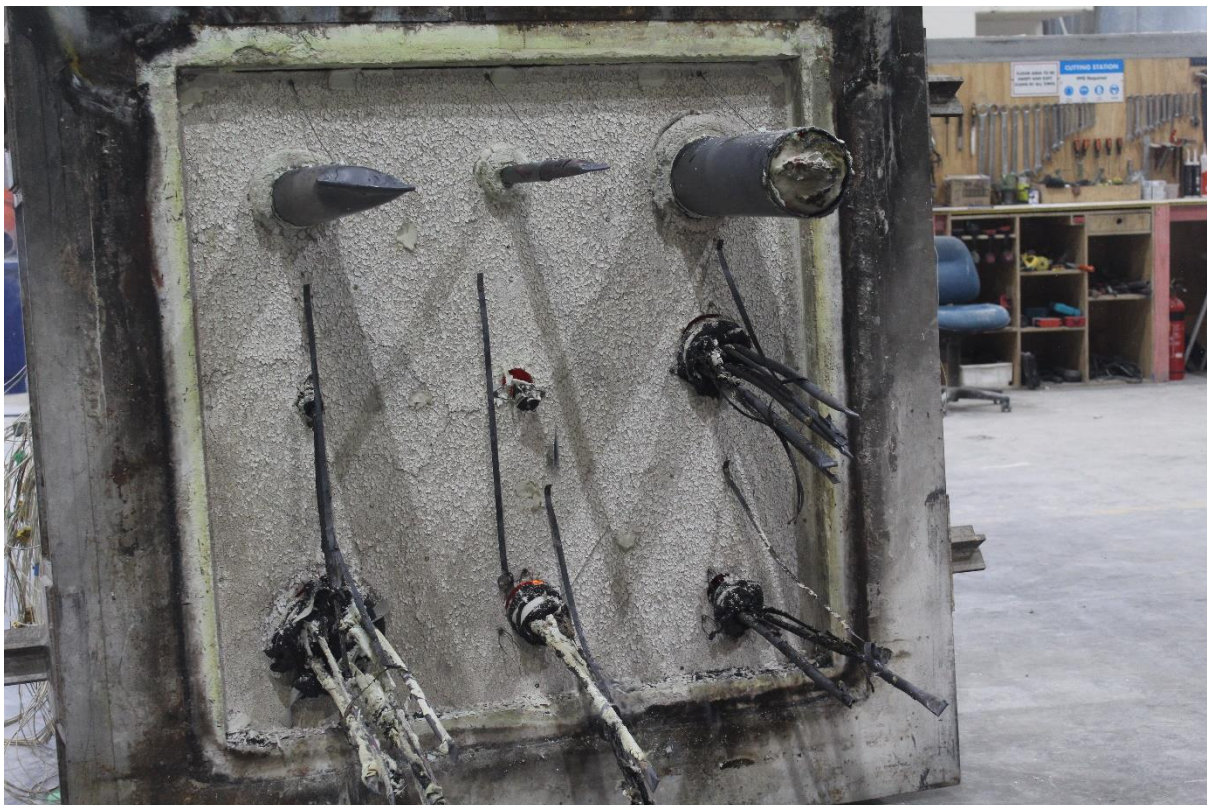
Figure 31 – Exposed face after the test
