# Regulatory Information Report

**RIRF25005**

**Fire resistance test for penetration through a  
vertical separating element**

| Test method: | AS1530.4-2014 |

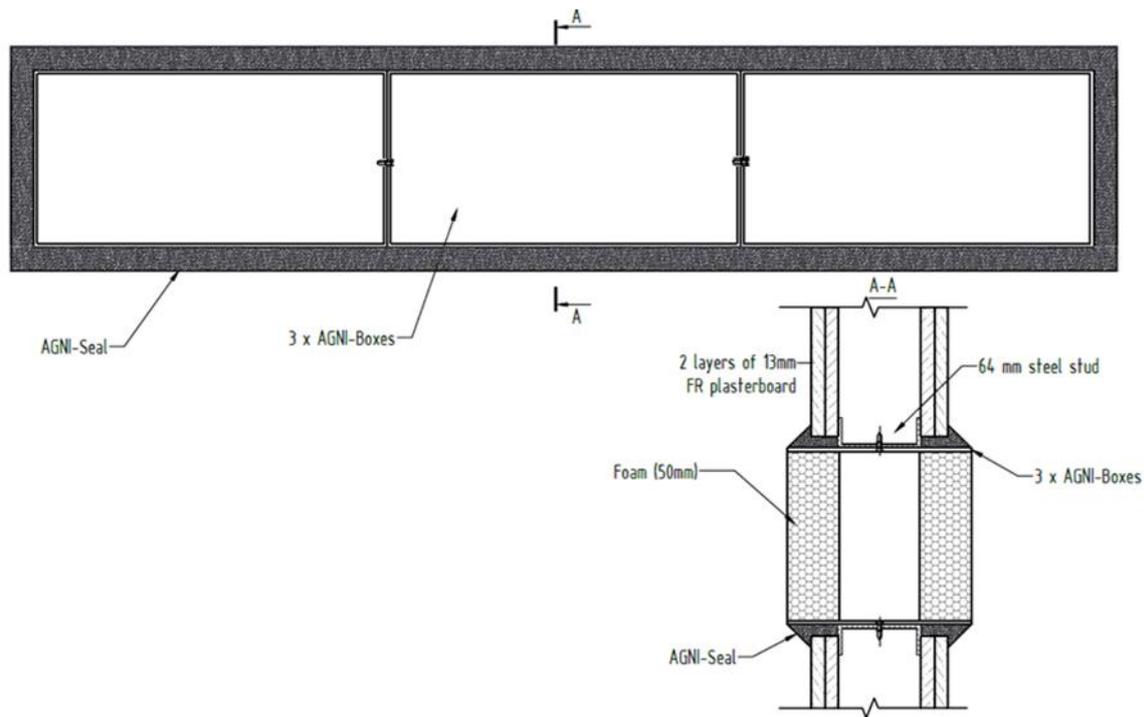
## 5.2 Specimen 1

| Service penetration details | |
|---|---|
| Service | 3 x AGNI-Boxes (horizontally joined) |
| Aperture Size | Width x Height: 910mm x 155mm |
| Annular Spacing | Min: 1.0mm, Max: 7.0mm |

| Local Fire-stopping system | |
|---|---|
| Procedure | <ol style="list-style-type: none"> <li>1. 10mm bead of AGNI-Seal applied to joining surfaces around the perimeter to seal any gaps between the AGNI-Boxes.</li> <li>2. AGNI-Boxes secured together horizontally using bolts and nuts through pre-punched holes in the centre of adjoining faces.</li> <li>3. AGNI-Boxes module inserted into the steel stud frame and secured using screws at the top and bottom of each box and sides of outer AGNI-Boxes. Screws were fixed through existing holes in the centre of each surface.</li> <li>4. 50mm x 50mm AGNI-Seal sealant cone applied around the perimeter of the three AGNI-Boxes.</li> </ol> |

| Specimen # | Service | Actual Integrity (min) | Actual Insulation (min) | FRL |
|---|--|---|---|---|
| 1 | 3 x AGNI-Boxes (horizontally joined) | 123NF | 123NF | -/120/120 |

| Time min | Test face | SP# | OBSERVATIONS/REMARKS |
|---|---|---|---|
| 61 | U | 1 | Box A (left most box) intumescent pushed foam face out of specimen |
| 69 | U | 1 | Box B (centre box) intumescent pushed foam face out of specimen |
| 70 | U | 1 | Box C (right most box) intumescent pushed foam face out of specimen |

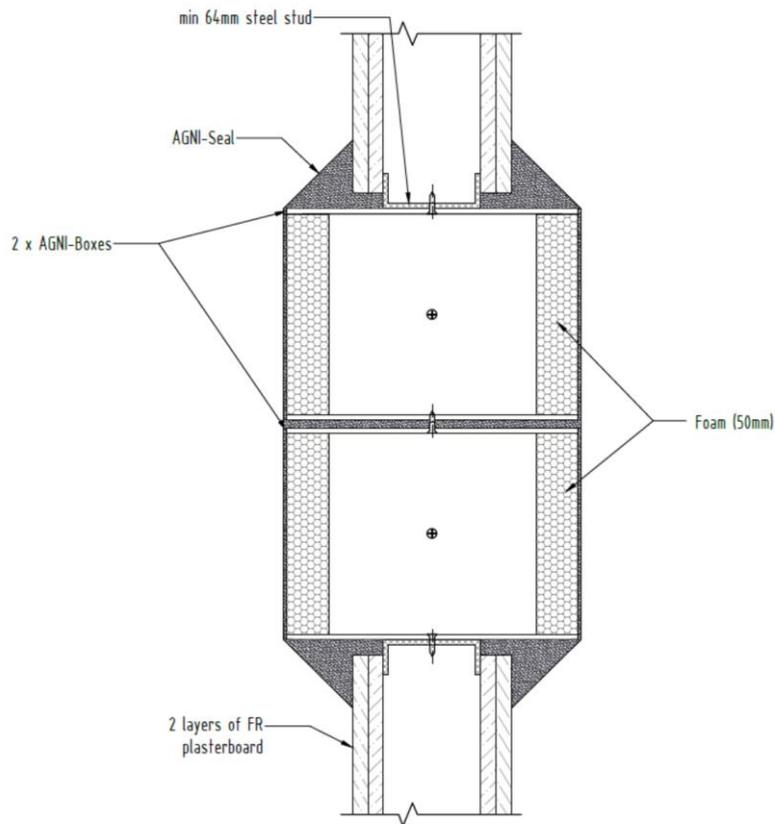
### 5.3 Specimen 2

| Service penetration details | |
|---|---|
| Service | 2 x AGNI-Boxes (vertically joined) |
| Aperture Size | Width x Height: 310mm x 310mm |
| Annular Spacing | Min: 1.0mm, Max: 9.0mm |

| Local Fire-stopping system | |
|---|--|
| Procedure | <ol style="list-style-type: none"> <li>1. 10mm bead of AGNI-Seal was applied to joining surfaces around the perimeter to seal any gaps between the AGNI-Boxes.</li> <li>2. AGNI-Boxes secured together vertically using bolt and nut through pre-punched holes in the centre of adjoining faces.</li> <li>3. AGNI-Boxes module inserted into the steel stud frame and secured using screws at the top and bottom of each box and sides of outer AGNI-Boxes. Screws were fixed through existing holes in the centre of each surface.</li> </ol> |

| | 4. 50mm x 50mm AGNI-Seal sealant cone applied around the perimeter of the three AGNI-Boxes. |

| Specimen # | Service | Actual Integrity (min) | Actual Insulation (min) | FRL |
|---|--|---|---|---|
| 2 | 2 x AGNI-Boxes (vertically joined) | 123NF | 123NF | -/120/120 |

| Time min | Test face | SP# | OBSERVATIONS/REMARKS |
|---|---|---|---|
| 76 | U | 2 | Box A (top box) intumescent pushed foam face out of specimen |
| 81 | U | 2 | Box B (bottom box) intumescent pushed foam face out of specimen |

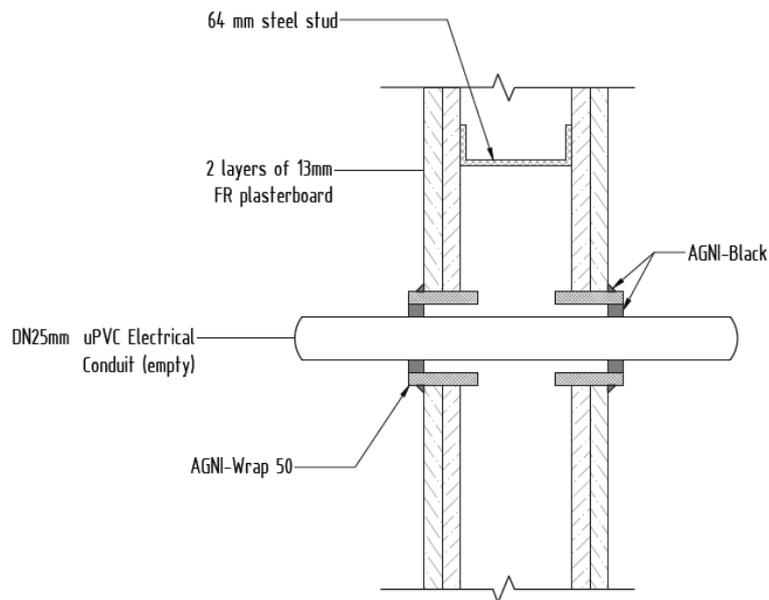
## 5.4 Specimen 3

| Service penetration details | |
|---|---|
| Service | uPVC Electrical Conduit 25mm (empty) |
| Aperture Size | 45.8mm |
| Annular Spacing | Min: 9.0mm, Max: 11.8mm |

| Local Fire-stopping system | |
|---|--|
| Procedure | <ol style="list-style-type: none"> <li>1. AGNI-Wrap 50 cut to fit one revolution of the aperture.</li> <li>2. AGNI-Wrap wrapped around the service and inserted into the aperture, finishing 10mm past the separating element.</li> <li>3. AGNI-Black applied into the gap between the AGNI-Wrap and the pipe 10mm (nominal) deep.</li> <li>4. 5mm (nominal) AGNI-Black applied to seal between the separating element and the AGNI-Wrap.</li> </ol> |

| Specimen # | Service | Actual Integrity (min) | Actual Insulation (min) | FRL |
|---|--|---|---|---|
| 3 | 25mm Conduit Pipe | 123NF | 123NF | -/120/120 |

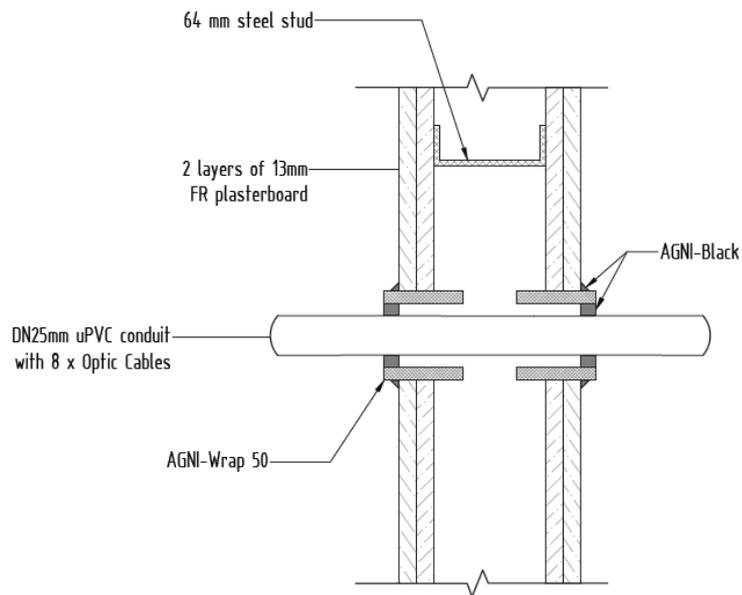
## 5.5 Specimen 4

| Service penetration details | |
|---|--|
| Service | uPVC Electrical Conduit 25mm with 8 x 4.8mm Optic Cables |
| Aperture Size | 45.7mm |
| Annular Spacing | Min: 7.4mm, Max: 13.3mm |

| Local Fire-stopping system | |
|---|--|
| Procedure | <ol style="list-style-type: none"> <li>1. AGNI-Wrap 50 cut to fit one revolution of the aperture.</li> <li>2. AGNI-Wrap wrapped around the service and inserted into the aperture, finishing 10mm past the separating element.</li> <li>3. AGNI-Black applied into the gap between the AGNI-Wrap and the pipe 10mm (nominal) deep.</li> <li>4. 5mm (nominal) AGNI-Black applied to seal between the separating element and the AGNI-Wrap.</li> </ol> |

| Specimen # | Service | Actual Integrity (min) | Actual Insulation (min) | FRL |
|---|--|---|---|---|
| 4 | 25mm Conduit Pipe + 8 x 4.8mm Optic Cables | 123NF | 123NF | -/120/120 |

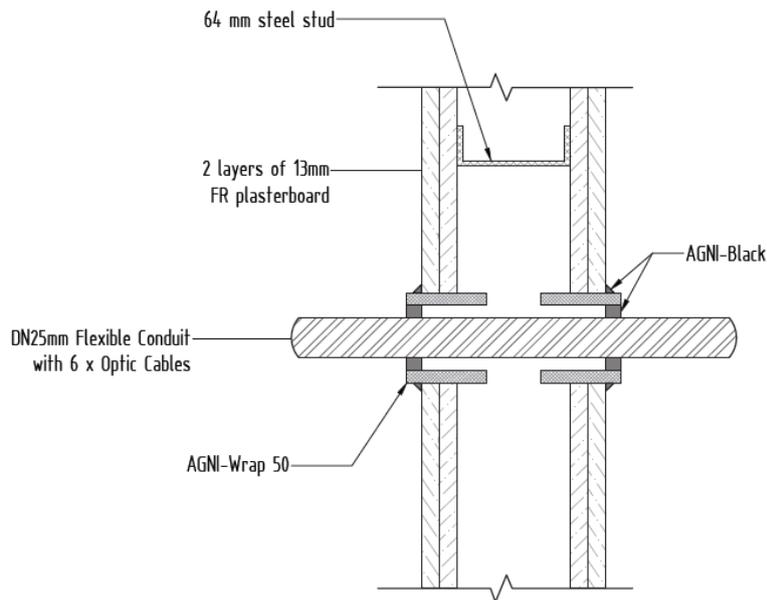
## 5.6 Specimen 5

| Service penetration details | |
|---|--|
| Service | uPVC Flexible Conduit – 25mm with 6 x 4.8mm Optic Cables |
| Aperture Size | 45.8mm |
| Annular Spacing | Min: 6.7mm, Max: 19.1mm |

| Local Fire-stopping system | |
|---|--|
| Procedure | <ol style="list-style-type: none"> <li>1. AGNI-Wrap 50 cut to fit one revolution of the aperture.</li> <li>2. AGNI-Wrap wrapped around the service and inserted into the aperture, finishing 10mm past the separating element.</li> <li>3. AGNI-Black applied into the gap between the AGNI-Wrap and the pipe 10mm (nominal) deep.</li> <li>4. 5mm (nominal) AGNI-Black applied to seal between the separating element and the AGNI-Wrap.</li> </ol> |

| Specimen # | Service | Actual Integrity (min) | Actual Insulation (min) | FRL |
|---|--|---|---|---|
| 5 | 25mm Flexible Conduit + 6 x 4.8mm Optic Cables | 123NF | 123NF | -/120/120 |

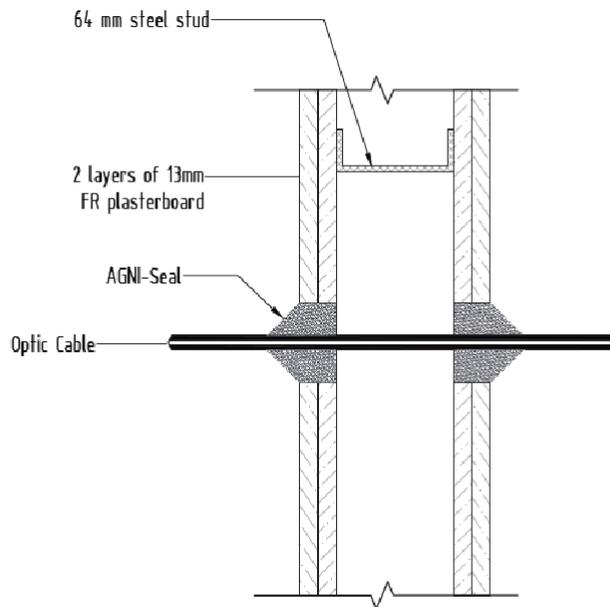
## 5.7 Specimen 6

| Service penetration details | |
|---|---|
| Service | 9.6mm Optic Cable |
| Service Support | Exposed Face: 250mm<br>Unexposed Face: 520mm and 1610mm |
| Aperture Size | 16.7mm |
| Annular Spacing | Min: 2.8mm, Max: 4.2mm |

| Local Fire-stopping system | |
|---|---|
| Procedure | <ol style="list-style-type: none"> <li>1. AGNI-Seal applied into the annular gap to depth of the lining, 26mm (nominal) deep.</li> <li>2. 20mm x 20mm AGNI-Seal sealant cone applied around the cable.</li> </ol> |

| Specimen # | Service | Actual Integrity (min) | Actual Insulation (min) | FRL |
|---|--|---|---|---|
| 6 | 9.6mm Optic Cable | 123NF | 123NF | -/120/120 |

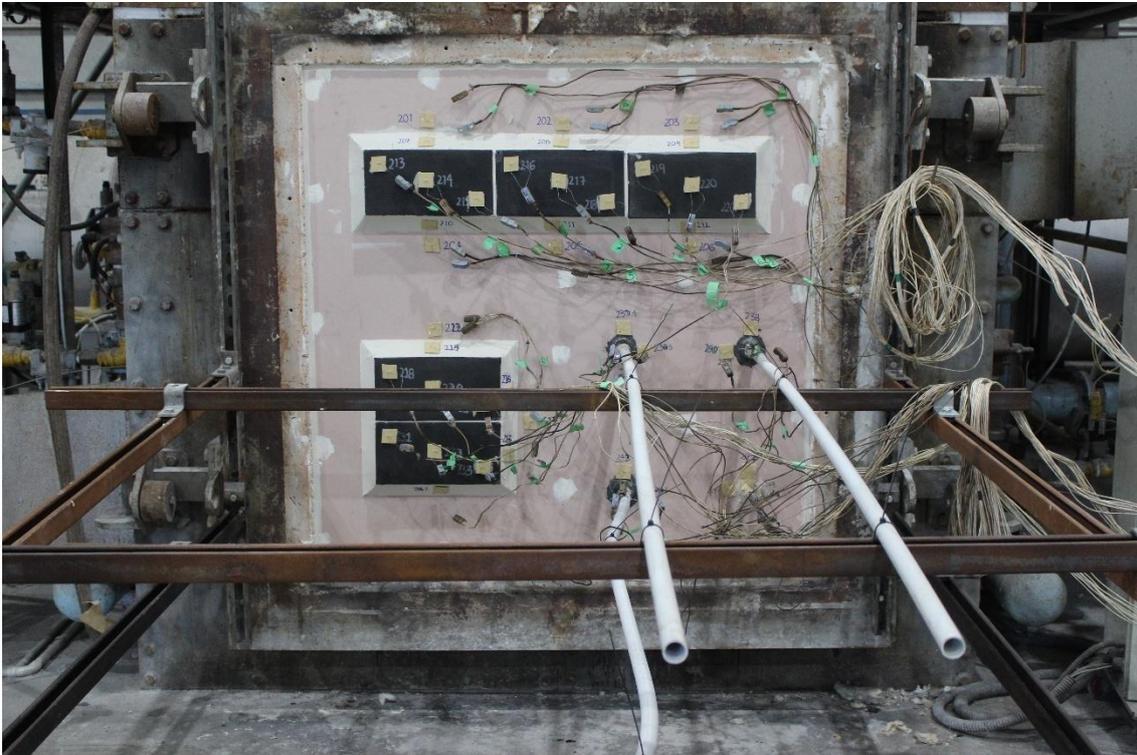
Figure 1 - Unexposed face prior to test commencement

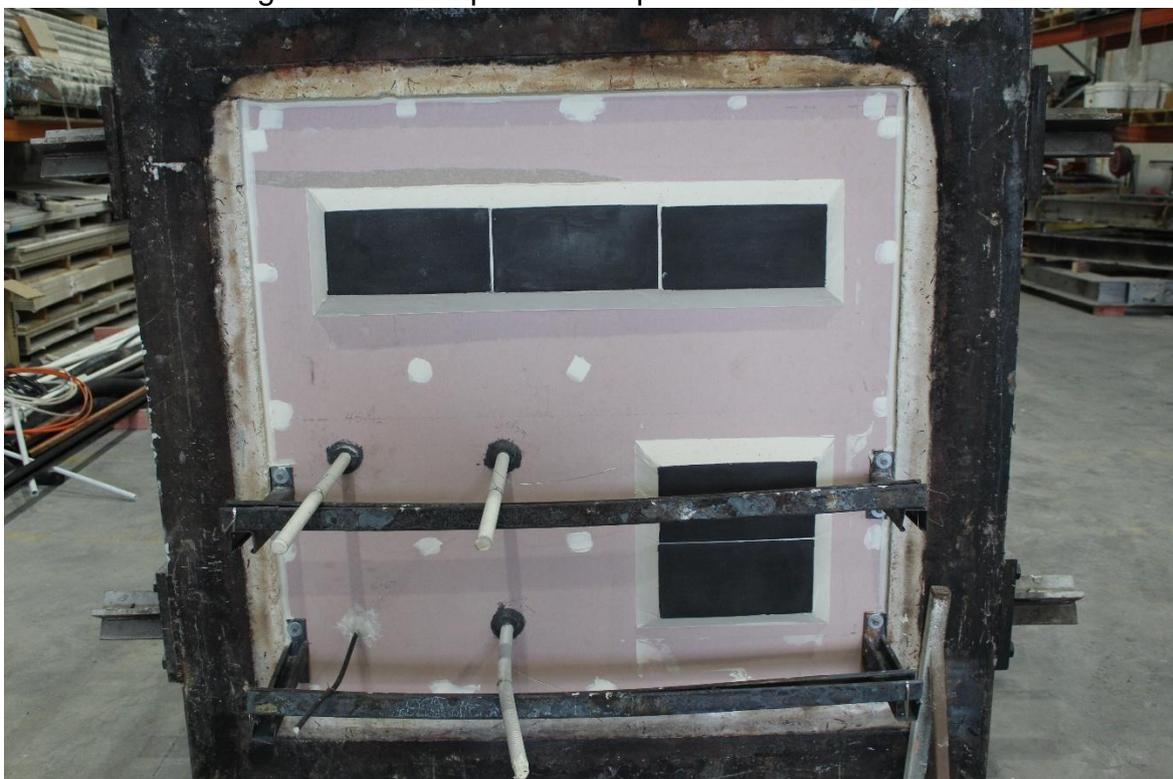
Figure 2 - Exposed face prior to test commencement
