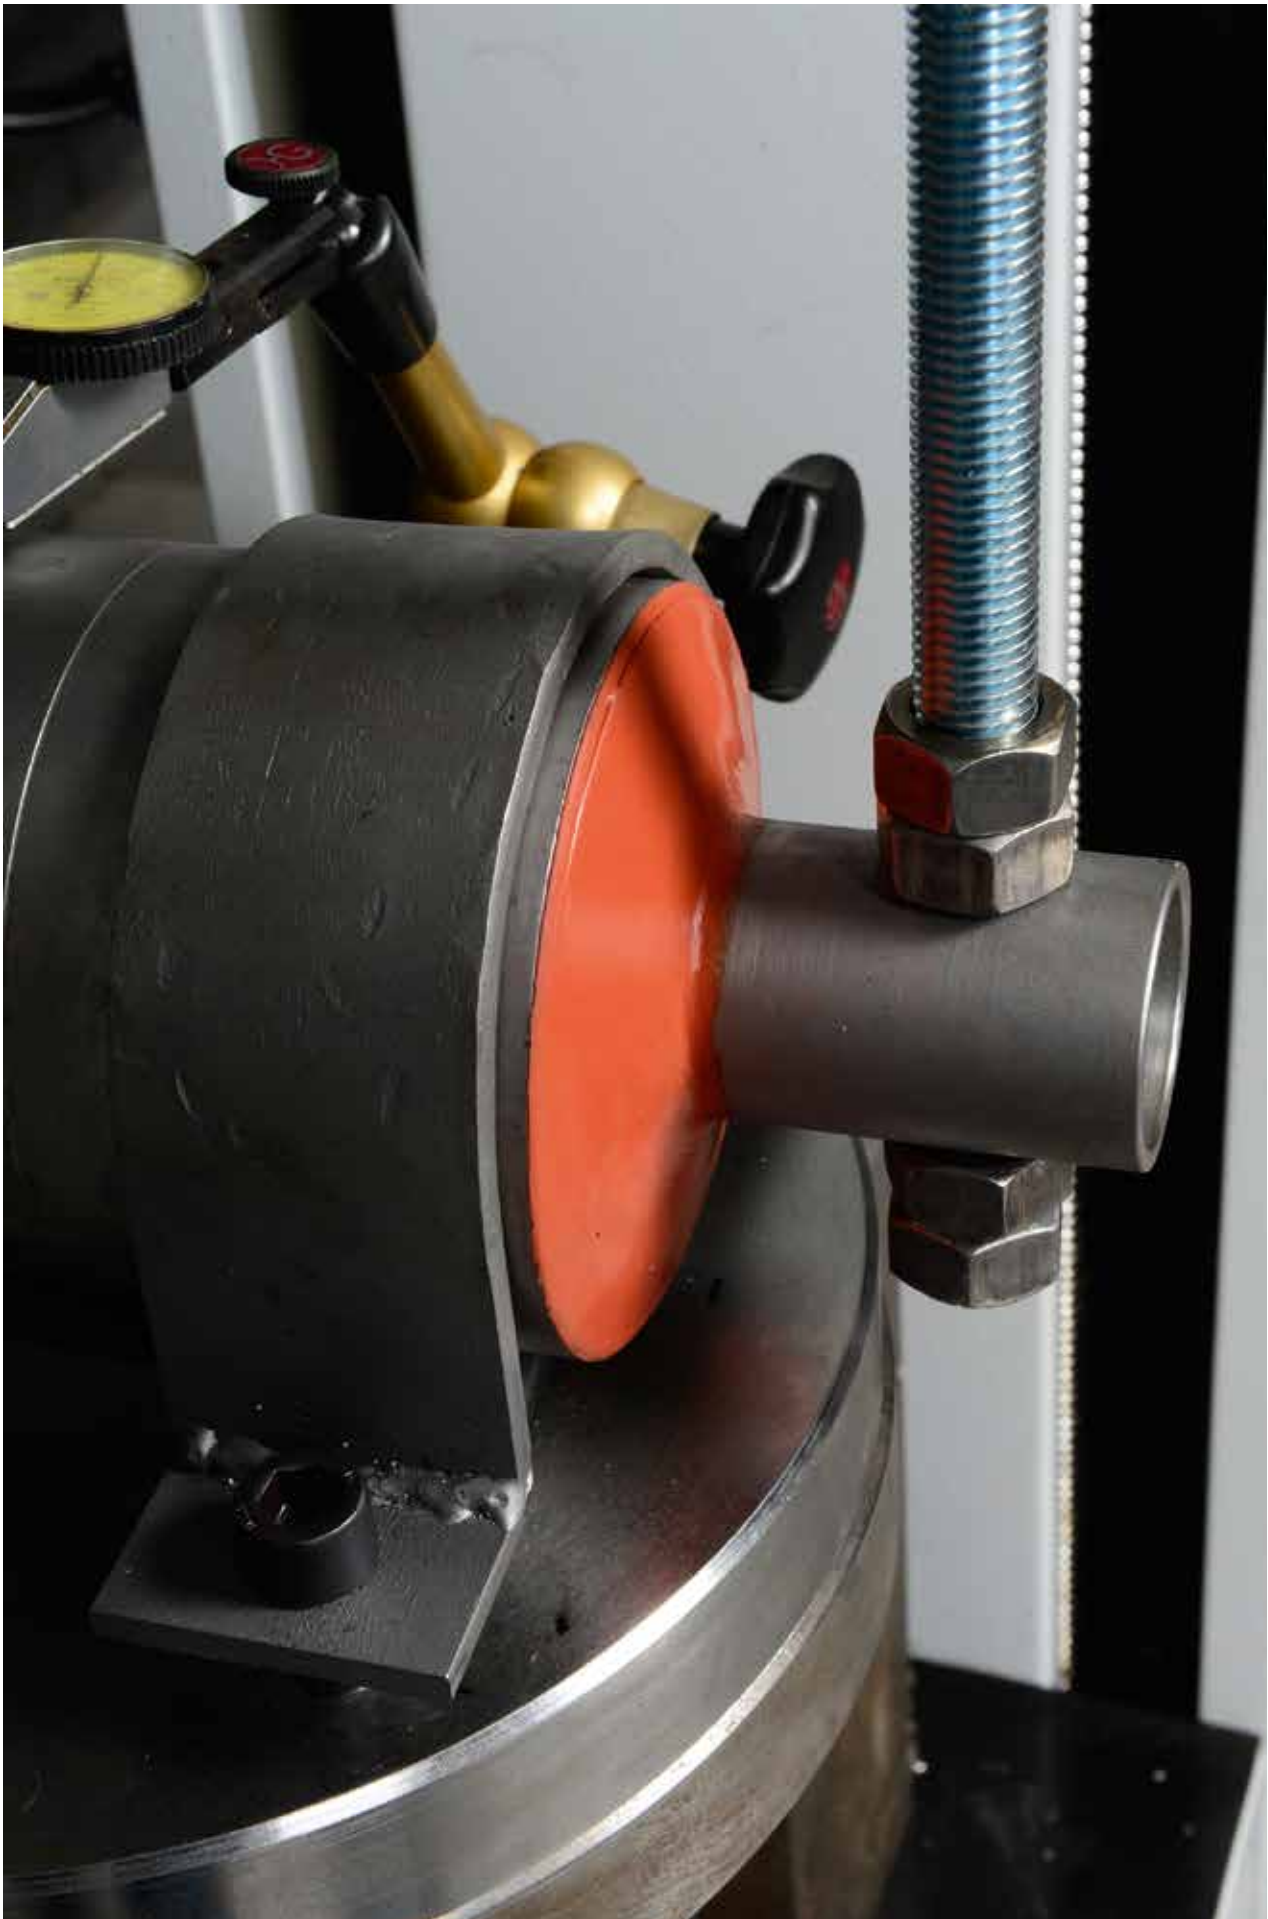
Test set-up for the vertical movement of the ducted pipe upwards/downwards. The upper part of the machine is used for linear displacement (stretch) of the ducted pipe.

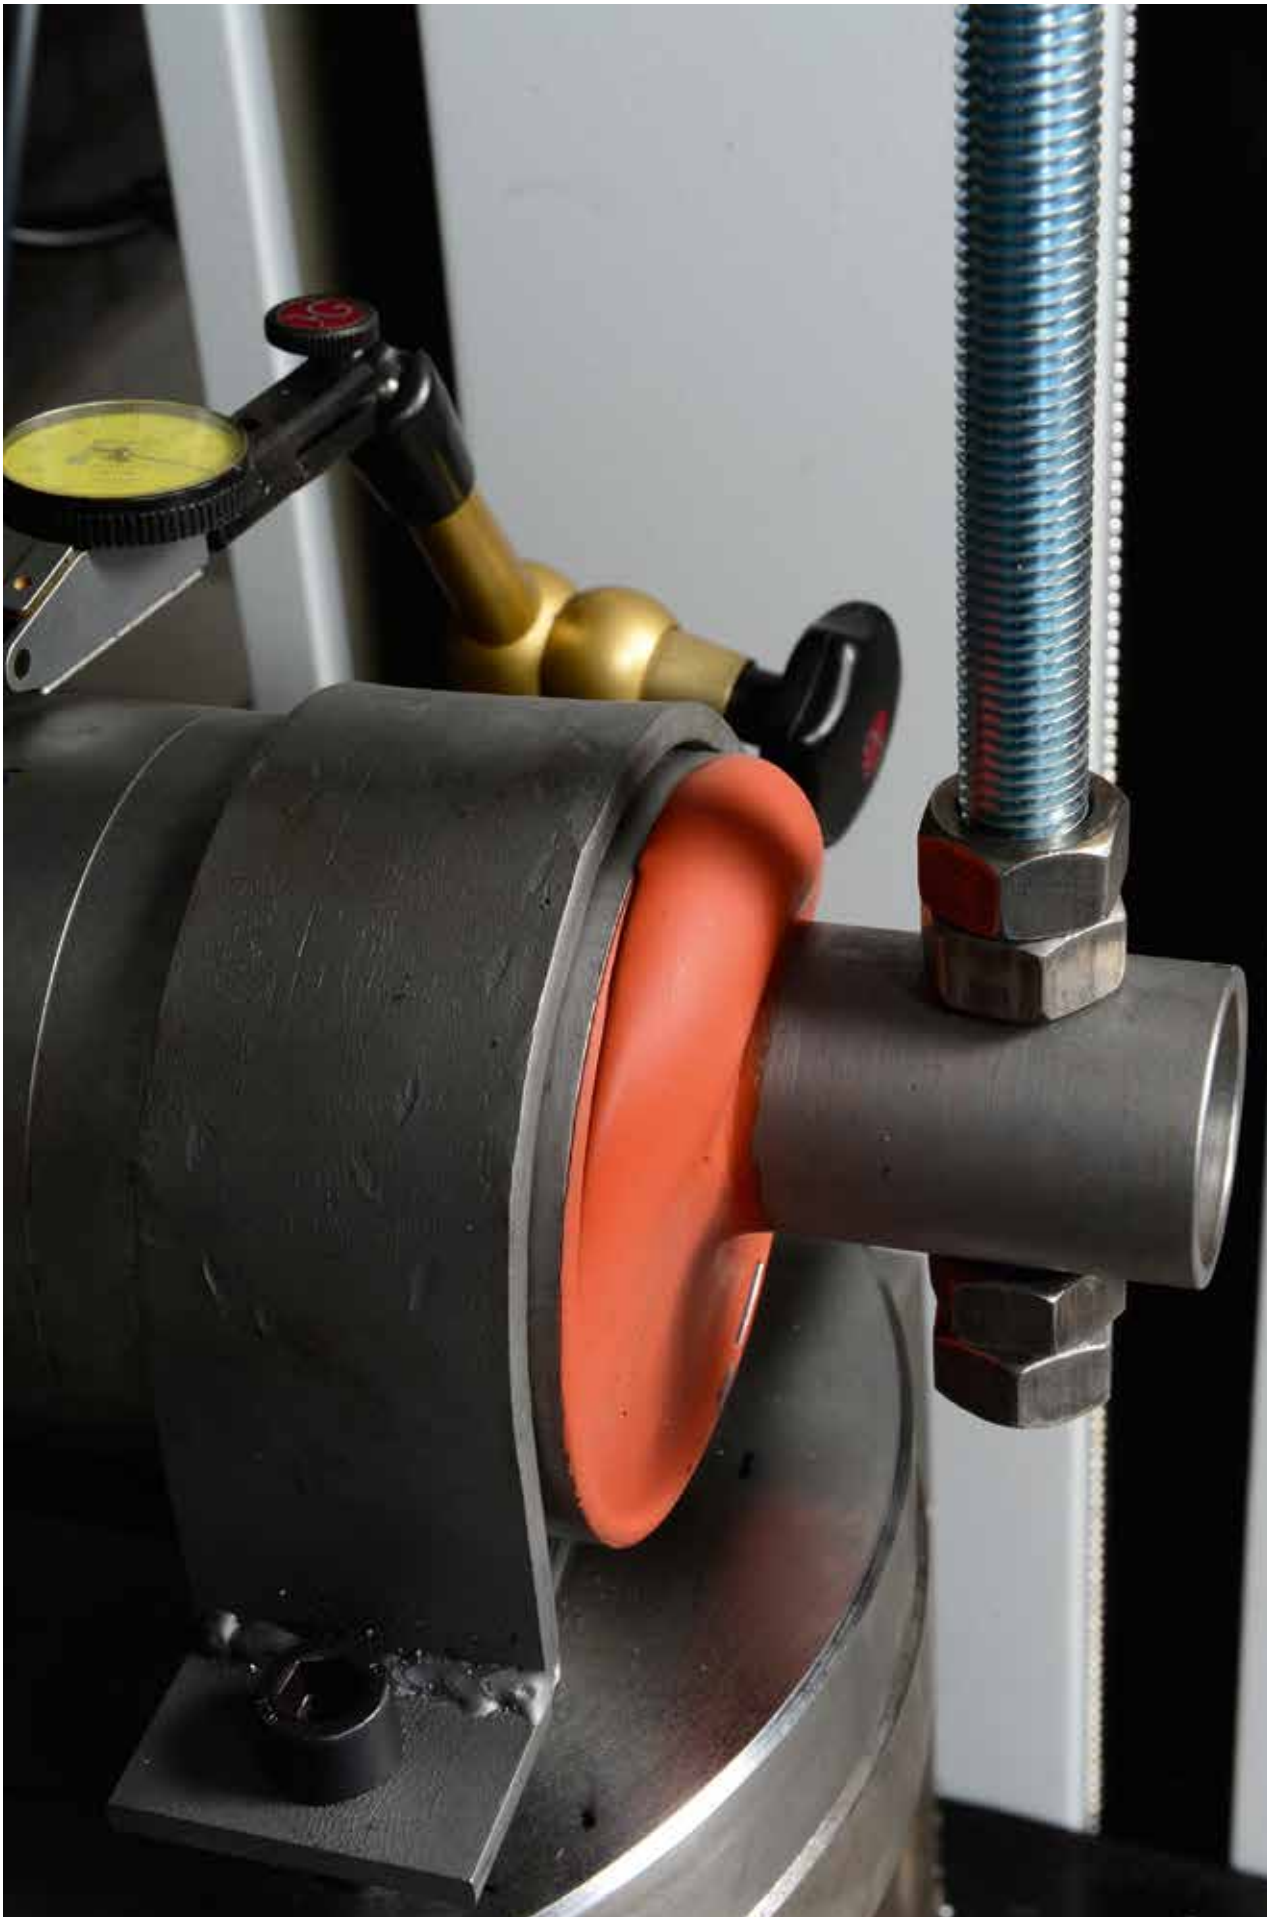
NOFIRNO sealing system with NOFIRNO filler sleeves around the ducted pipe and at both sides a layer of 20 mm NOFIRNO sealant.

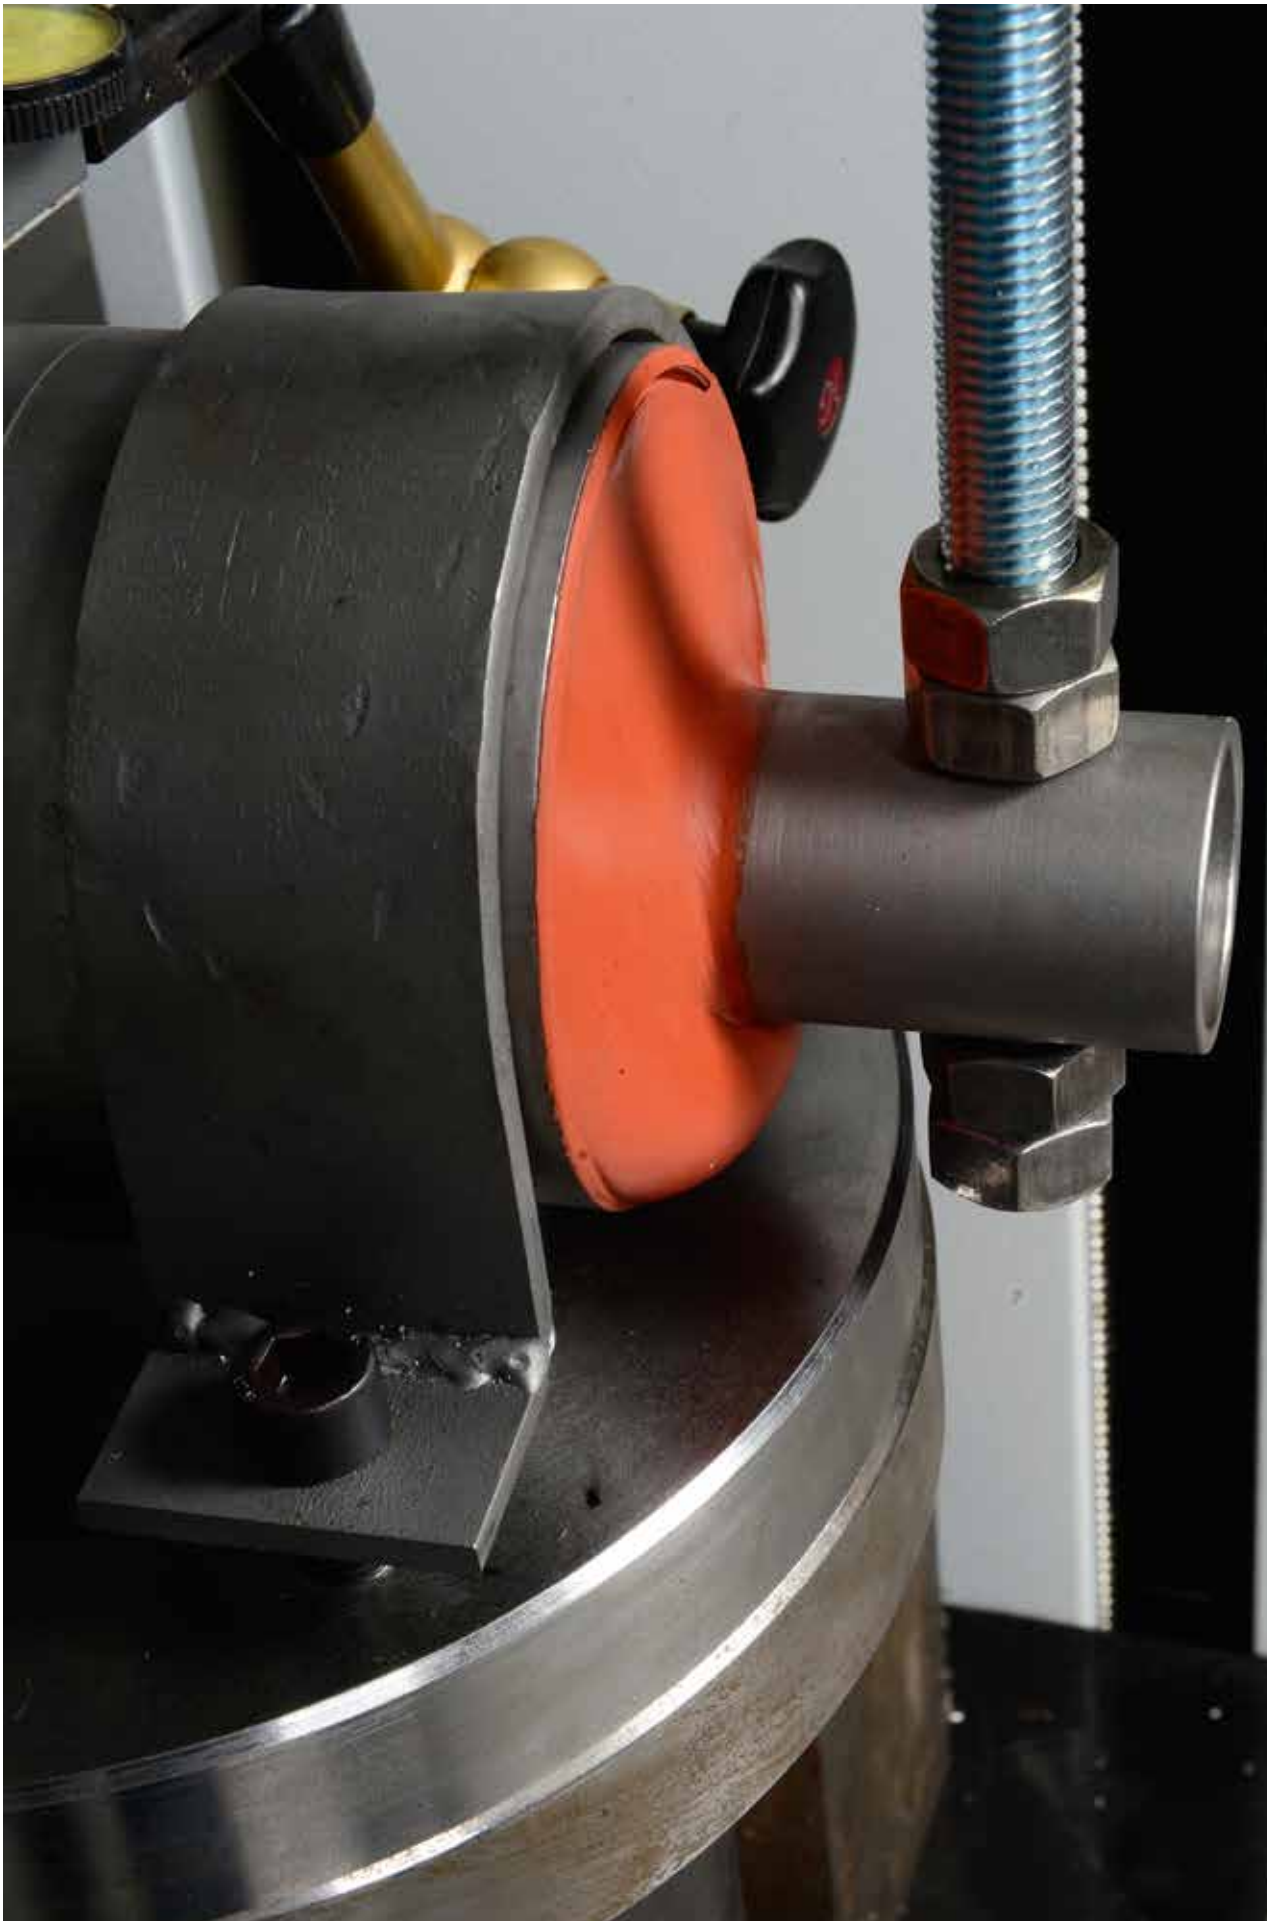
Clearance between the ducted pipe and the conduit sleeve is 30 mm. Movement is set to $+10/-10$ mm. Test is carried out with low up to highest possible speed of the test machine.

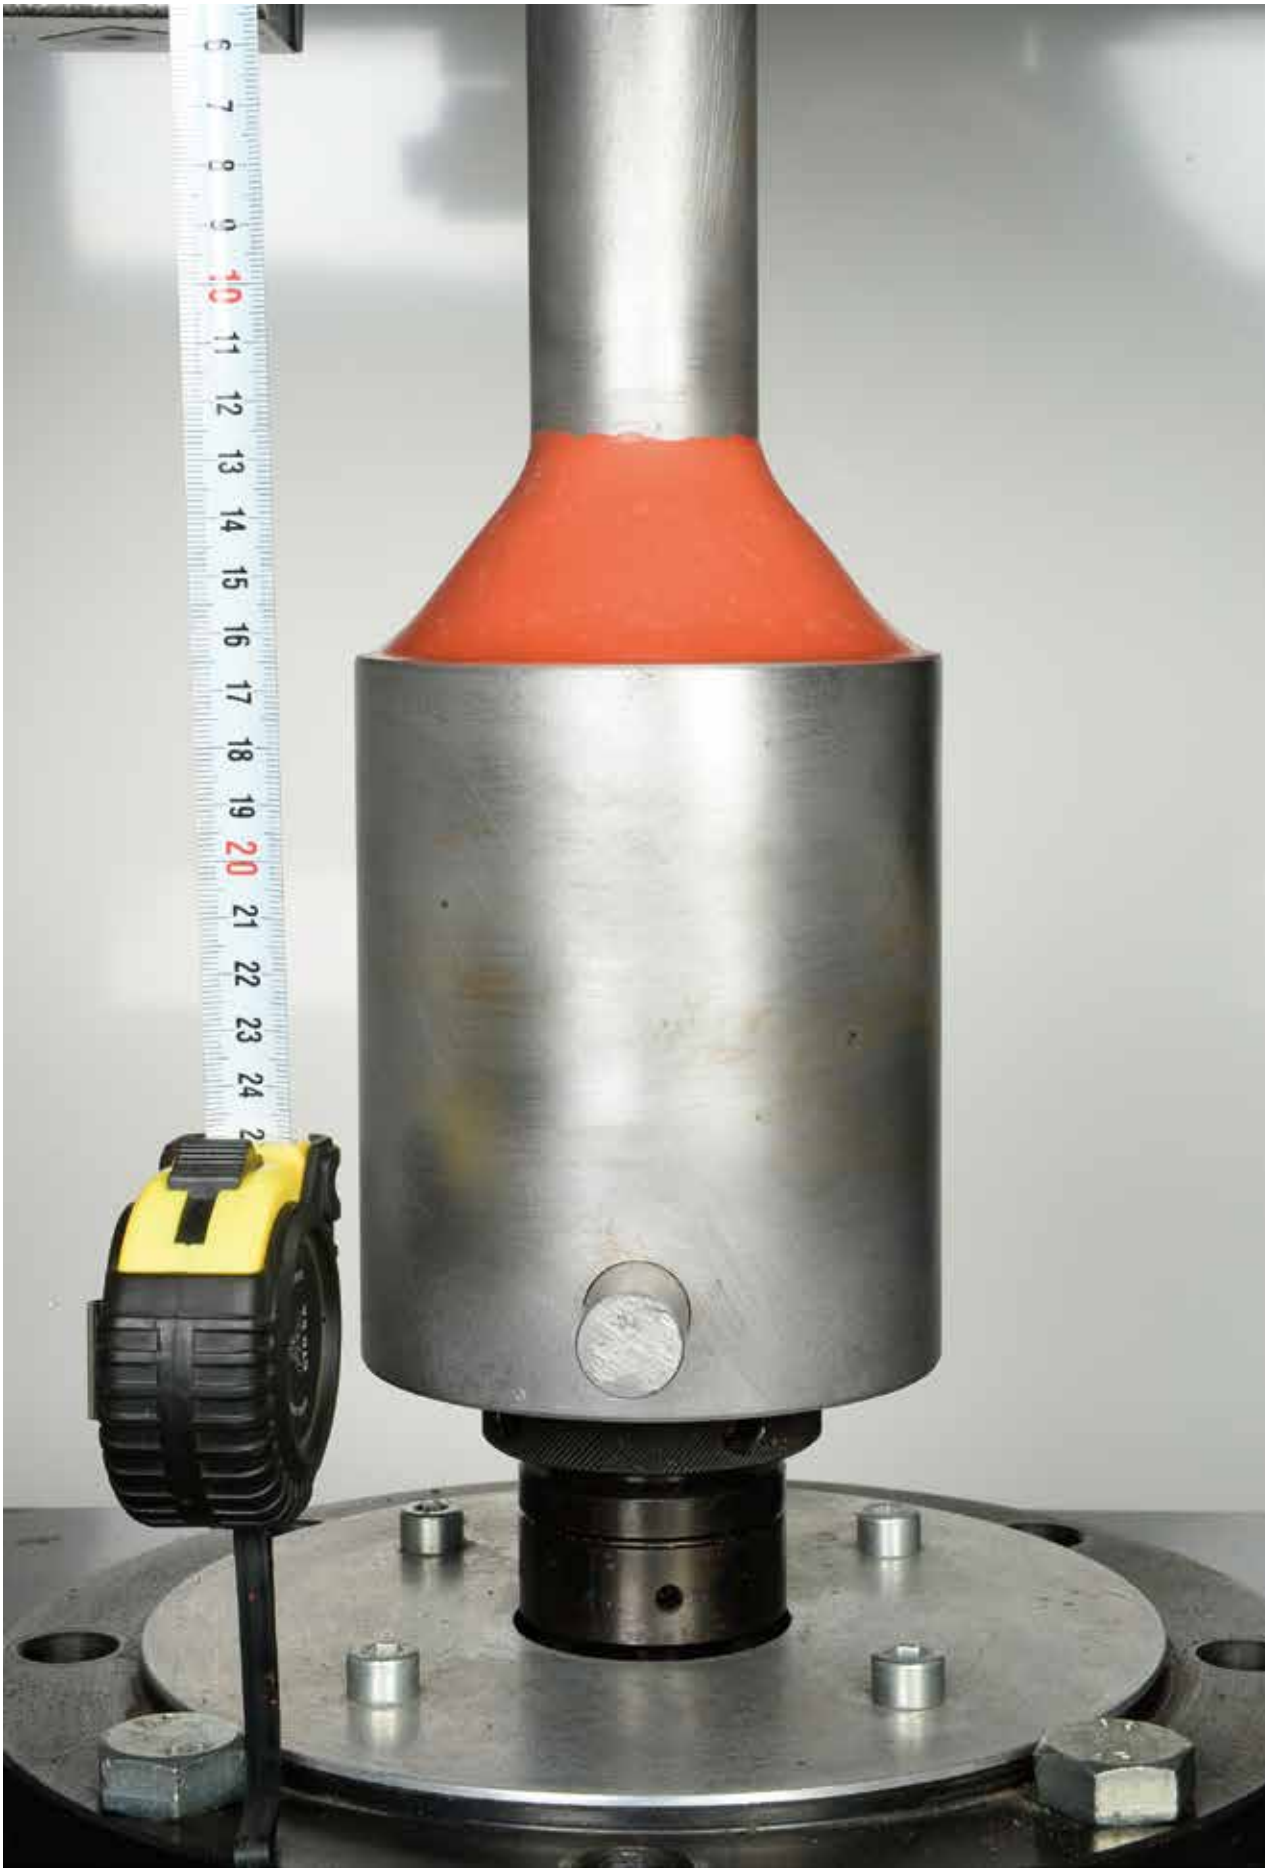
Test set-up for linear movement of the ducted pipe.
