# **Test report # PF23016**

**Client: Tech Coatings NZ Limited**

**Fire resistance test for the steel penetrations  
through the wall**

**Test method: AS 1530.4:2014**

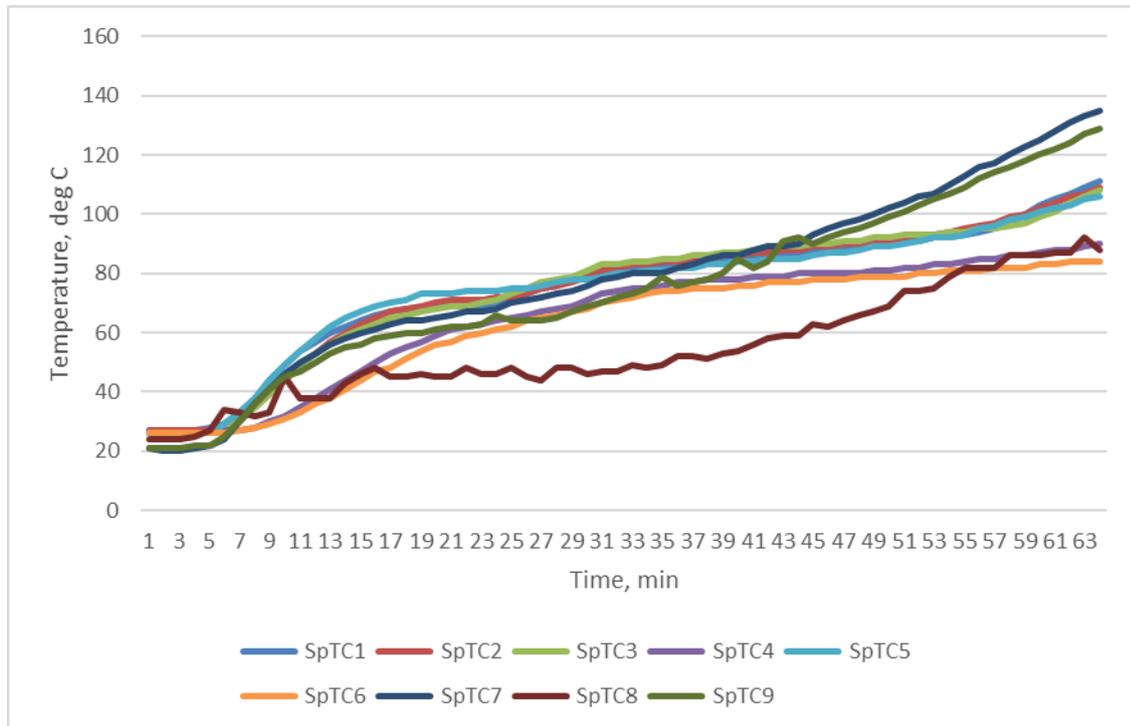
Fig. 5 – Specimen A. Thermocouples data

<b>Structural adequacy</b>	<b>Not applicable</b>
<b>Integrity</b>	<b>No failure at 63 min</b>
<b>Insulation</b>	<b>No failure at 63 min</b>

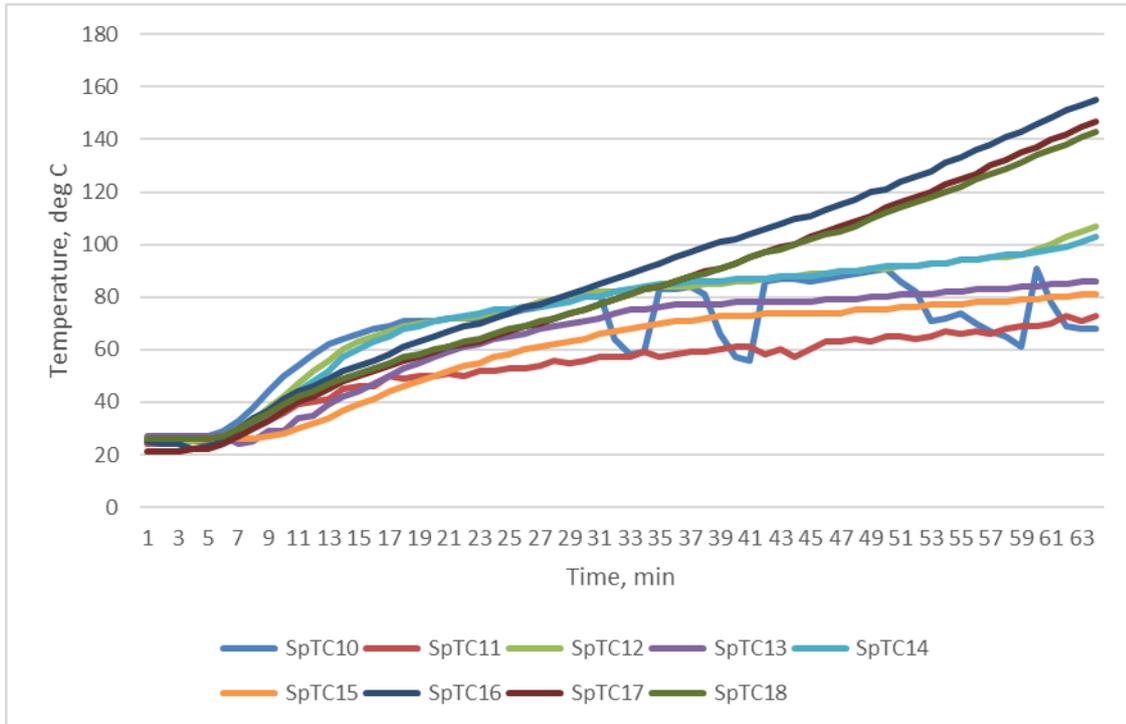
Fig. 7 – Specimen B. Thermocouples data.

<b>Structural adequacy</b>	<b>Not applicable</b>
<b>Integrity</b>	<b>No failure at 63 min</b>
<b>Insulation</b>	<b>No failure at 63 min</b>

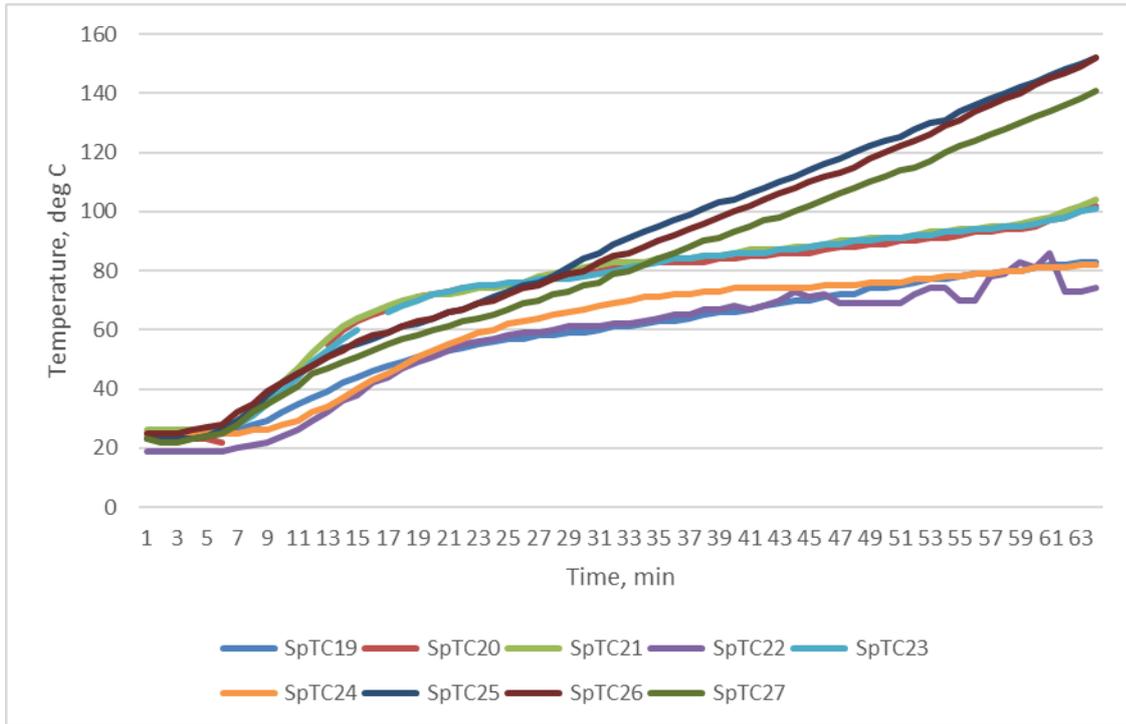
Fig. 9 – Specimen C. Thermocouples data.

<b>Structural adequacy</b>	<b>Not applicable</b>
<b>Integrity</b>	<b>No failure at 63 min</b>
<b>Insulation</b>	<b>No failure at 63 min</b>

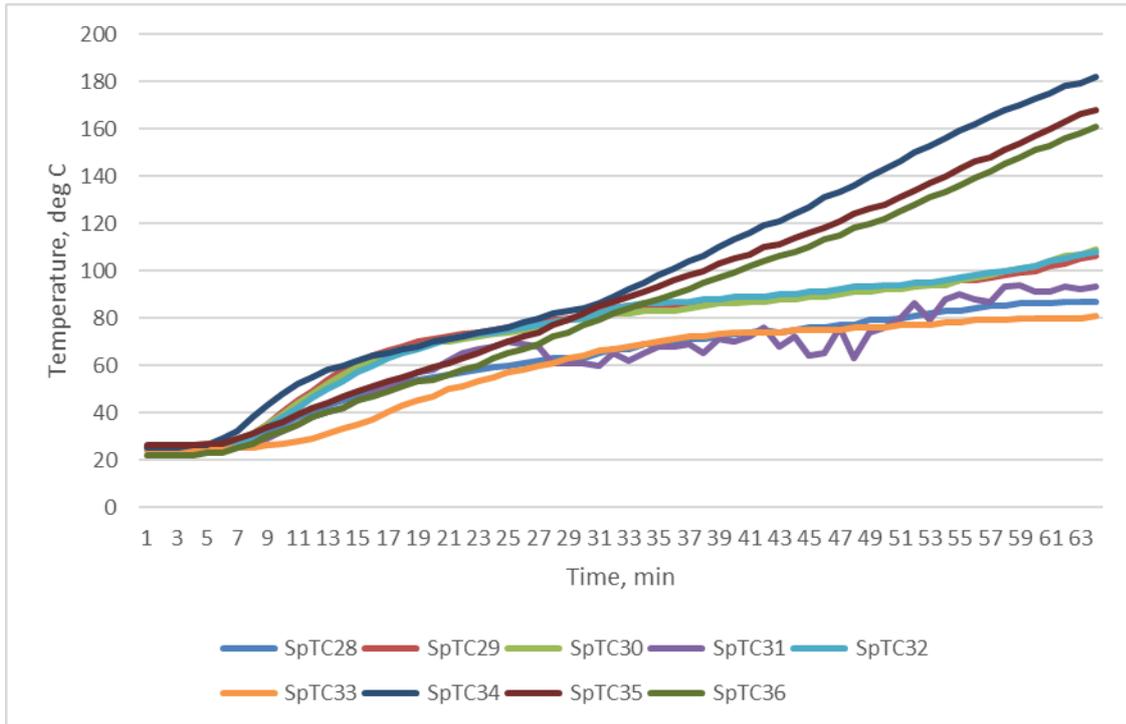
Fig. 11 – Specimen D. Thermocouples data.

<b>Structural adequacy</b>	<b>Not applicable</b>
<b>Integrity</b>	<b>No failure at 63 min</b>
<b>Insulation</b>	<b>No failure at 63 min</b>
